3555-006

**Re: District of Oak Bay
Oak Bay Marina – Dock - Condition Assessment**

Oak Bay Marina – Dock - Condition Assessment

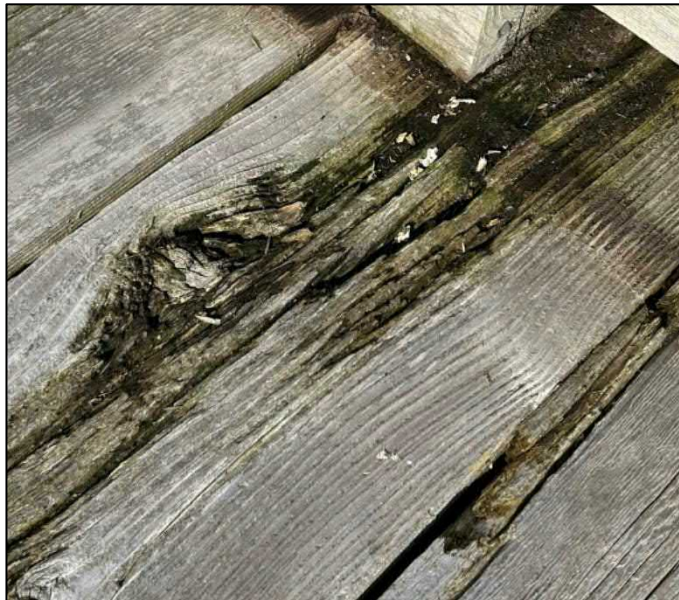
Figure 27 - Example of Deck Board Decay

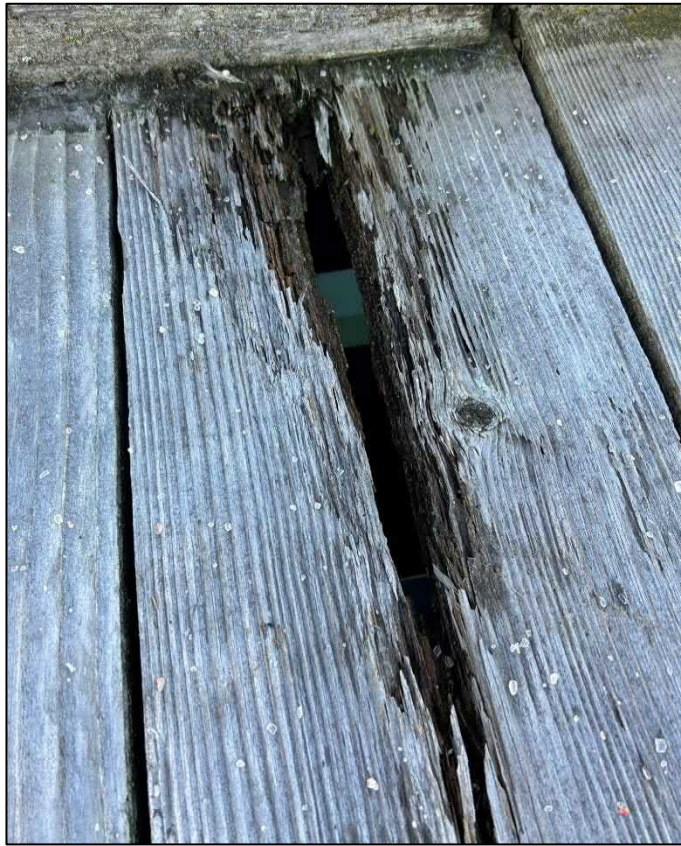
Figure 28 - Example of Deck Board Decay

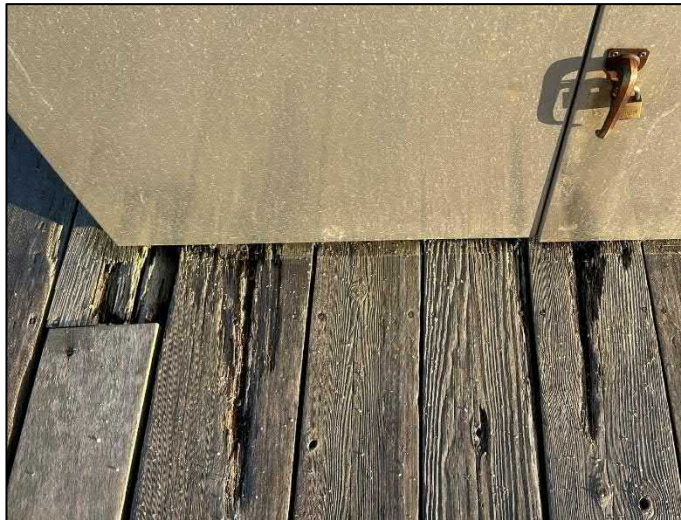
Figure 29 - Example of Deck Board Decay Near Electrical Kiosk

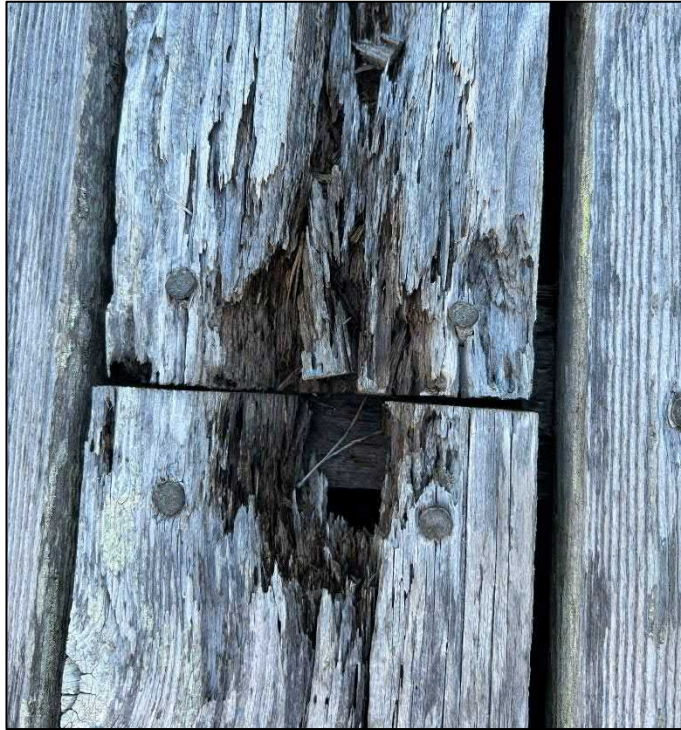
Figure 30 - Example of Deck Board Decay

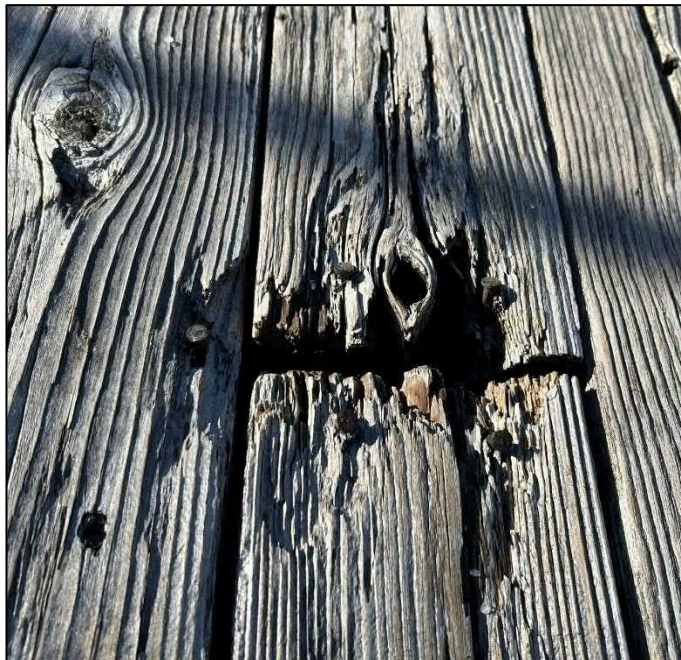
Figure 31 - Example of Deck Board Decay

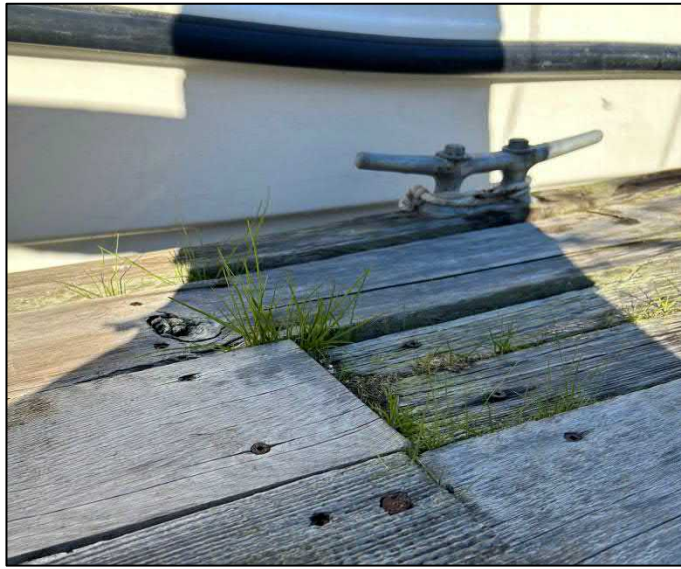
Figure 32 - Example of Deck Board Decay

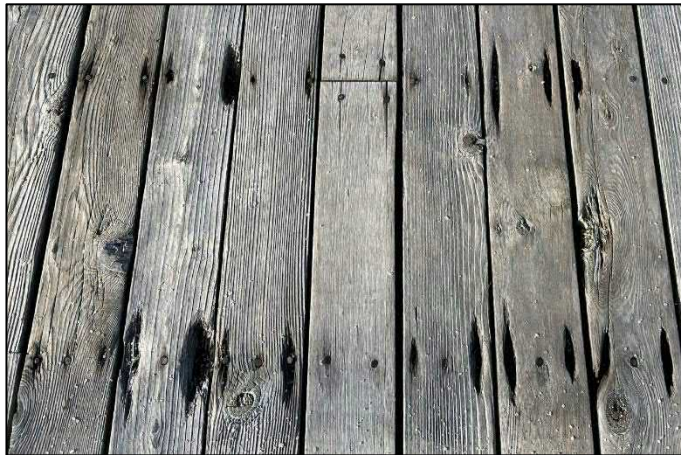
Figure 33 - Example of Deck Board Decay

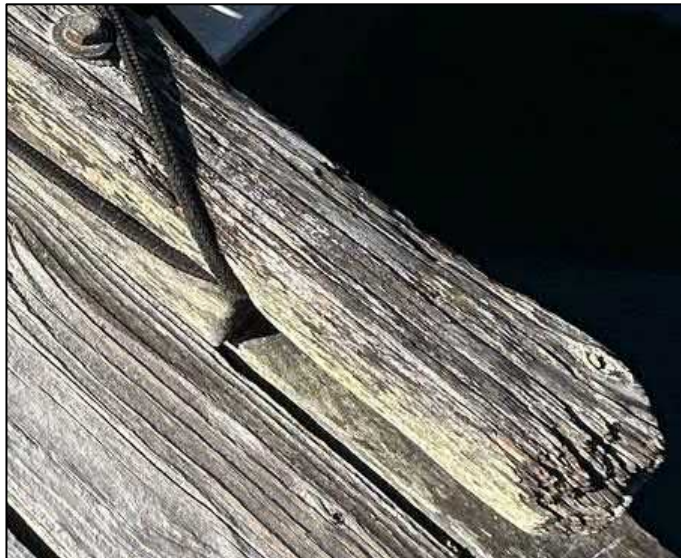
Figure 35 - Example of Decayed Bull Rail

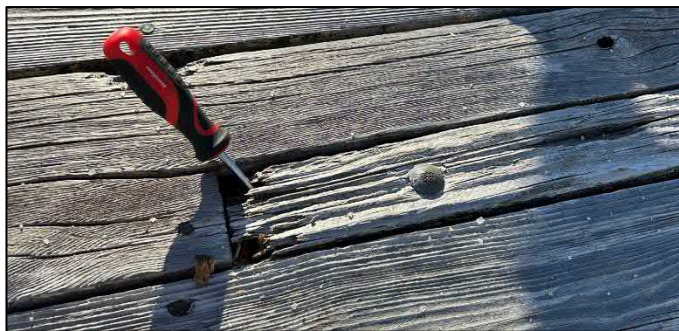
Figure 36 - Example of Decayed Connection Member at Finger Connection to Wing Dock

- The typical connection between the finger sections and the wing docks where the edge members and/or the framing below have deteriorated. Refer to Figure 36, Figure 37, and Figure 38.
- Where a separate float structure is tied to the main dock and Dock B near slips B1 to B7, the additional weight of the attached float appears to be pulling the existing dock framing out of place. In this location, framing members were observed to be split, sagging, and disjointed. It is recommended that these components be replaced, that the area is reinforced, and that additional separate flotation be provided for the attached float. Refer to Figure 42 and Figure 43
- The framing near slip B12 on Dock B has experienced decay and the area is sagging. It is recommended that these timber members be replaced. Refer to Figure 41.

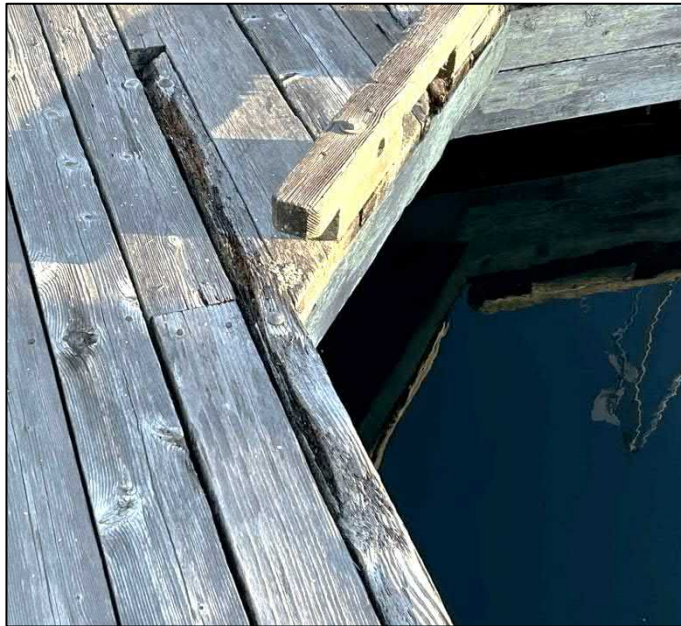
Figure 37 - Example of Decayed Connection Member at Finger Connection to Wing Dock

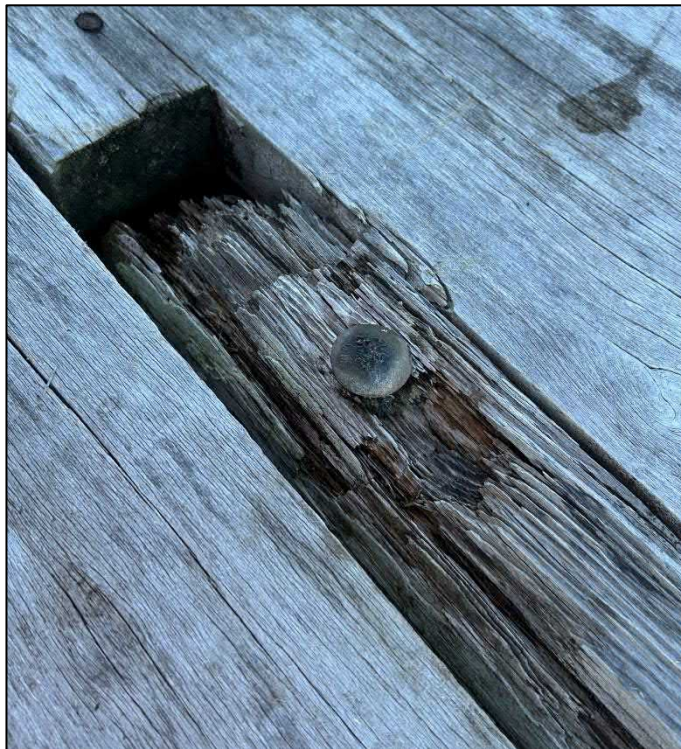
Figure 38 - Example of Decayed Connection Member at Finger Connection to Wing Dock

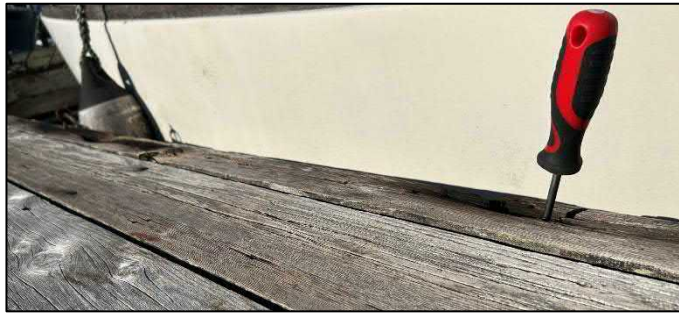
Figure 39 - Example of Decayed Edge Framing Member Along Finger

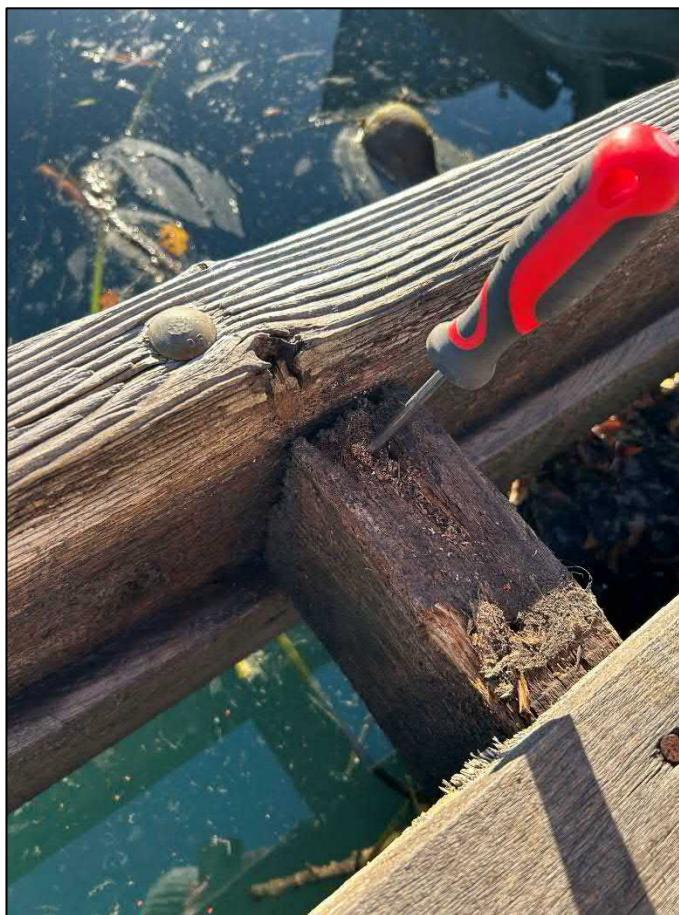
Figure 40 – Example of Decayed Framing Member

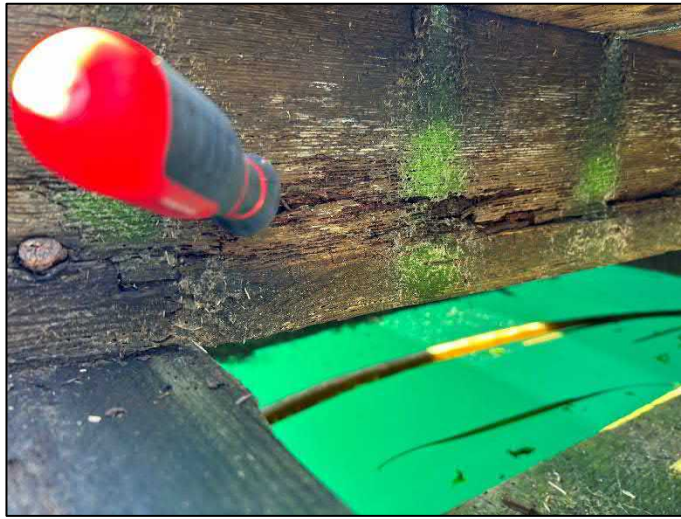
Figure 41 – Decayed Framing Near Slip B12 on Dock B

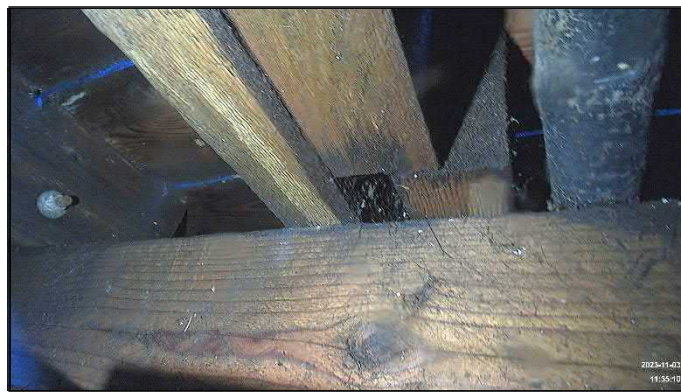
Figure 42 - Disjointed Connection Near Slip B6 on Dock B

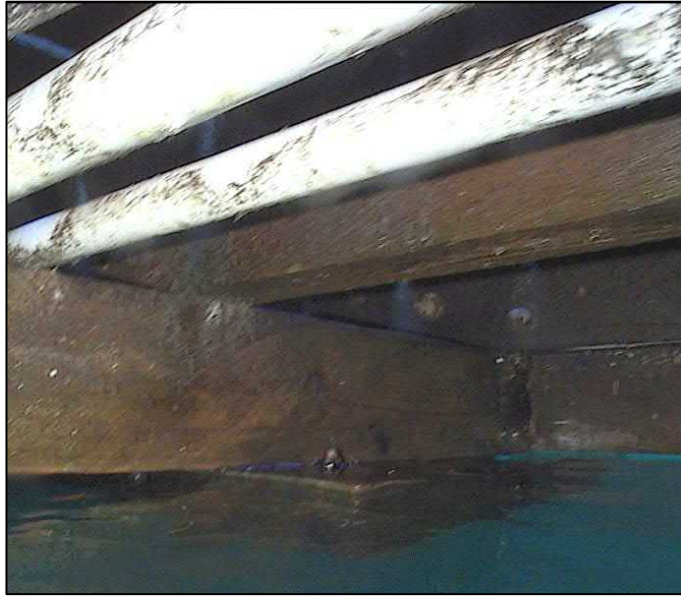
Figure 43 - Sagging Framing Near Slip B7 on Dock B – Near Location of Attached Float

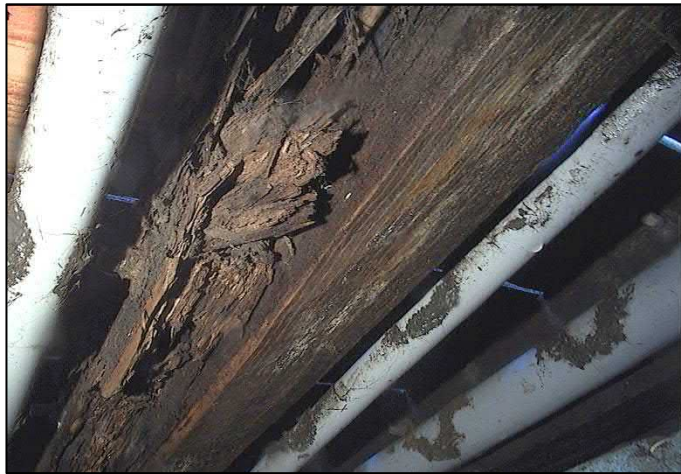
Figure 44 – Damaged Framing Near Dock C and Main Dock Connection

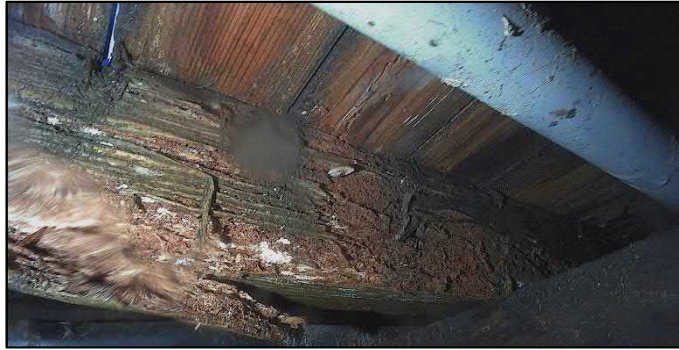
Figure 45 - Decayed Framing Near Slip E31 on Dock E

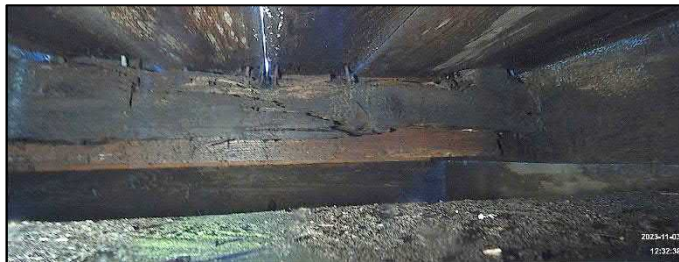
Figure 46 - Decayed Framing on Finger Near Slip C30 on Dock C

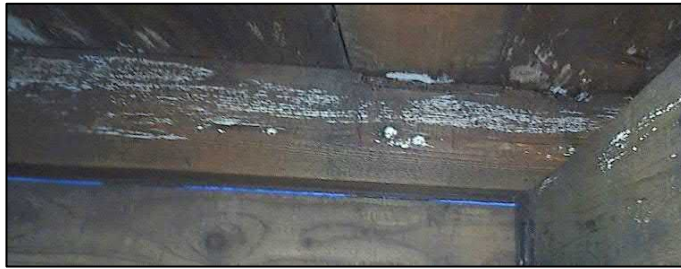
Fungal growth was observed in some areas. These locations are exhibiting minor signs of decay that are considered typical for a marine environment but that also lead to more extensive damage and decay over time. These locations should be monitored for deterioration and addressed as needed with maintenance activities including cleaning, replacing, or sistering existing framing members.

Figure 48 - Example of Fungal Growth on Framing

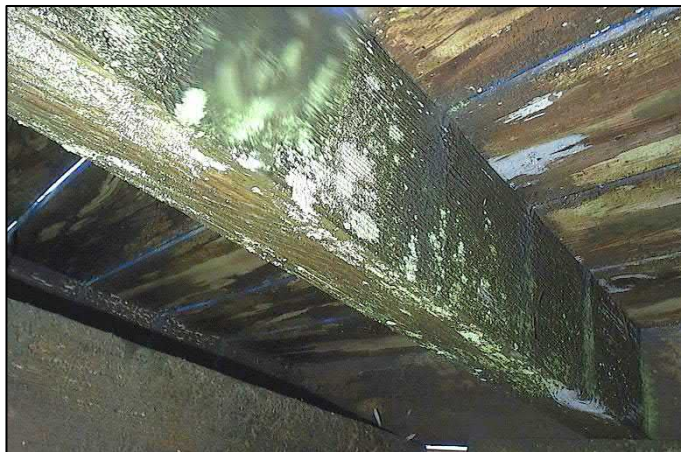
Figure 49 - Example of Fungal Growth on Framing

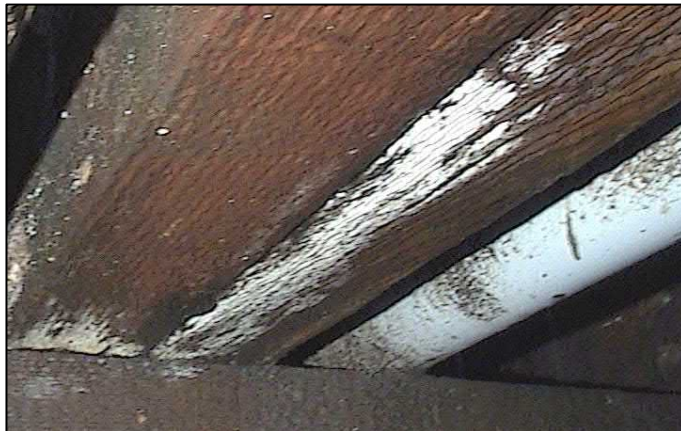
Figure 50 - Example of Fungal Growth on Framing

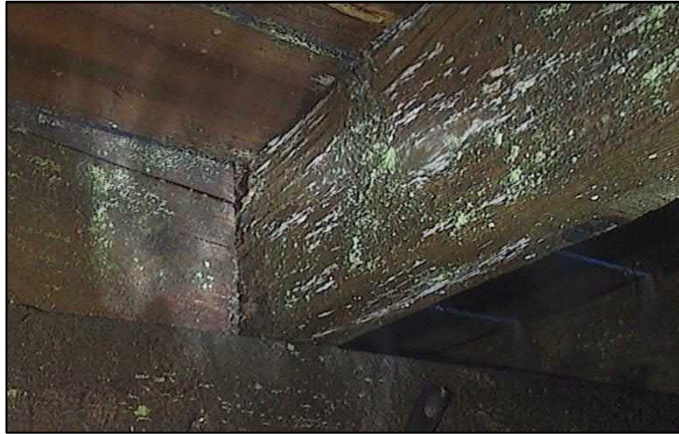
Figure 51 - Example of Fungal Growth on Framing

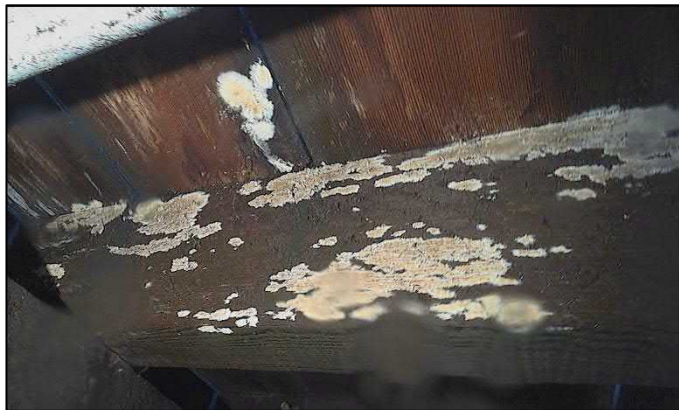
Figure 52 - Example of Fungal Growth on Framing

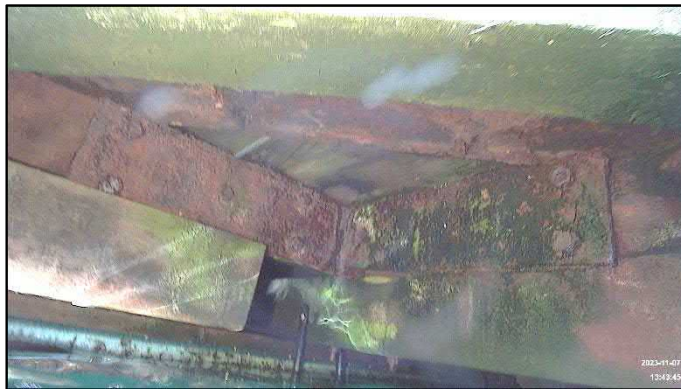
Figure 54 - Example of a Corroded Connection Plate Between Wing Dock and Main Dock

Many of the steel connection plates that connect the wing docks to the main dock have experienced varying degrees of corrosion. There is variation in the condition of these plates throughout the dock – some appear to be in relatively good condition and others appear to be at the end of their service life. Refer to Figure 53, Figure 54, Figure 55, and Figure 56. It is unknown if some of the steel plates have been replaced since the original construction although the variable condition may also be caused by different levels of exposure in different locations. It is recommended that the extensively corroded steel plates (i.e., those which have experienced pitting and/or cross-sectional area loss) be replaced.

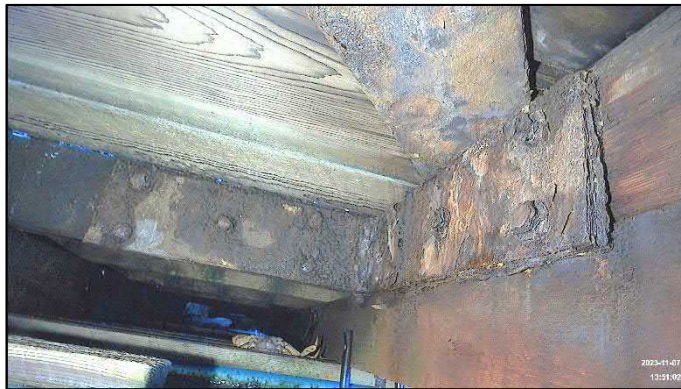
Figure 55 - Example of an Extensively Corroded Connection Plate Between Wing Dock and Main Dock

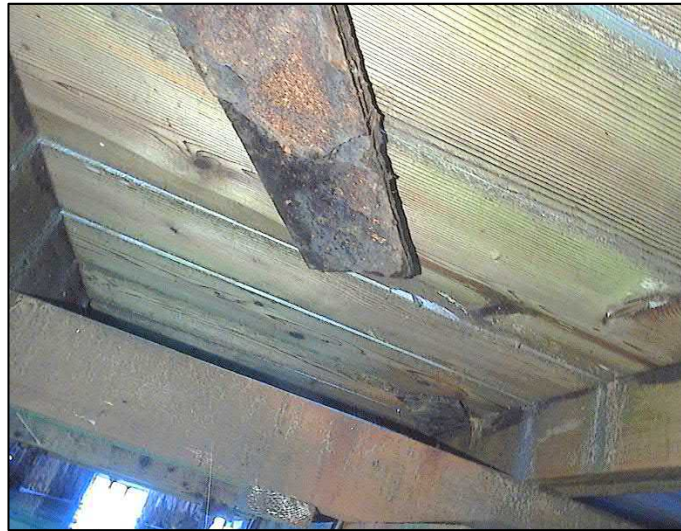
Figure 56 - Example of a Corroded and Failed Steel Brace Near T-Sections at Dock G to Dock K

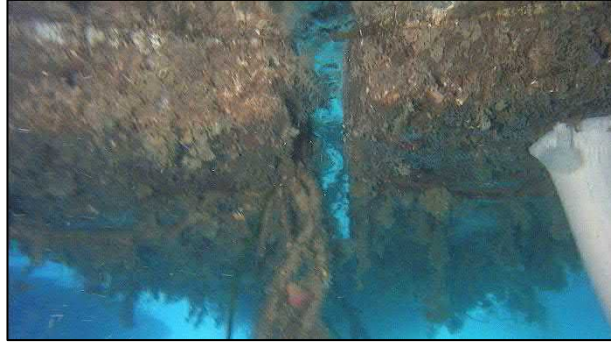
Figure 57 - Typical Marine Growth on Polystyrene Billets

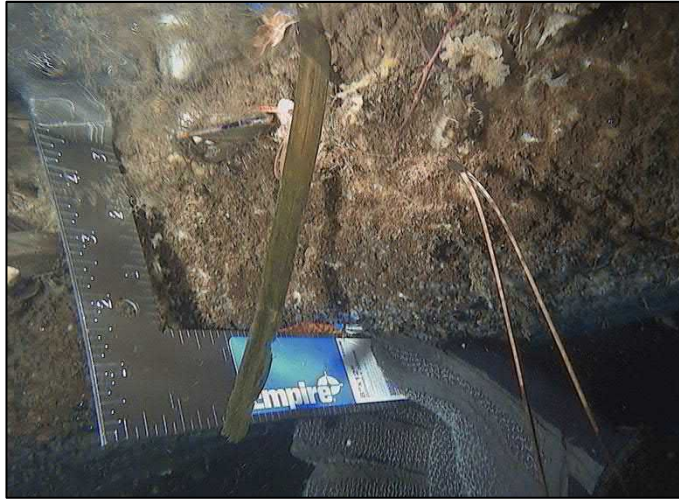
Figure 59 - Relative Measurement of Loss of Cross-Sectional Area on Polystyrene Billet

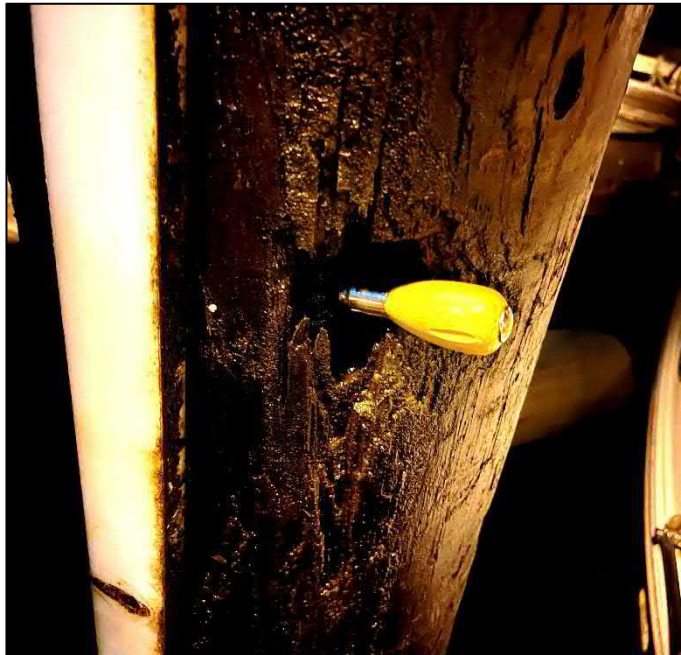
Figure 61 - Typical Hole in Timber Pile

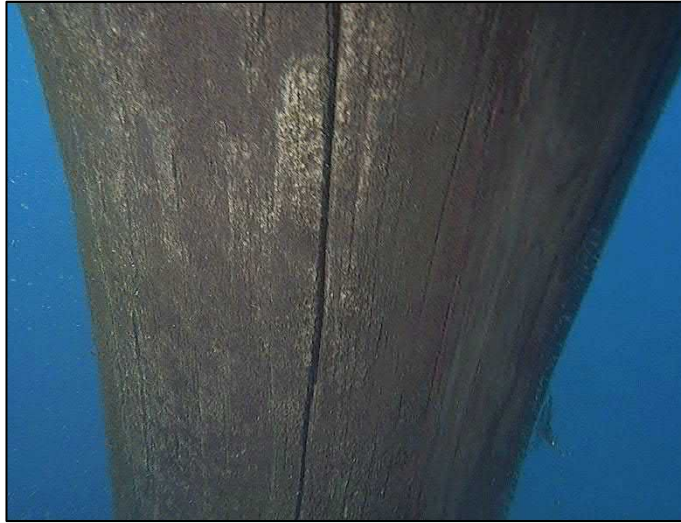
Figure 63 - Typical Crack in Timber Pile

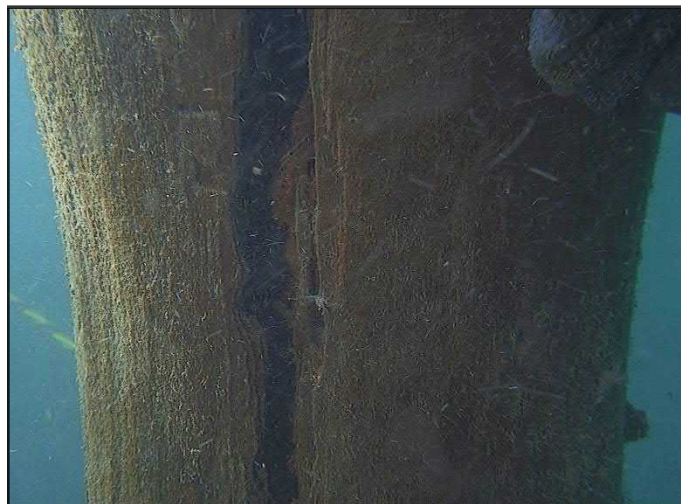
Figure 64 - Typical Decayed Timber Pile

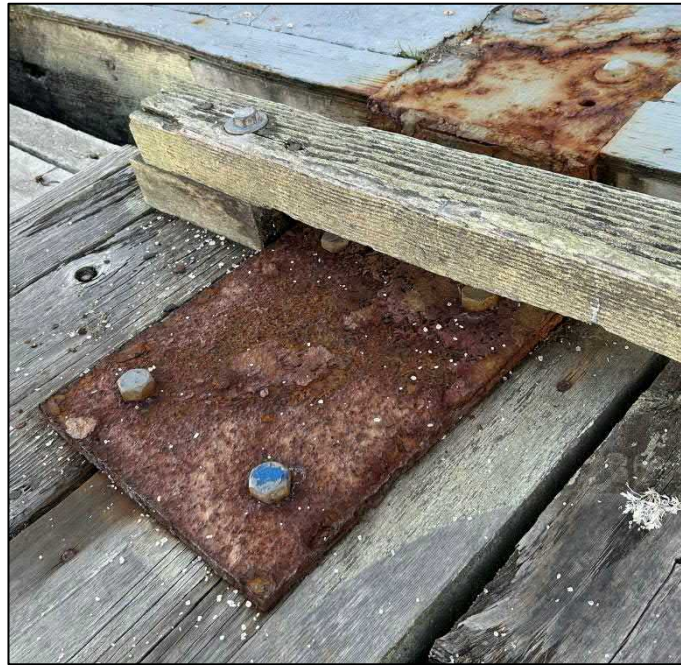
Figure 67 - Corroded Steel Plates at Fuel Dock
