Phase I Environmental Site Assessment 1327 Beach Drive, Victoria, BC

**North West
Environmental Group Ltd.**

NWest Project #: 38993

Date issued: December 31, 2019

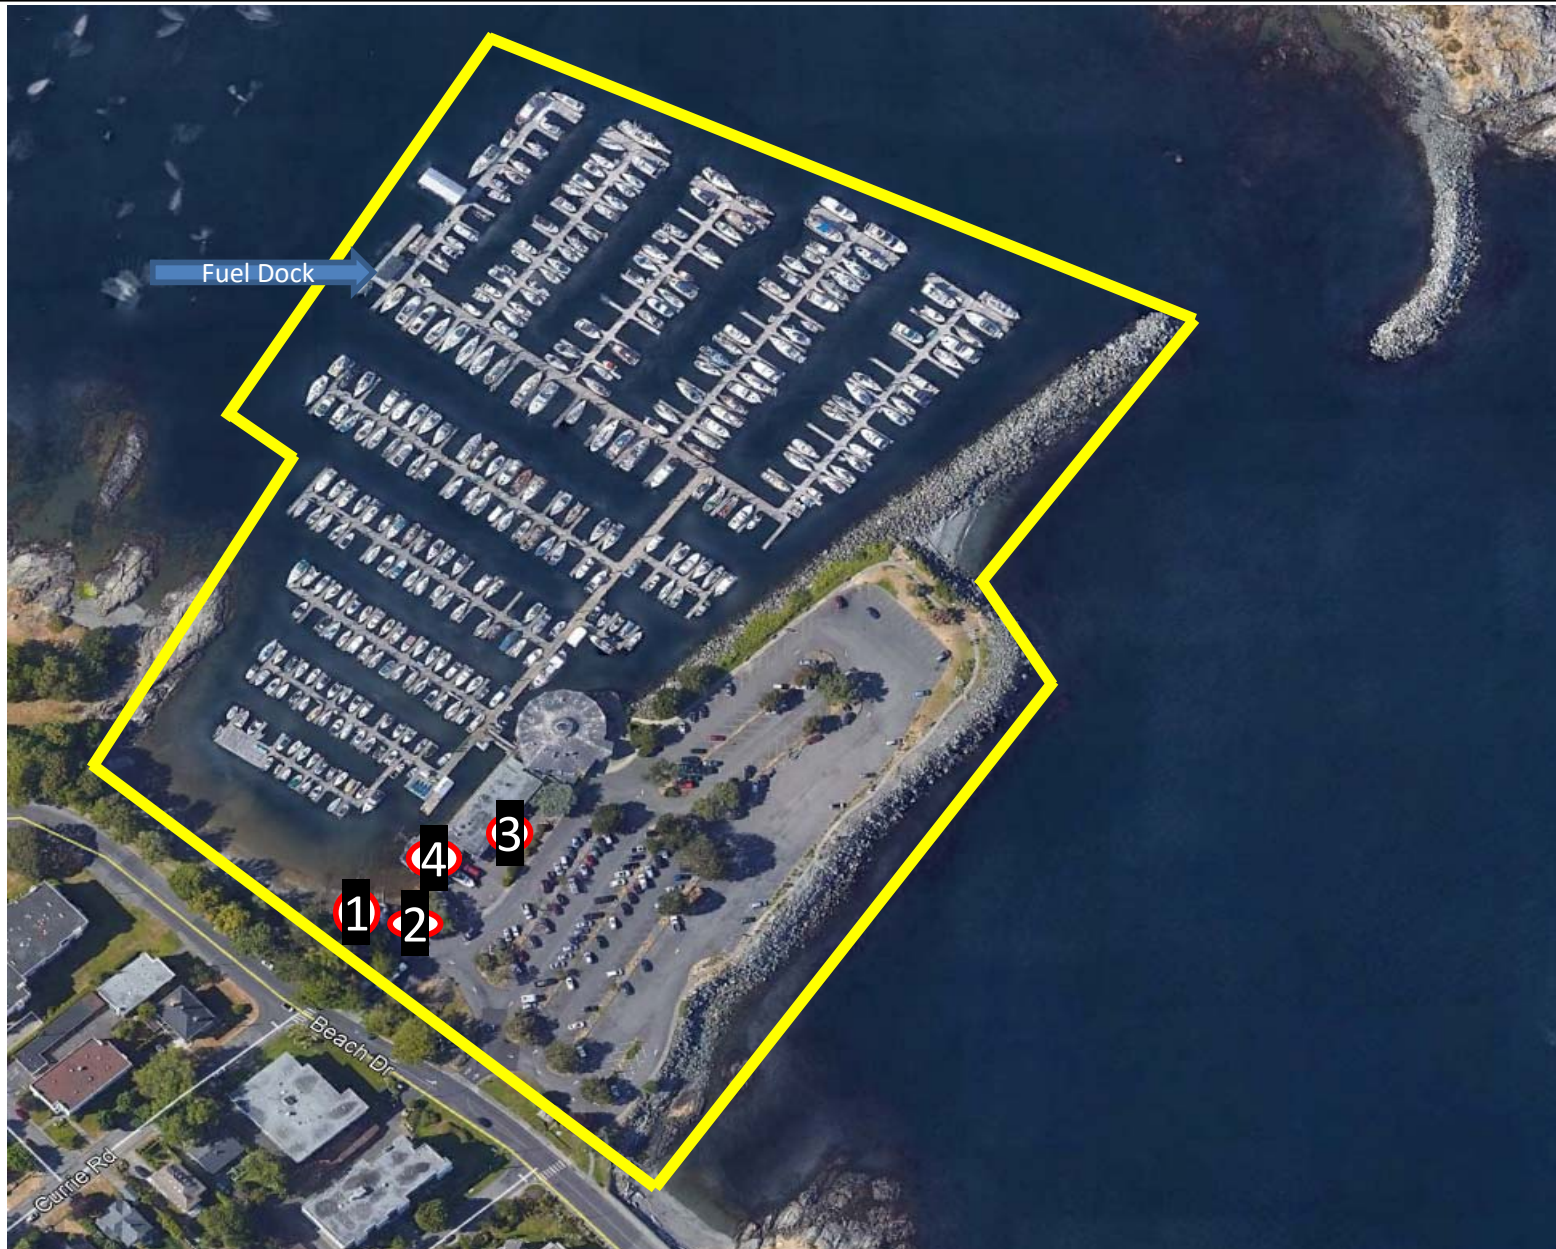
Drawing Title:
 Figure 3 – Site Plan

Please refer to Figure 3 for the approximate location of these APECs.

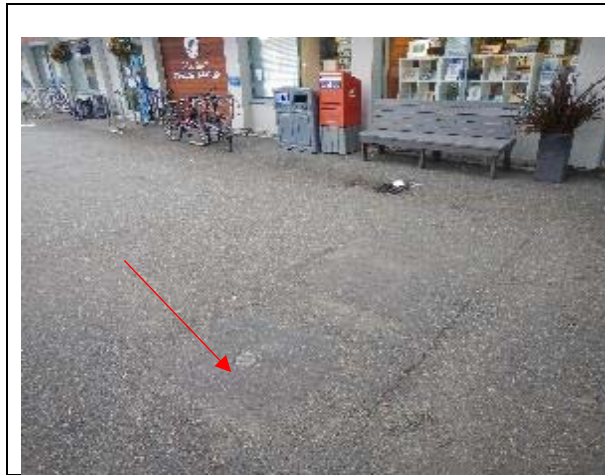
Evidence of another UST was identified in front of the entrance to the gift shop, including markings on the paved surface and a fuel cap.

| APEC | PCOCs |
|---|--|
| APEC 2 – Former decommissioned UST adjacent the gift shop | LEPH, HEPH, PAH, BTEXS, VPH, metals and regulated soil vapour parameters |

Photo 1
Description: Evidence of UST at the site (adjacent gift shop entrance) with fill cap in foreground

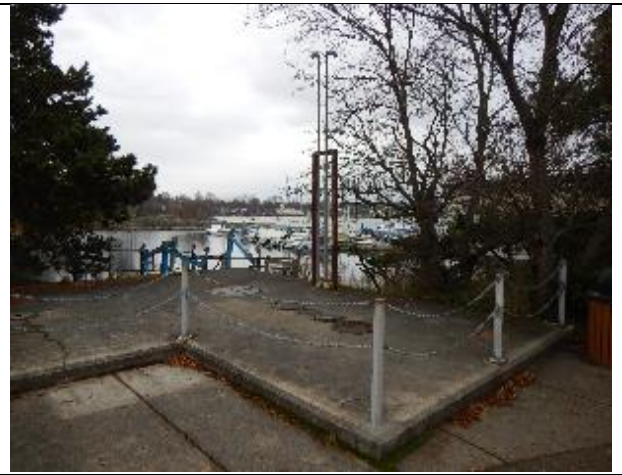
Fuel (gasoline and diesel) is supplied to the floating fuel dock from underground storage tanks (USTs) located at the southwestern extent of the site. The capacity of the gasoline tank is 10,000 L and the capacity of the diesel tank is 25,000 L. The double-lined galvanized fuel lines from the UST nest, travel along the shore to the administrative office building where they meet the network of floats and run on the underside of the floats to the fuel dock at the northwest extent of the marina.

| APEC | PCOCs |
|---|--|
| APEC 1 – Fuel USTs and associated infrastructure | LEPH, HEPH, PAH, BTEXS, VPH, metals and regulated soil vapour parameters |

Photo 2
Description: Floating fuel dock UST area with fill caps and vent stacks at south west corner of site

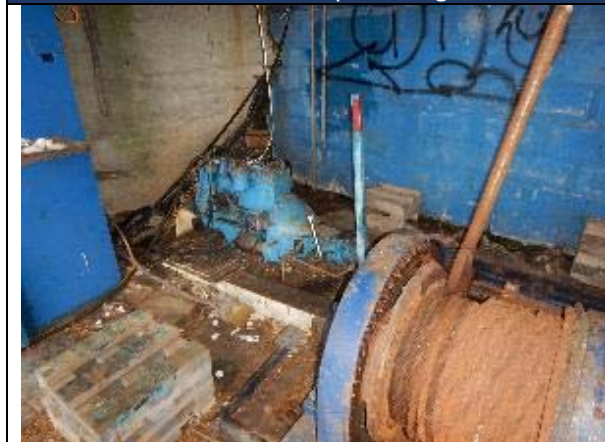
Two abandoned marine ways are located at the southwest extent of the site. One has only track remaining, the other has a diesel driven winch system in place within a shack at the head of the way.

| APEC | PCOCs |
|---|--|
| APEC 3 – Former marine way infrastructure in winch shed | LEPH, HEPH, PAH, BTEXS, VPH, metals and regulated soil vapour parameters |

Photo 3
Description: Marine way winch system at south west extent of site

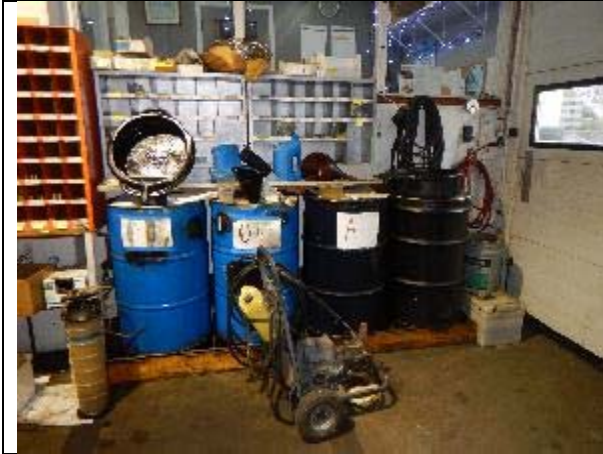
Floor drains and sumps within the buildings and paved parking areas at the site are reportedly connected to the municipal system except for one floor drain within the boat repair facility that drains directly into the sea below.

| APEC | PCOCs |
|---|--|
| APEC 4 – Boat repair activities | LEPH, HEPH, PAH, BTEXS, VPH, VOCs, metals and glycols |

Photo 5
Description: Waste fluid storage area in boat repair facility

Boat repair activities (APEC 4) present a risk of environmental impairment at the site due mainly to the presence of the floor drain that opens directly to the marine environment. The floor drain in the boat repair facility should be modified so waste entering it is captured instead of draining directly into the sea.
