TOD HOUSE, 2564 HERON STREET OAK BAY - CONDITION SURVEY AND SPECIFICATION DRAWINGS

PREPARED FOR THE DISTRICT OF OAK BAY

Conservation and Repair
Specification, Tod House,
2564 Heron Street, Oak
Bay

Aug. 2020

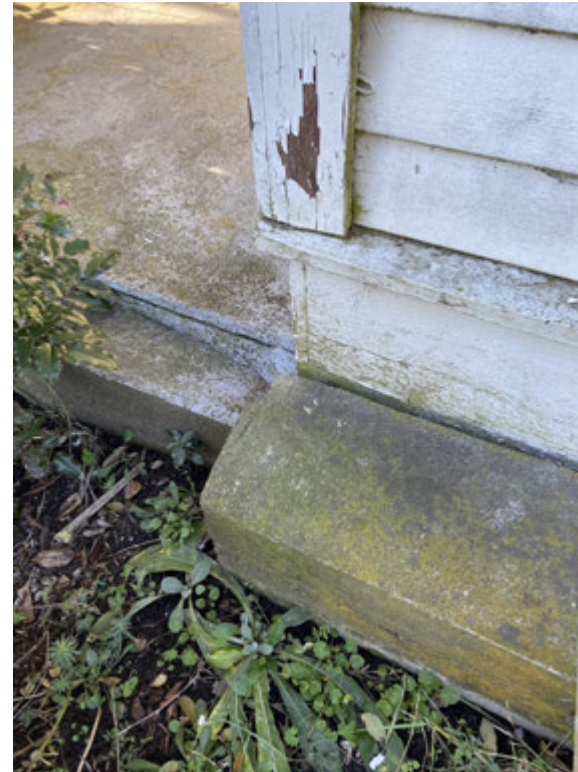
East Elevation. Gap behind curb is a vulnerable location for collecting rain and surface water.

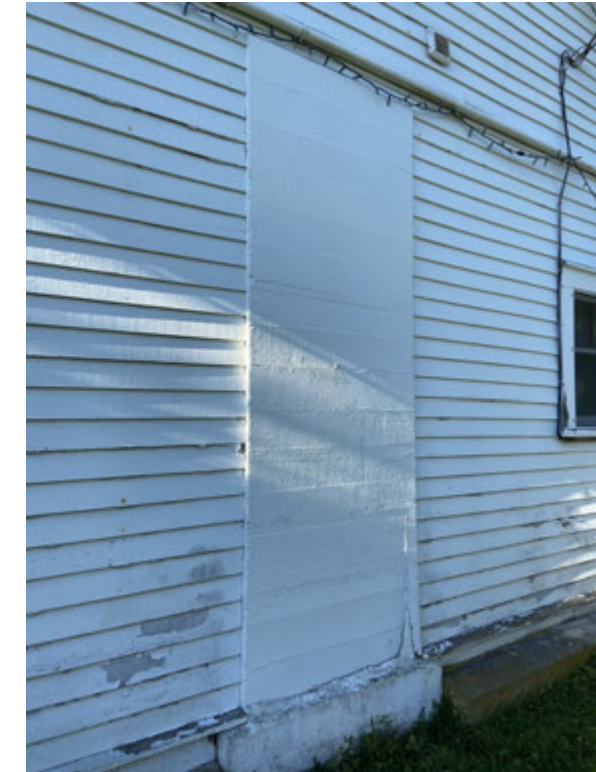
Brick chimney stack encased in concrete with form board finish to exterior wall .

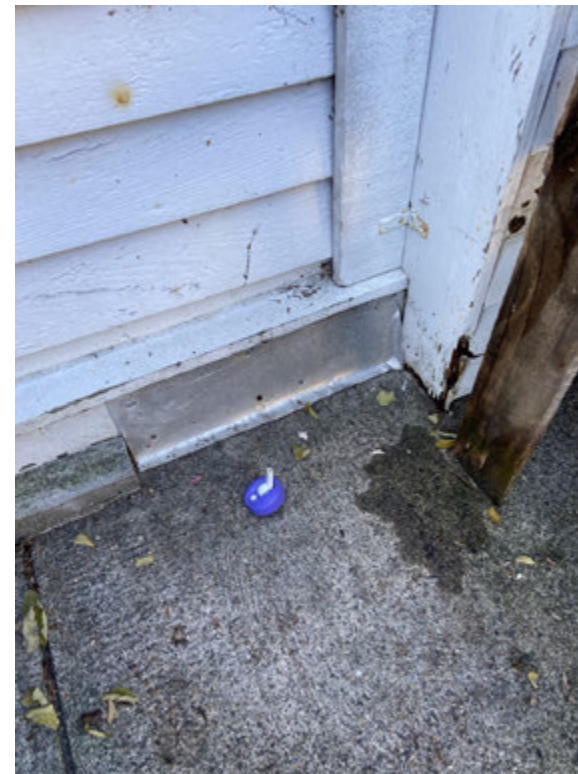
East Elevation. Rear patio rodent proofing at foundation level.

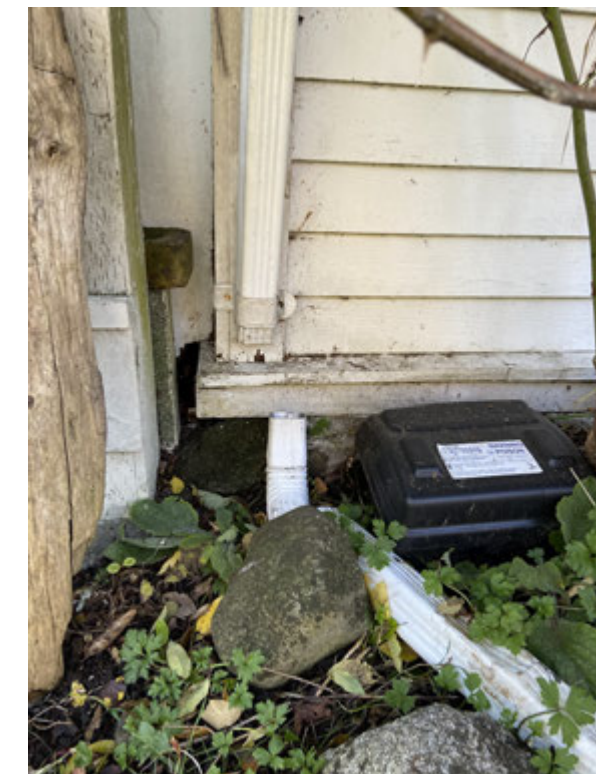
Northeast corner. Detached downspout and surface drain typical of most downspouts.

1.4	Reinstate Rainwater/Down-water Goods <ul style="list-style-type: none"> Ensure all gutters, downspouts and rainwater leaders are free of debris and flowing freely. Check all gutter slopes. 	High

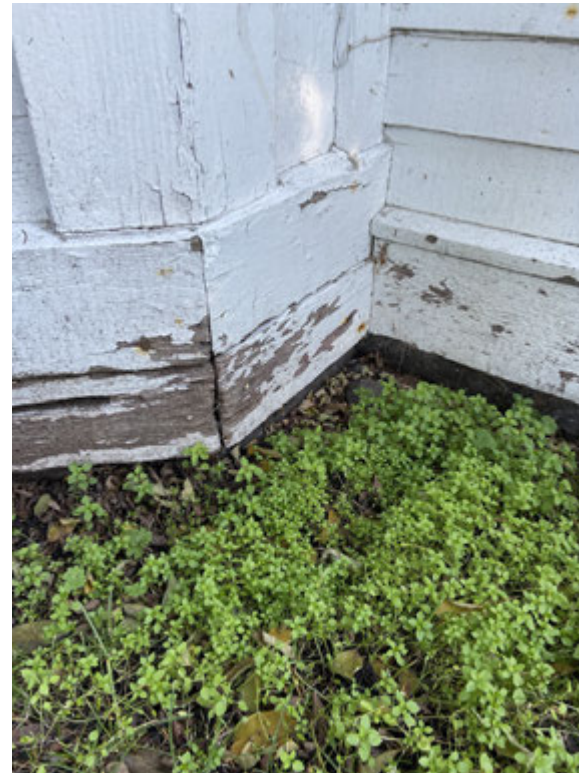
West Elevation, bay window. Heavily weathered trim boards at foundation level.

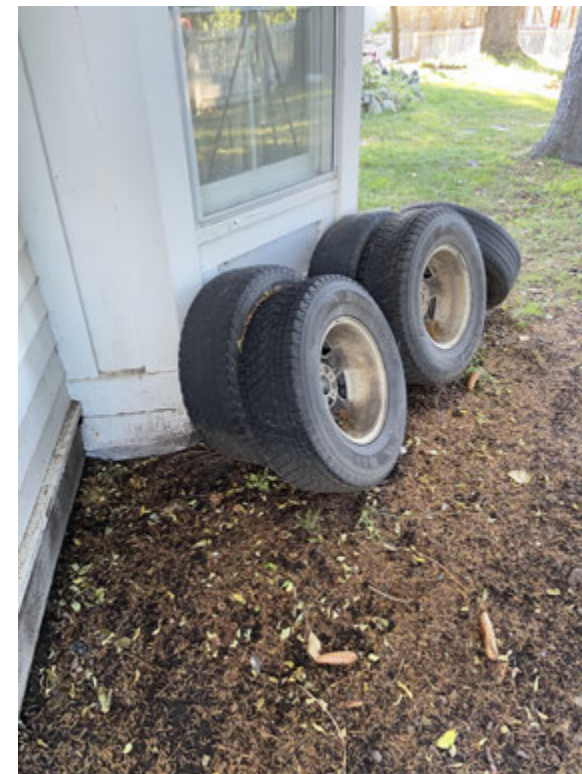
Bay window, current conditions.

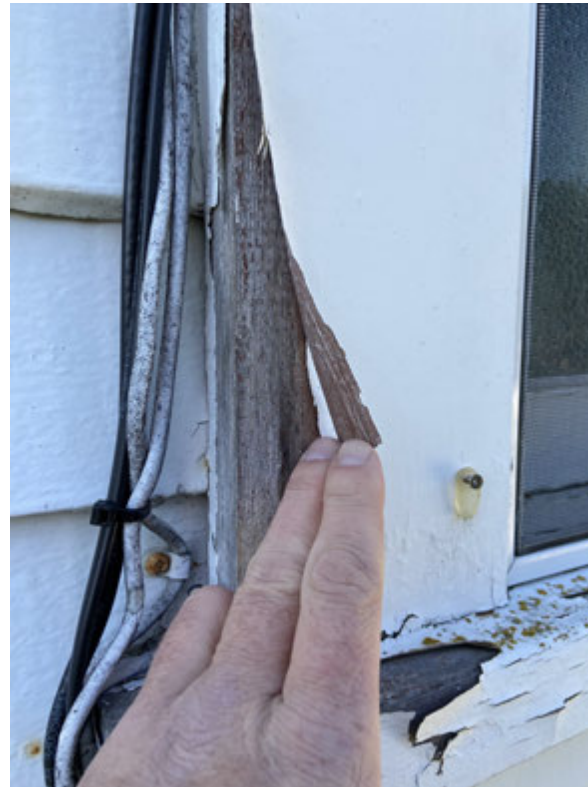
Peeling vinyl base paint (typ.) over old red ochre paint on window trims.

1.3	Repaint Exterior <ul style="list-style-type: none"> Prepare (by hand) all exterior surfaces for painting in accordance with original color scheme. Perform carpentry repairs as necessary at windows, siding and trims. Paint all exterior surfaces with KEIM mineral paints. Limewash exposed stone chimney using materials that match original. 	High

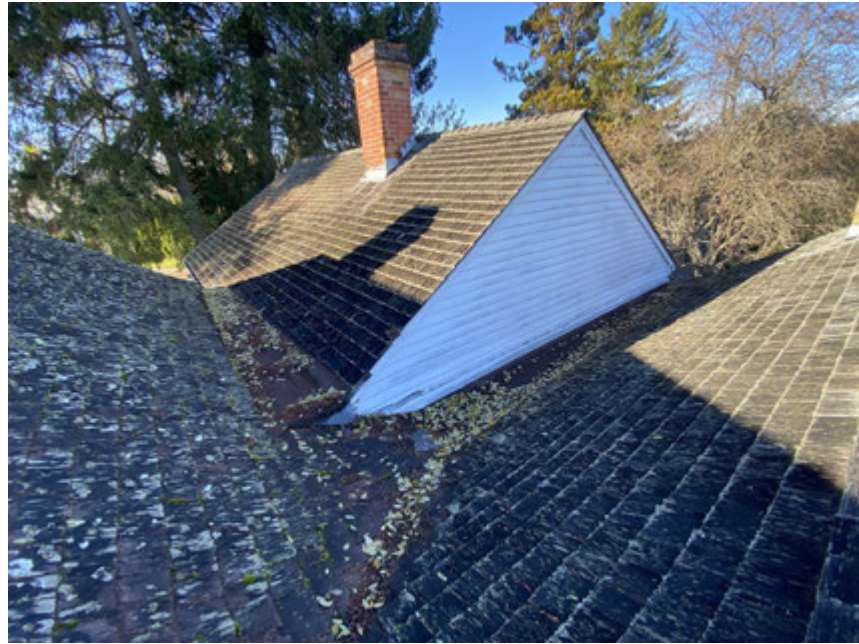
Roof over 1890s addition facing northwest. Valley gutters are full of leaf litter.

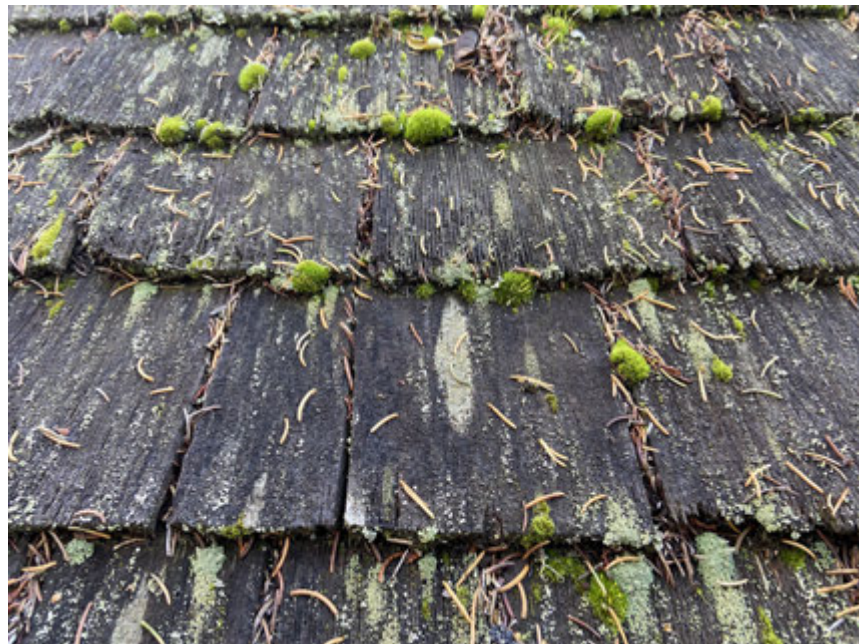
Typical condition of cedar shingles showing moss and lichen growth and debris from fir adjacent conifers..

Tod House Category 1 Repairs, Emergency Works	1.1	Replace Roofing <ul style="list-style-type: none"> Strip all exterior roofs to reveal/inspect the condition of underlying sarking boards. Do not remove any of the historic shakes visible within the attic. Repair the minimum amount of sarking necessary using materials that exactly match the historic fabric. Install new split cedar shakes to match the original roofing and exposure to the weather as existing in the attic above the Kitchen/Hall. Fire retardant should be considered but wood preservatives should not be used. Install new metal flashings throughout. Look for evidence of original flashings to determine the correct type. In areas of complex roof intersections (e.g., interior valleys) make such improvements to the flashings as necessary to improve the performance of the roof. Do not impede the breathability of the roof by inserting impermeable 'peel and stick' type membranes. Remove and dispose of all waste. 	High

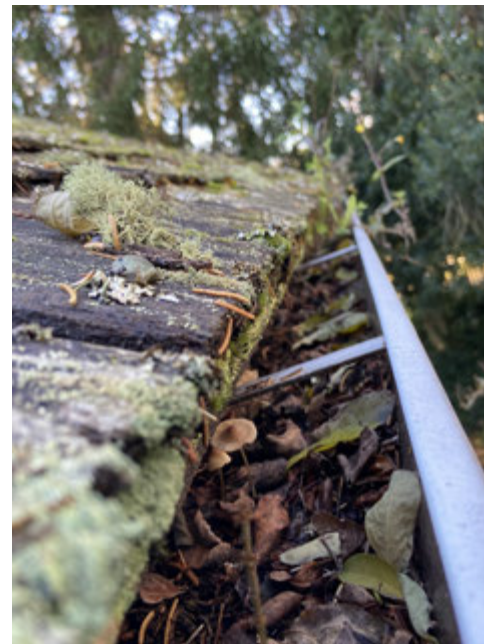
Gutters require regular cleaning.

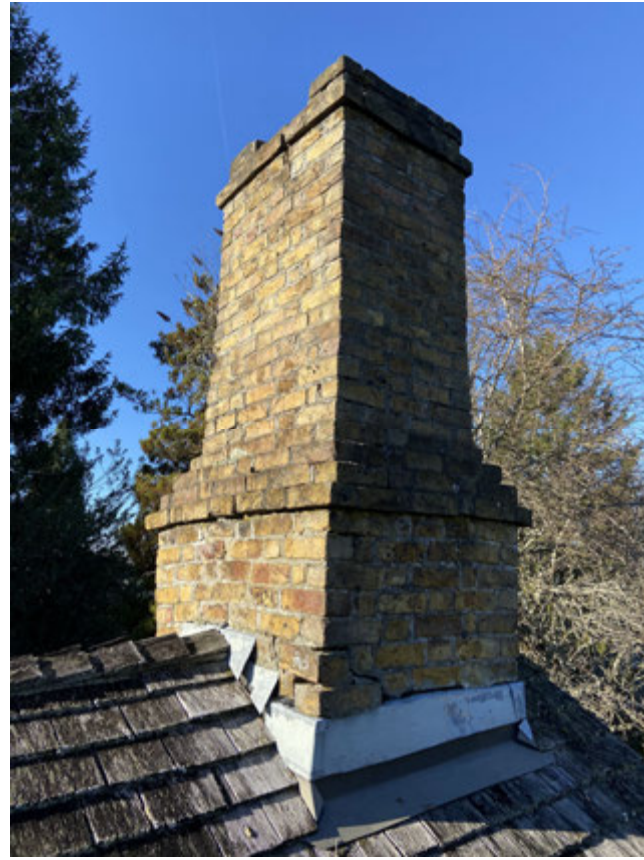
Chimney flashings require replacing and the lower brick courses repointing. Vegetation should be removed and joints repointed mortar is missing or detached.

1.2	Repoint Chimneys <ul style="list-style-type: none"> Systematically inspect and repoint each of the chimneys with mortar that exactly matches the original. Replace any modern, cementitious mortars/repairs that are encountered, with compatible material. Remove all vegetation. Repair all cracks with mortar. Cap the chimneys with mortar to protect them. Install new metal flashings in reglets as necessary to enable roofing repairs. Replace and reinforce any dislocated bricks. Do not seal the bricks. 	High

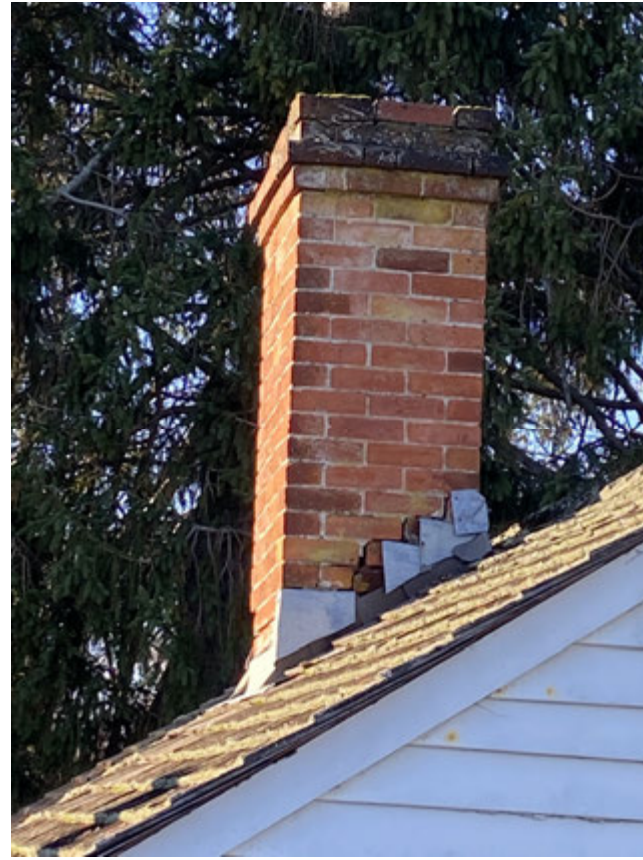
Red brick chimney over 1890s addition. Step flashings should be replaced and mortar joints re-pointed
