Facility Condition Assessment

2022 - Simple Inflation Update to Report

Oak Bay Marina
1327 Beach Drive, Victoria, British Columbia
March 08, 2022

Project Number **221-02267-00**

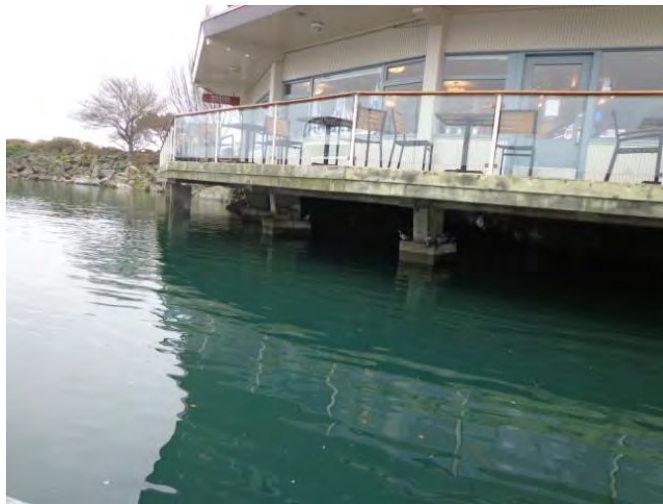
In 2019, the District hired WSP to conduct an investigation of the concrete substructure at the site and a corresponding report was issued. The report stated that the concrete substructure was in fair condition, with localized evidence of concrete deterioration due to chloride-induced reinforcing steel corrosion and recommended concrete repairs should be implemented within the next two years to prevent more extensive deterioration. The report also noted the larger concrete jackets installed at the concrete column bases that are not on the original structural drawings that could have been installed as part of a prior seismic upgrade. As our review was limited to land-based observations, the concrete substructure was not adequately re-evaluated during our site visit.

Photo #5: Restaurant Concrete Piles - Typical

Based upon the previous recommendations in the 2019 investigation report, a budget has been included for repairs to the concrete substructure. You may choose to defer this project to a later date or phase the project over several years. When phasing the project, you can also choose to shut the coffee shop and restaurant temporarily while these repairs are completed or have certain areas remain open and have the project work around these areas. The latter option would require an extended project schedule and is susceptible to increased costs. A budget is also included for periodic evaluation of the substructure following completion of the aforementioned repairs.

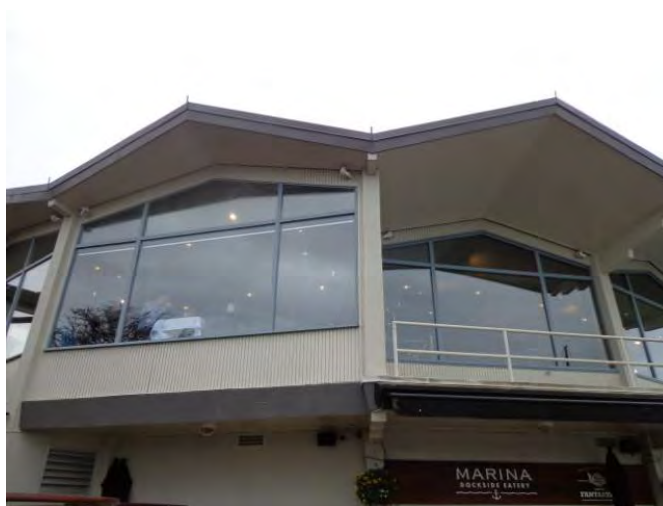
No leakage through the wall assemblies was noted or reported at interior areas accessed. We noted peeling paint on walls and wood trim boards as well as small local cracks in the stucco and concrete block walls. We also noted rusted edge trim at stucco walls adjacent to the Restaurant front planters. From grade, we could not see evidence of an obvious, widespread problem; however, this does not preclude the risk of concealed damage. Sealants were in serviceable condition around doors and windows but surface crazing and cracking were noted throughout.

Photo #6: Restaurant Walls and Windows - Typical

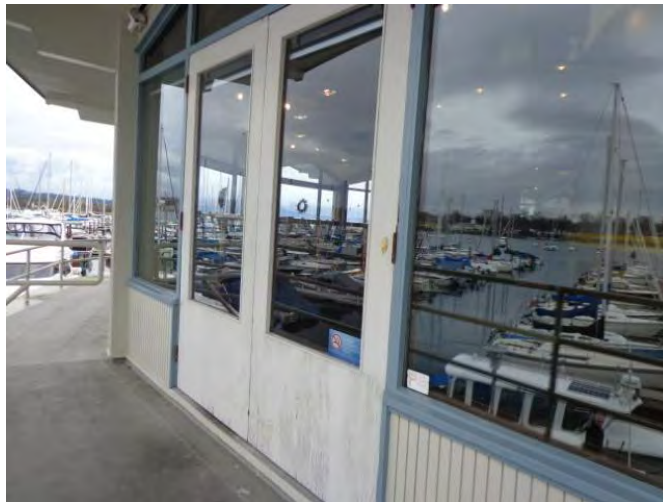
The exterior doors were in serviceable condition, with no water leakage or operational issues noted or reported during our review. The wood-framed panel doors leading to the upper-level walkway on the Restaurant building are old and weathered and we have budgeted for replacement accordingly.

Photo #7: Restaurant Doors

2.2.1 Replace Exterior Restaurant Doors to Upper Level Walkway *

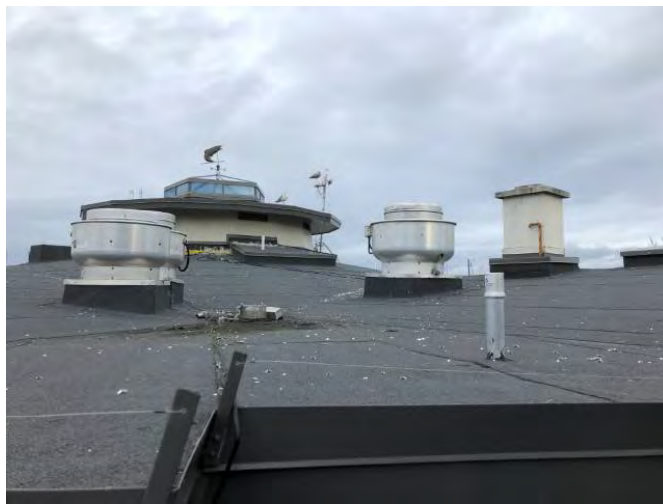
The Restaurant roof is in serviceable condition, with no major issues noted or reported during our review. We noted clogged area drains causing minor roof ponding, which we assume will be cleaned as part of ongoing maintenance. With a typical theoretical service life of around 25 years, we have included a budget for the eventual replacement of the Restaurant roof later in the report term.

Photo #8: Restaurant Roof - Typical.

2.3.2 Replace Restaurant Flat Roofing *^

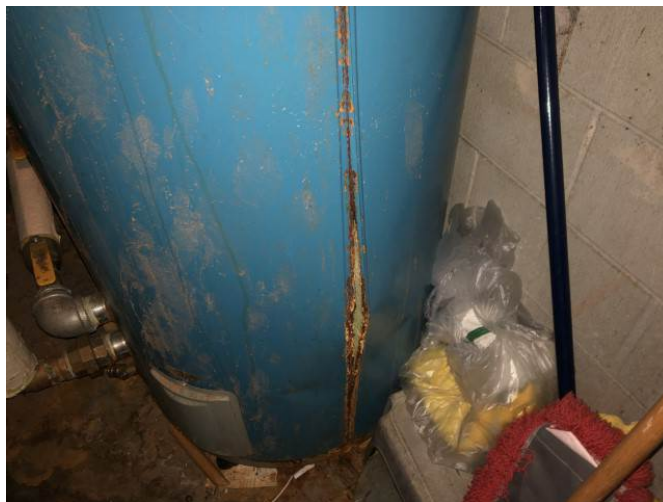
Photo #24: Restaurant Hot Water Tank Bulging.

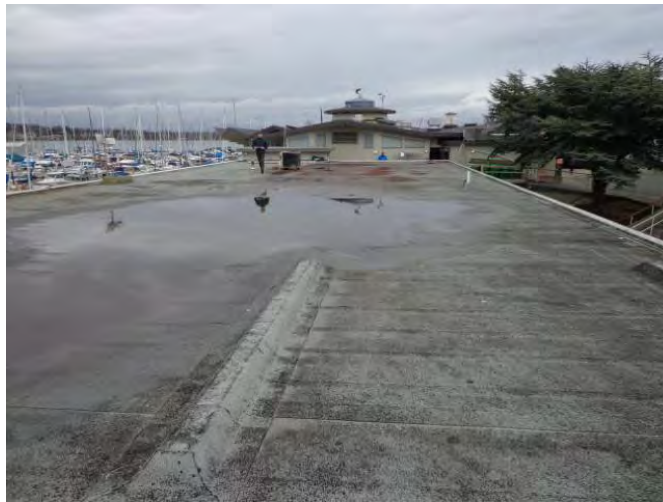
The Office and Dockworks building roofs are older and in fair condition. We noted surface cracking and granular loss throughout. As such, we have budgeted to replace the Office and Dockworks roofs within the report term as a single project to conserve mobilization costs. The budget will also include an allowance for resealing the sloped canopy glazing and relining the drainage trough on the Office building.

Photo #32: Office Roof Looking North

2.3.1 Replace Office and Dockworks Roofing *^

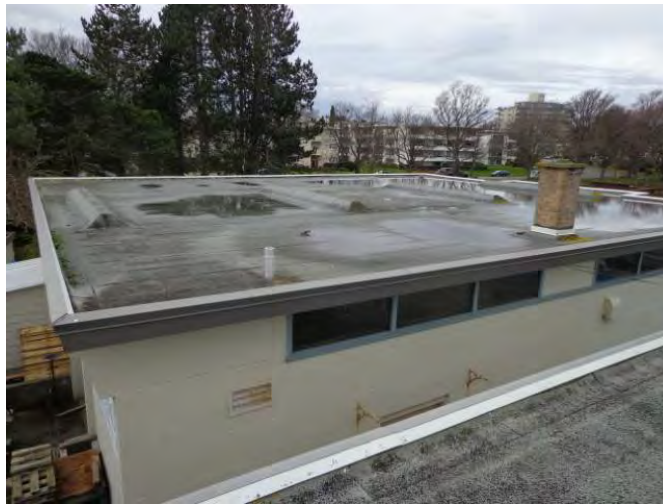
Photo #43: Dockworks Roof

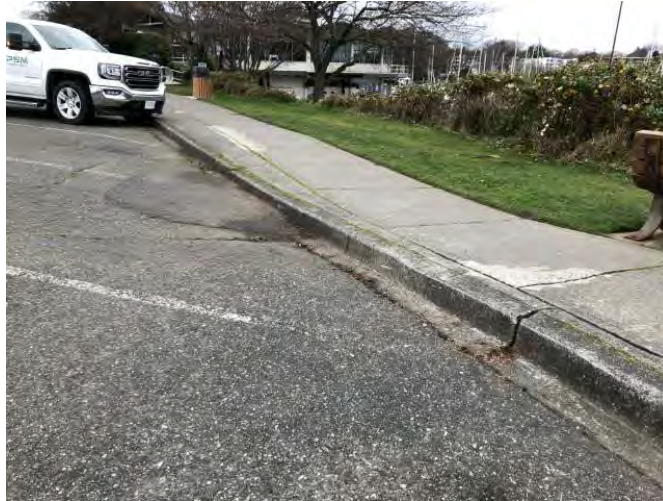
Photo #61: Parking Lot Settlement.

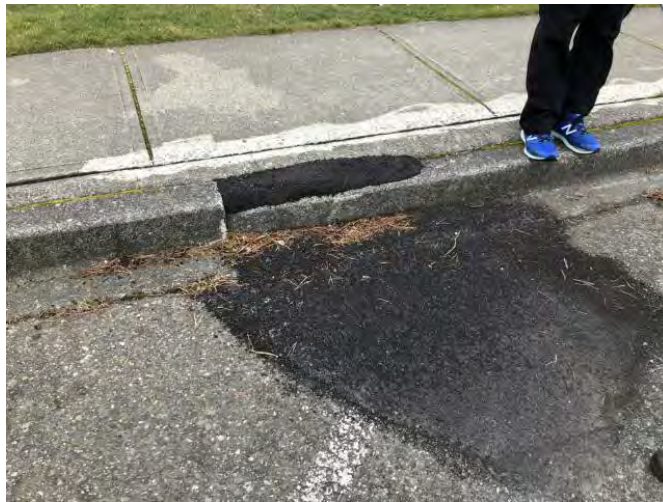
Photo #62: Parking Lot Asphalt Patch.

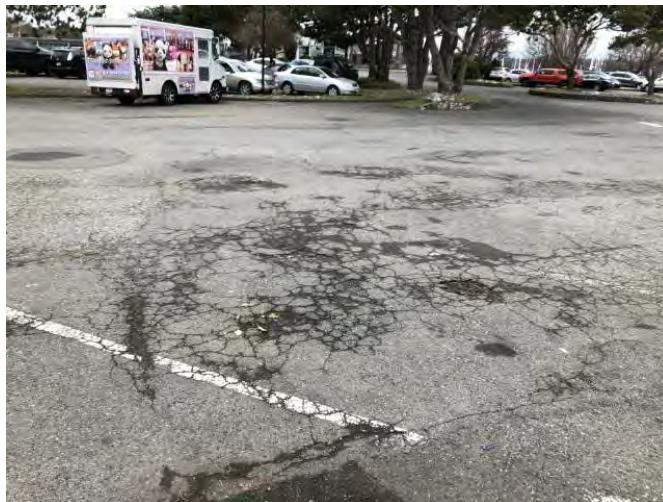
Photo #63: Parking Lot Cracking - Typical.

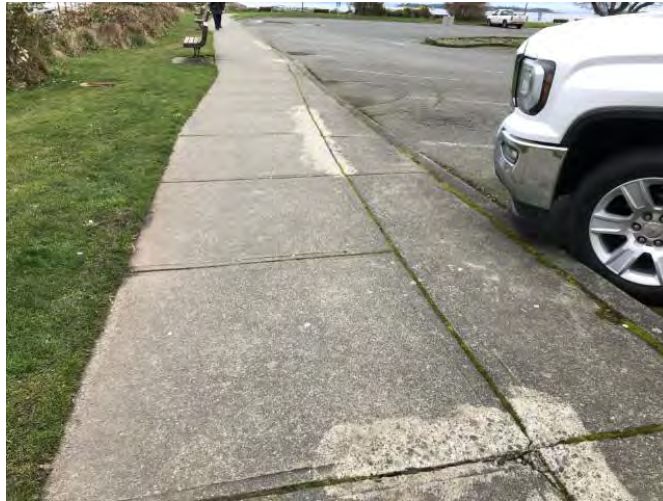
Photo #64: Concrete Sidewalk Settlement.
