3555-006

**Re: District of Oak Bay
Oak Bay Marina – Dock - Condition Assessment**

Oak Bay Marina – Dock - Condition Assessment

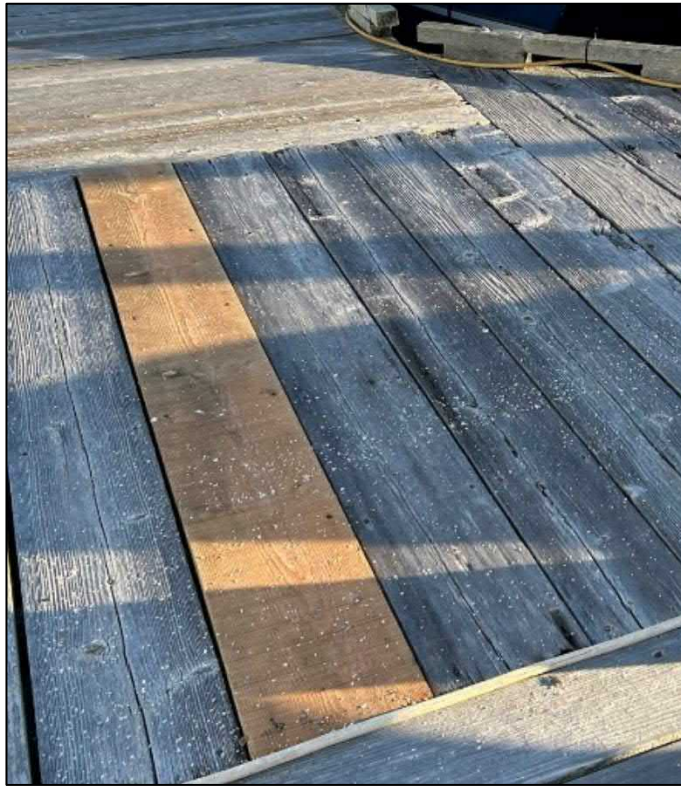
The deck boards are subject to foot and storage cart traffic as well as seasonal exposure to de-icing salt. Most of the deck boards appear to be original although replacement boards were observed in certain areas. Refer to Figure 34. Many of the original deck boards remain in serviceable condition and areas of damage or decay have been noted on the plan view markup provided in Appendix A.

Figure 34 - Example of Deck Board Replacement

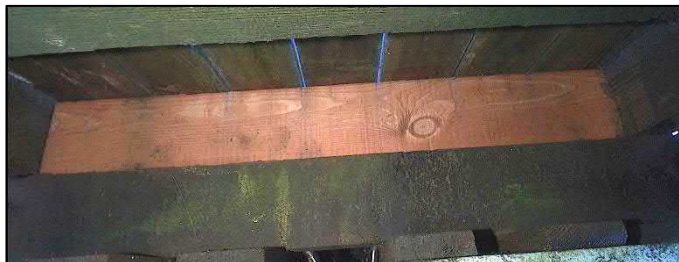
The support framing is partially protected above by the deck boards and partially protected by the billets below but large areas of the framing are continuously exposed to saltwater. Most of the framing appears to be original although replacement members were observed in certain areas. Refer to Figure 47.

Figure 47 - Example of Framing Replacement

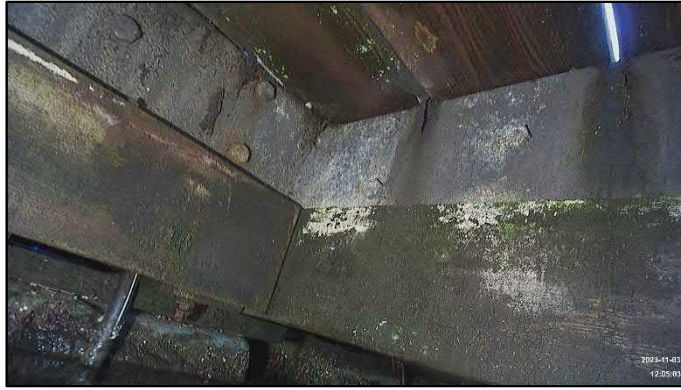
Many of the steel connection plates that connect the wing docks to the main dock have experienced varying degrees of corrosion. There is variation in the condition of these plates throughout the dock – some appear to be in relatively good condition and others appear to be at the end of their service life. Refer to Figure 53, Figure 54, Figure 55, and Figure 56. It is unknown if some of the steel plates have been replaced since the original construction although the variable condition may also be caused by different levels of exposure in different locations. It is recommended that the extensively corroded steel plates (i.e., those which have experienced pitting and/or cross-sectional area loss) be replaced.

Figure 53 - Example of a Presumably Galvanized Steel Connection Plate in Good Condition

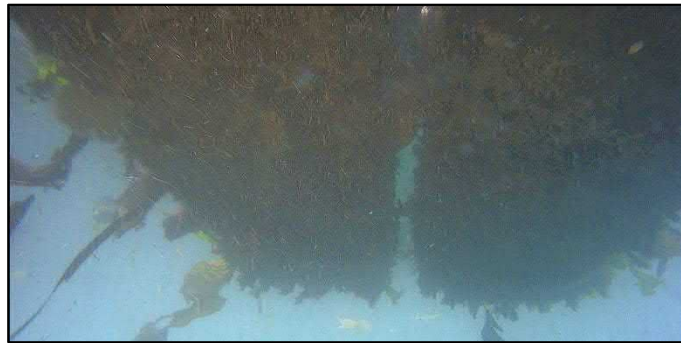
Figure 58 - Typical Marine Growth on Polystyrene Billets

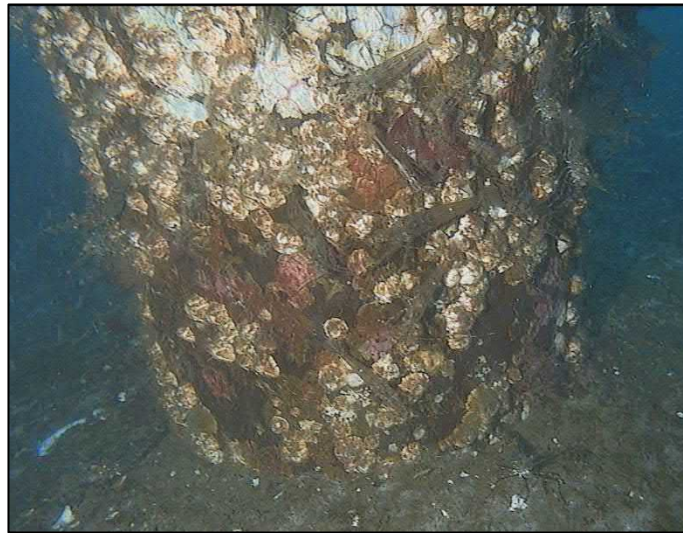
Figure 60 - Typical Base of Timber Pile

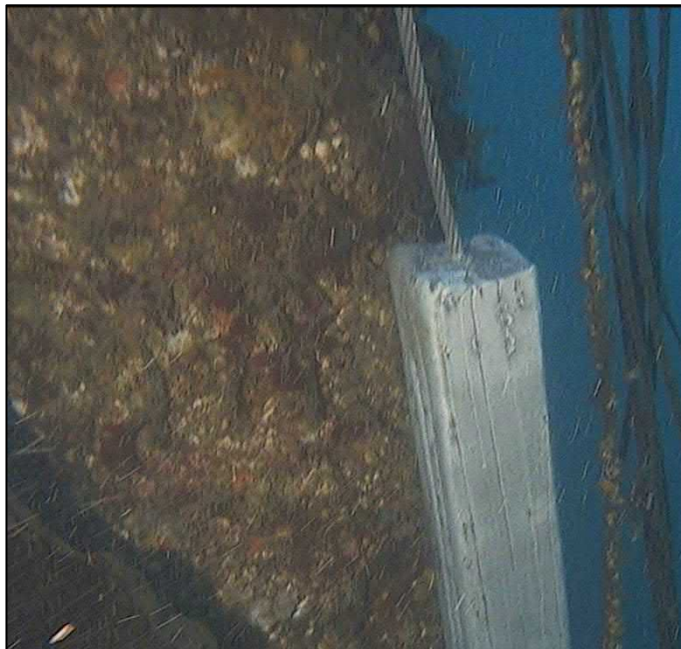
- The steel piles were observed to have galvanic anodes attached which are designed to limit the rate of corrosion. During the course of the review, seasonal maintenance was occurring at the marina dock including anode replacement, therefore some anodes were noted to be recently replaced. Refer to Appendix C.
- Some existing anodes were observed to be nearly unconsumed. For these anodes, it is recommended that all connections points for the anodes be checked for connectivity. It is also recommended that connections be welded instead of clamped for durability.

Figure 62 - Typical Galvanic Anode at Steel Pile

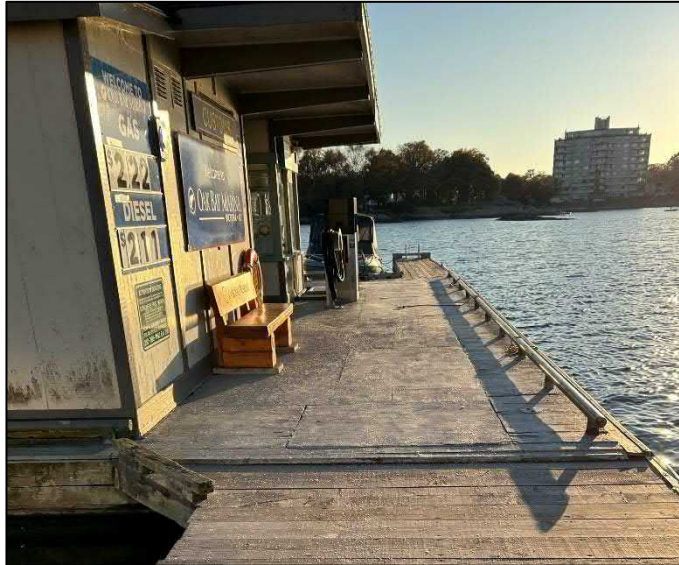
The fuel dock structure was subject to a limited review from the surface as the framing is covered with coated plywood. Refer to Figure 65. The underside of the fuel dock was observed to be timber framing with mostly PVC encapsulated billets. Refer to Figure 66.

Figure 65 - Fuel Dock Topside View

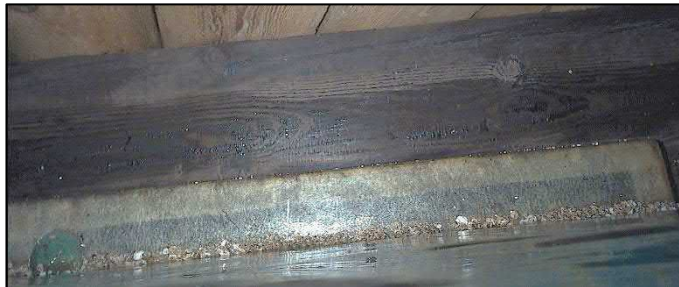
Figure 66 - Fuel Dock - Underside View with PVC Billet

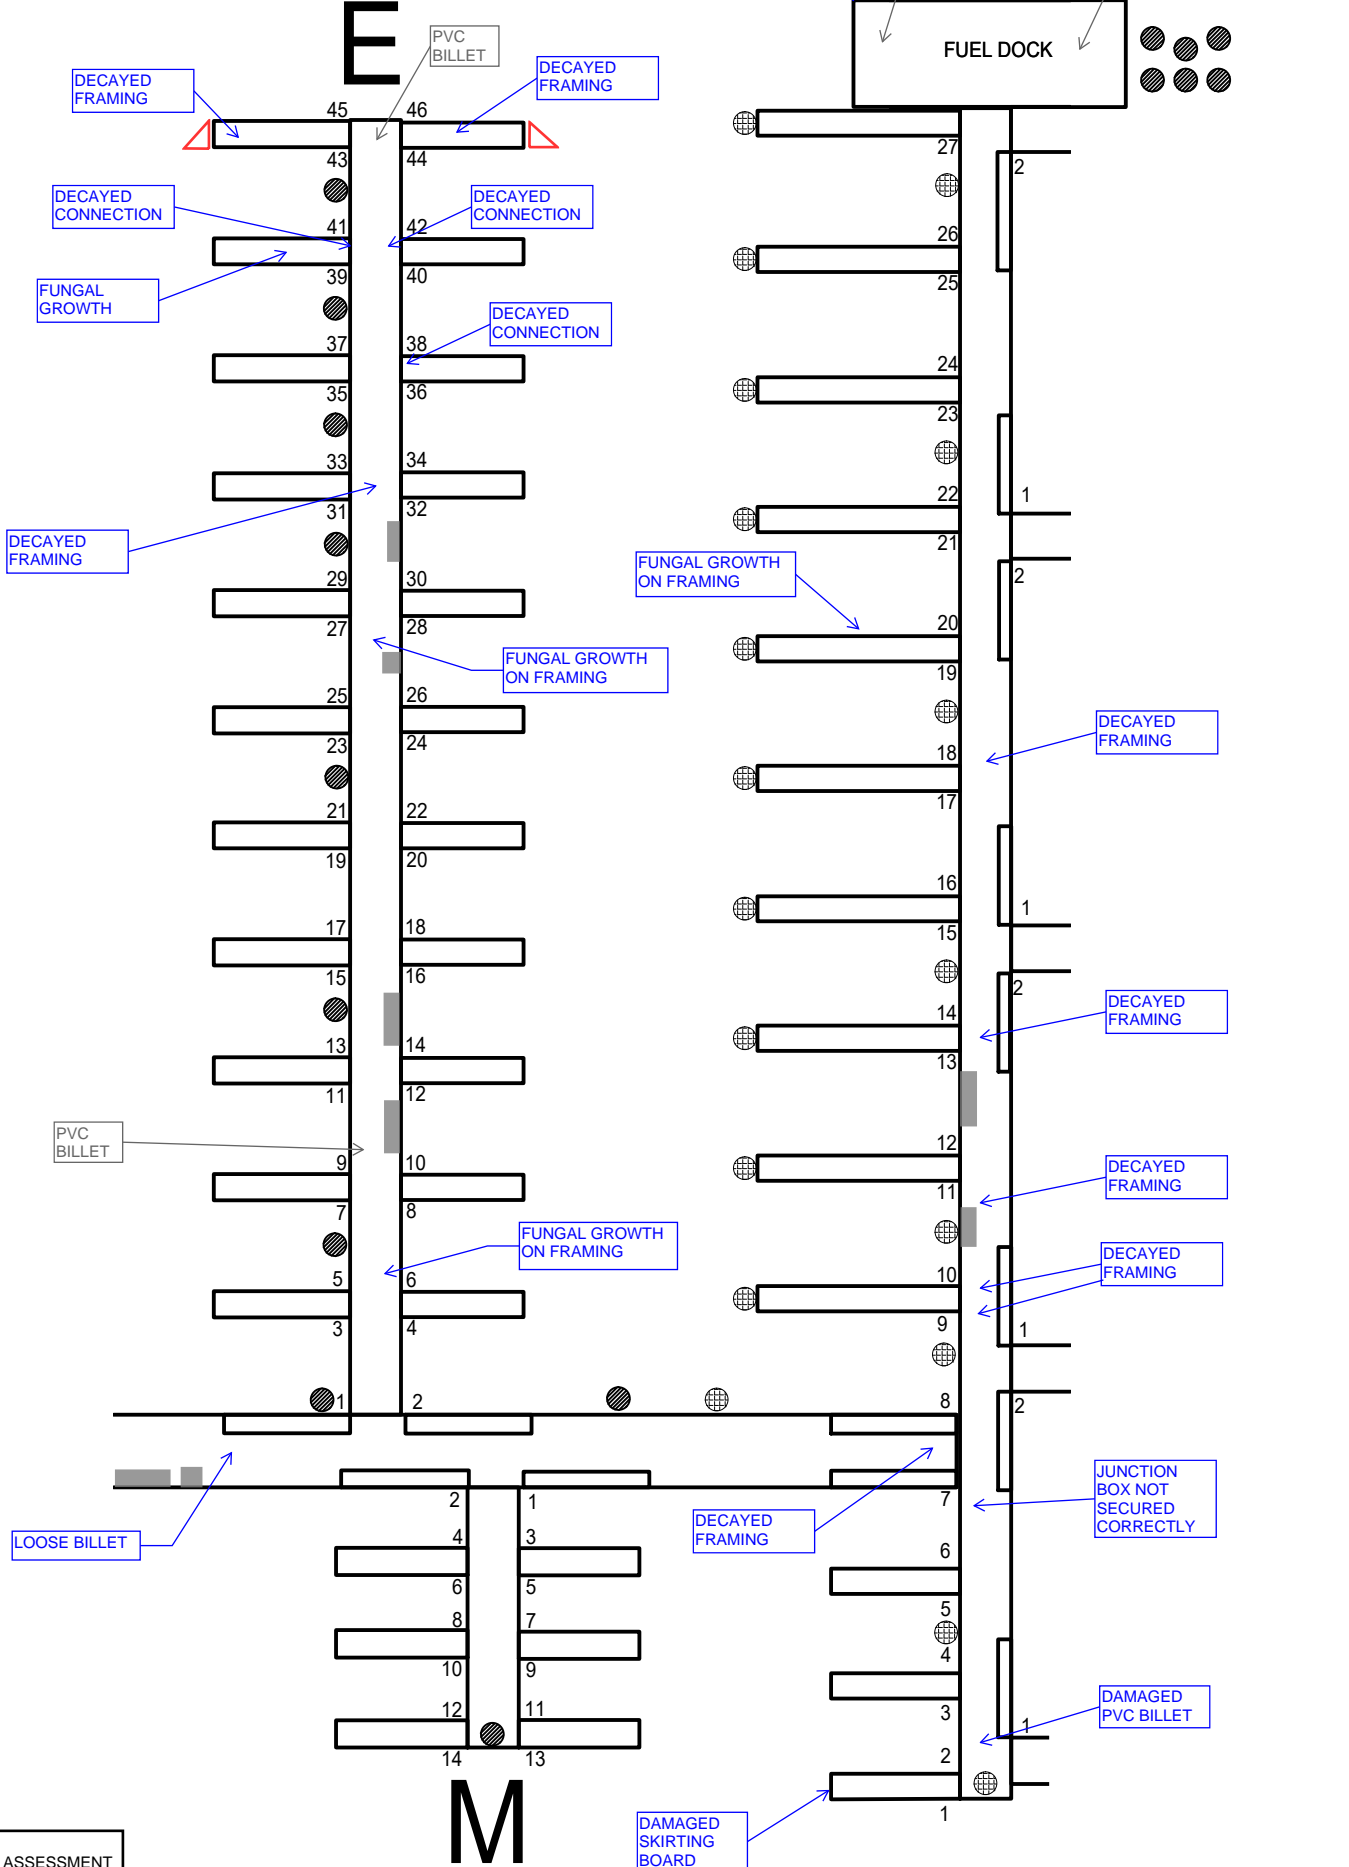
Appendix B Plan View – Timber Support Framing Condition Assessment

RUSTED STEEL CONNECTION PLATES

RUSTED STEEL FRAME AROUND DOLPHIN

NO STEEL PLATES OBSERVED AT CONNECTION. WOOD CONNECTION

BOLTS MISSING AT STEEL BRACKET

DECAYED CONNECTION

DECAYED FRAMING

LOOSE BILLET

BROKEN STEEL BRACE

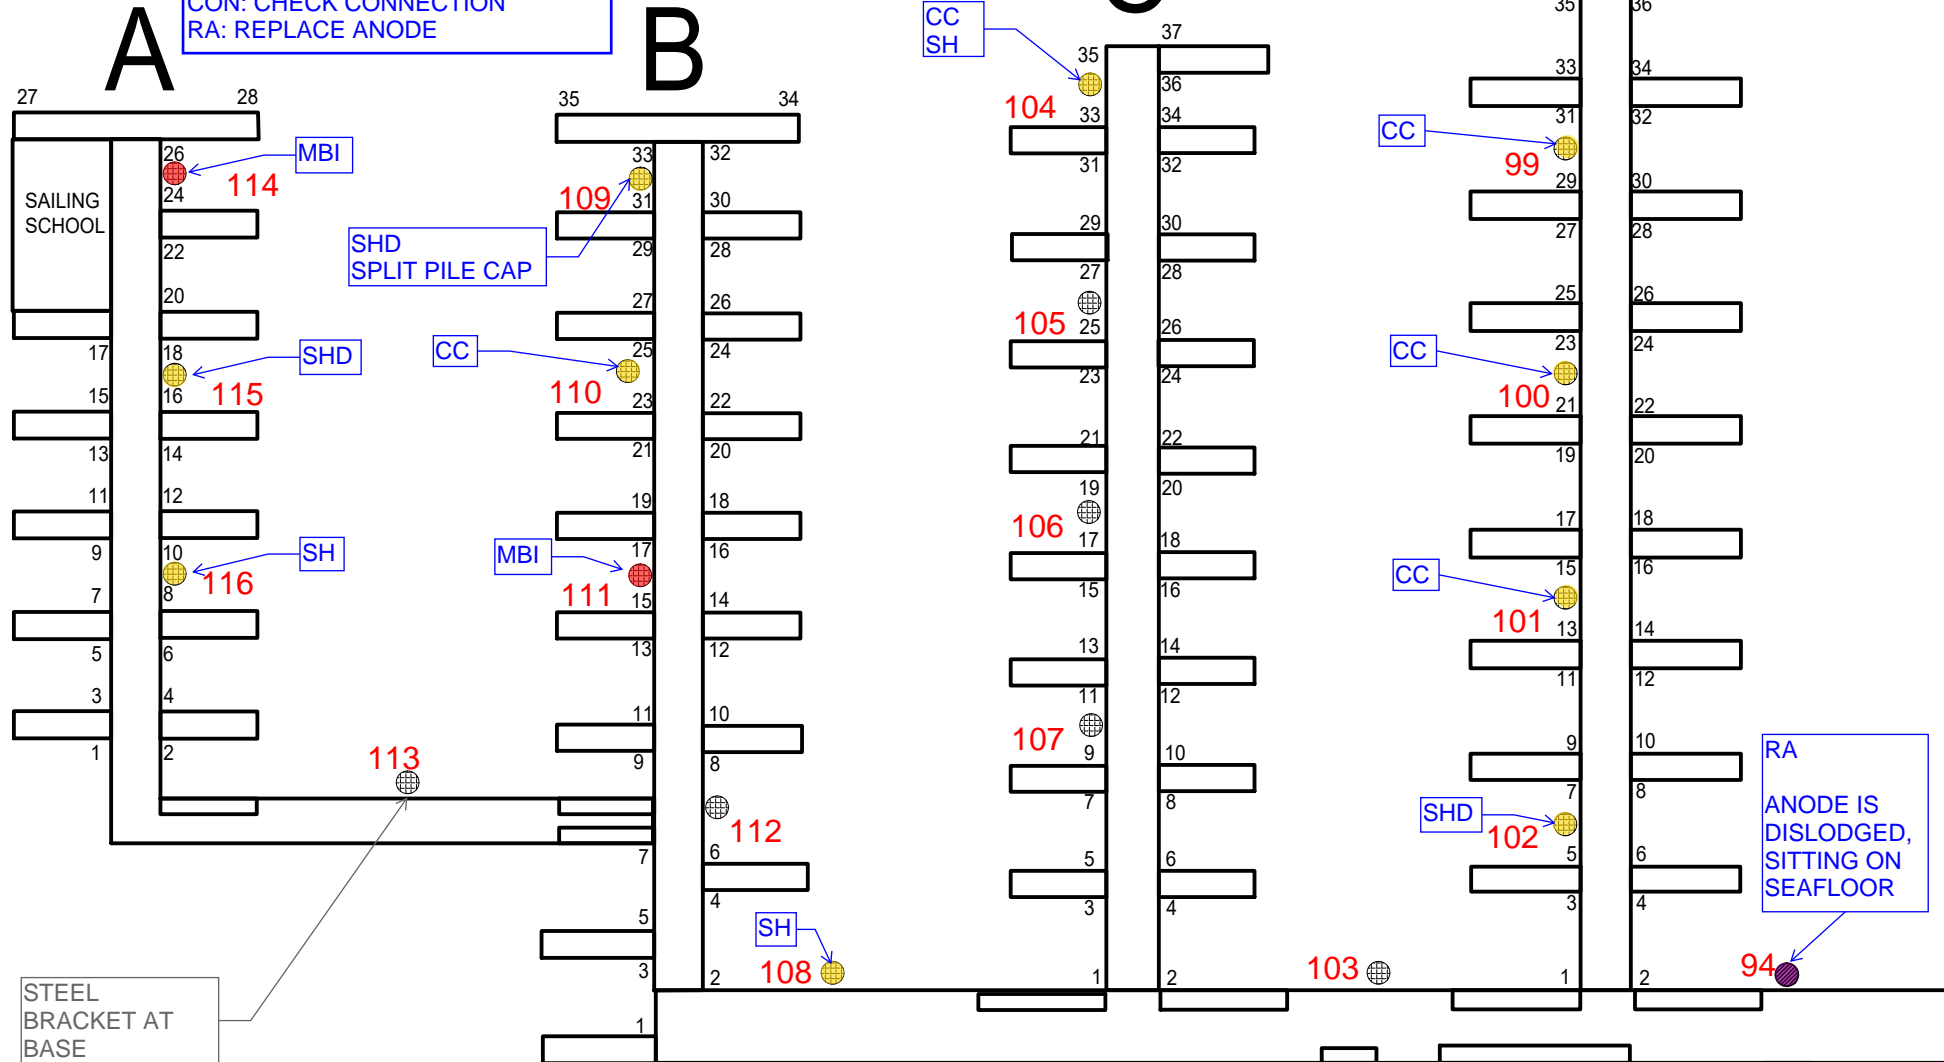
Appendix C Plan View – Mooring Pile Condition Assessment

RA
 ANODE IS DISLODGED, SITTING ON SEAFLOOR

LOOSE AND LEANING

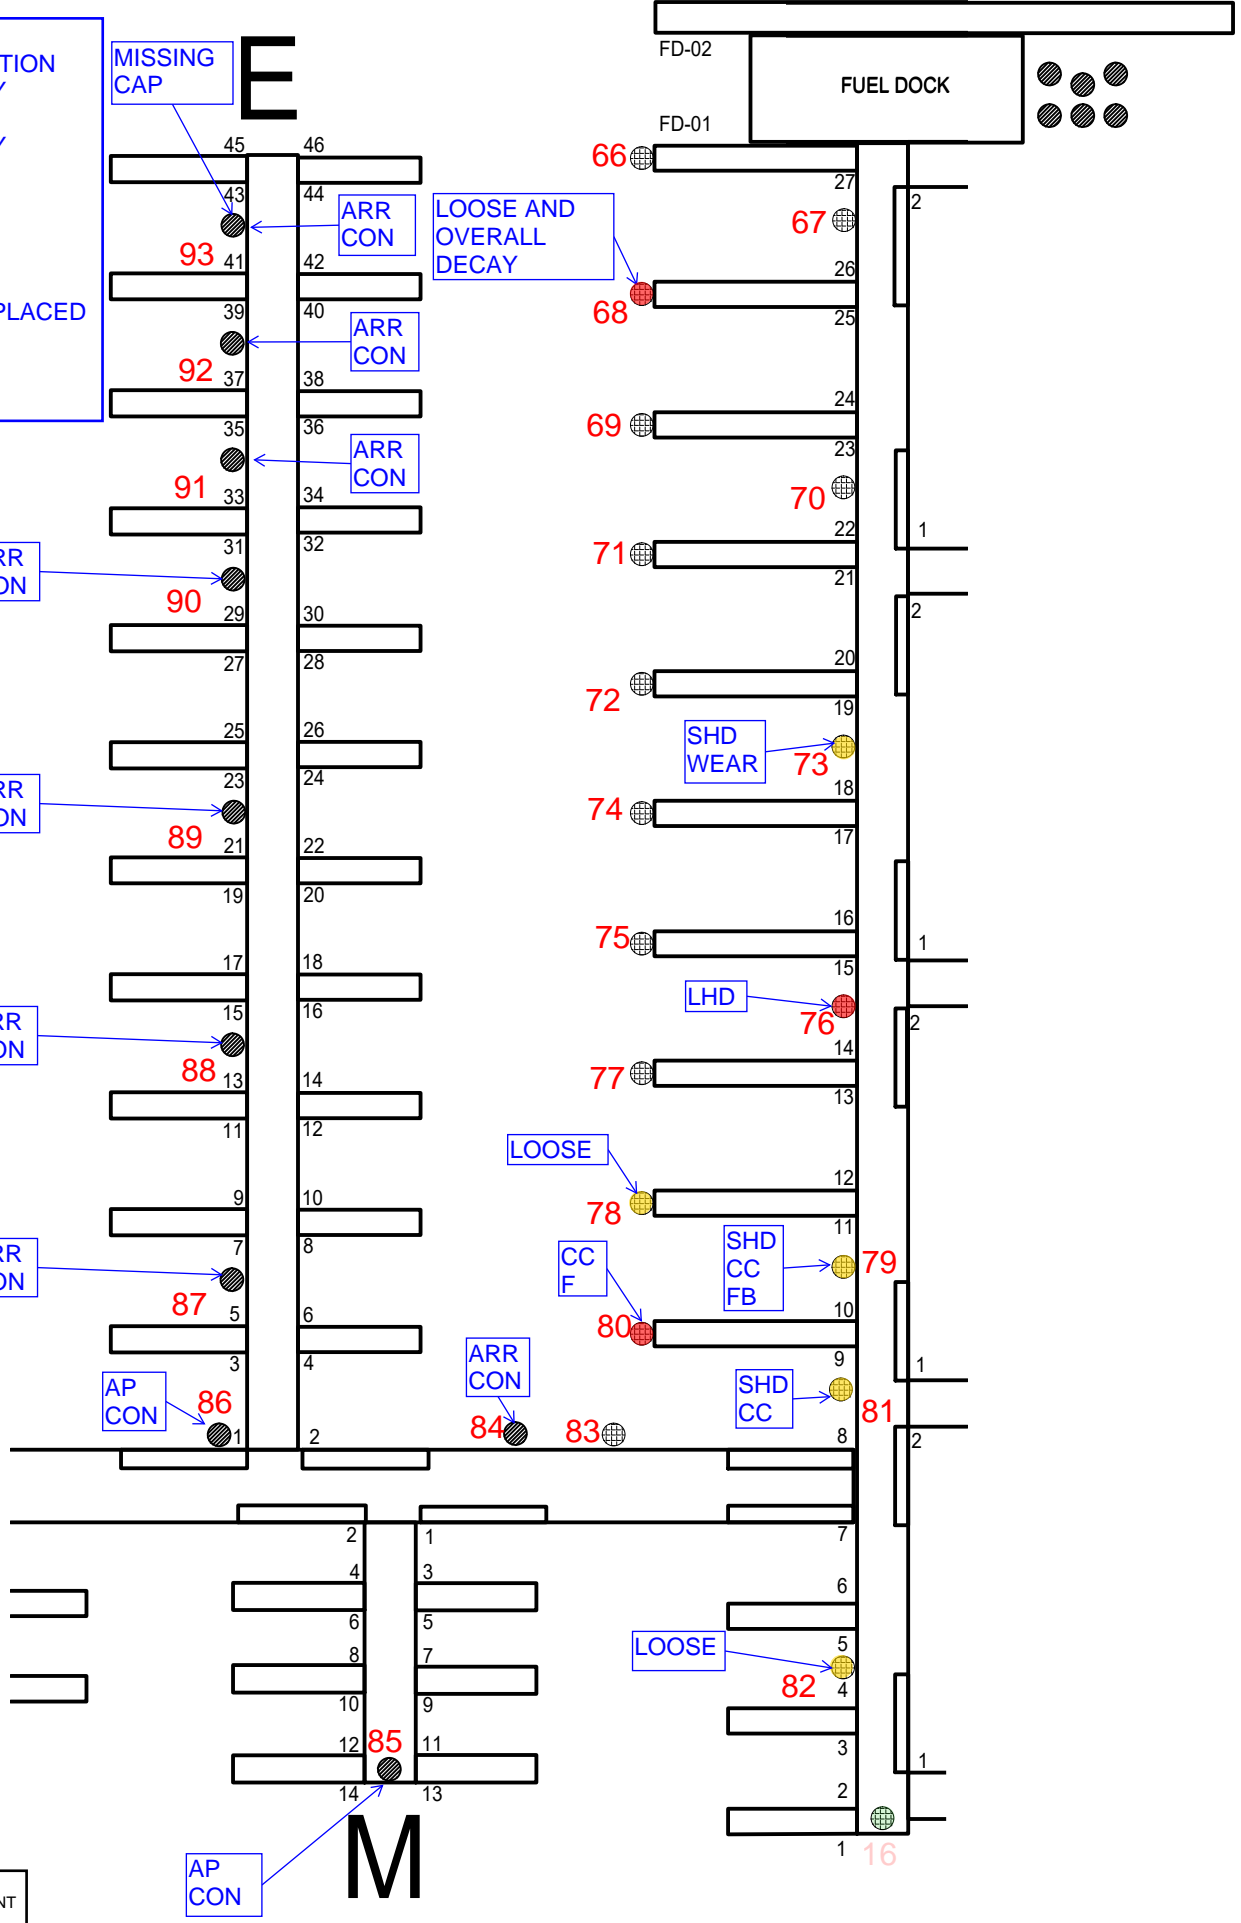
RUST PATCHES
NEAR ITZ

PITTING AND RUST SCALE.
 REPLACE ANODE AT FD5.
 CHECK CONNECTION AT ALL
 ANODES AT DOLPHIN

DECAYED
BLOCKING
BETWEEN PILES
