TOD HOUSE, 2564 HERON STREET OAK BAY - CONDITION SURVEY AND SPECIFICATION DRAWINGS

PREPARED FOR THE DISTRICT OF OAK BAY

Conservation and Repair
Specification, Tod House,
2564 Heron Street, Oak
Bay

Aug. 2020

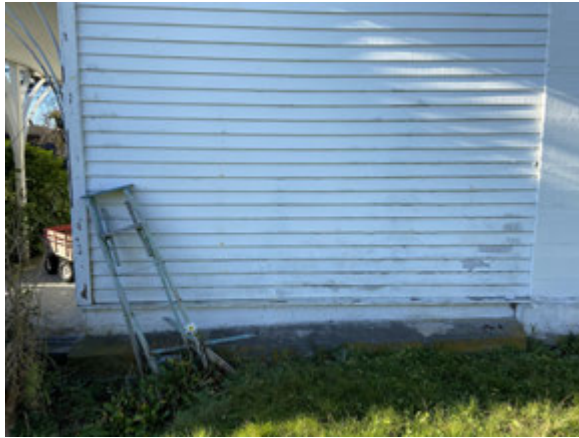
East Elevation, concrete curb poured against wall framing.

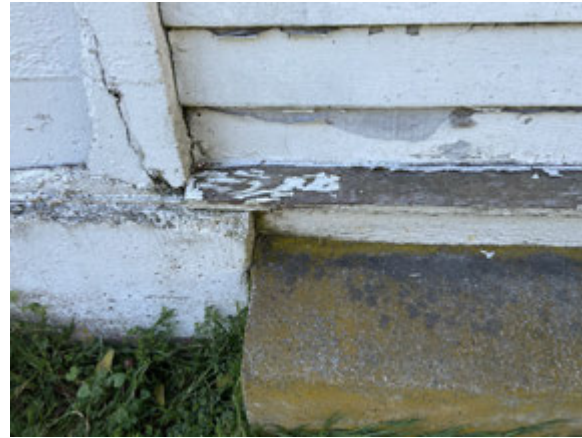
East Elevation. Different phases of concrete work built up against wall at chimney .

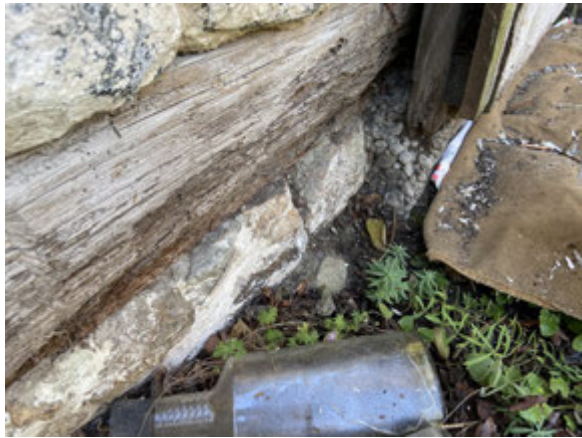
North Elevation. Original rubble foundation with hewn fir bottom sill.

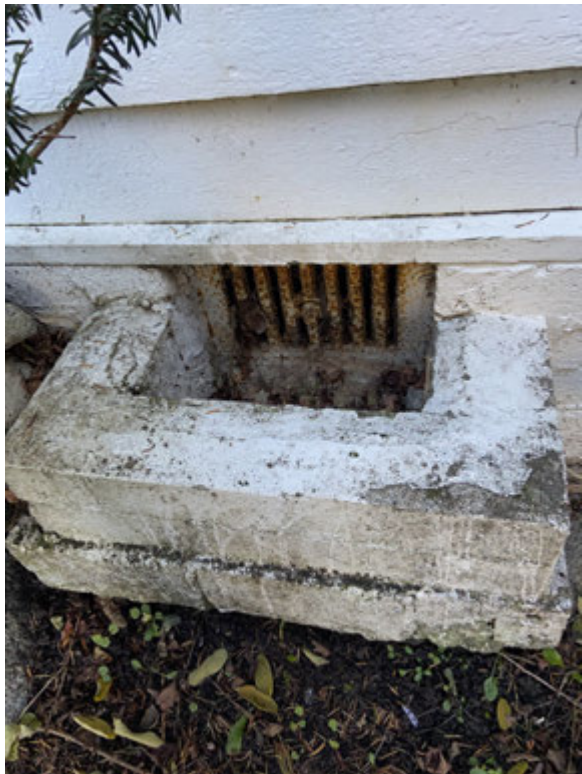
North Elevation. Vented crawl space.

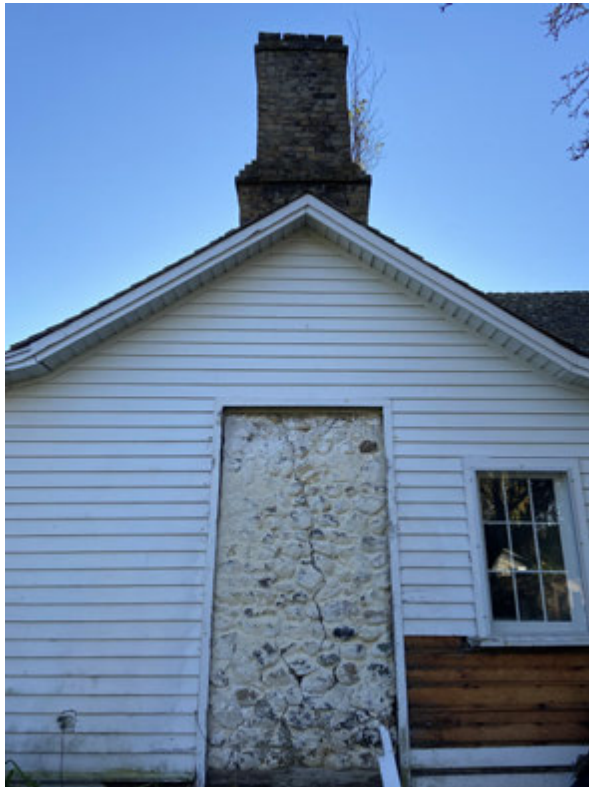
North Elevation rubble and brick chimney detail belonging to oldest part of the house.

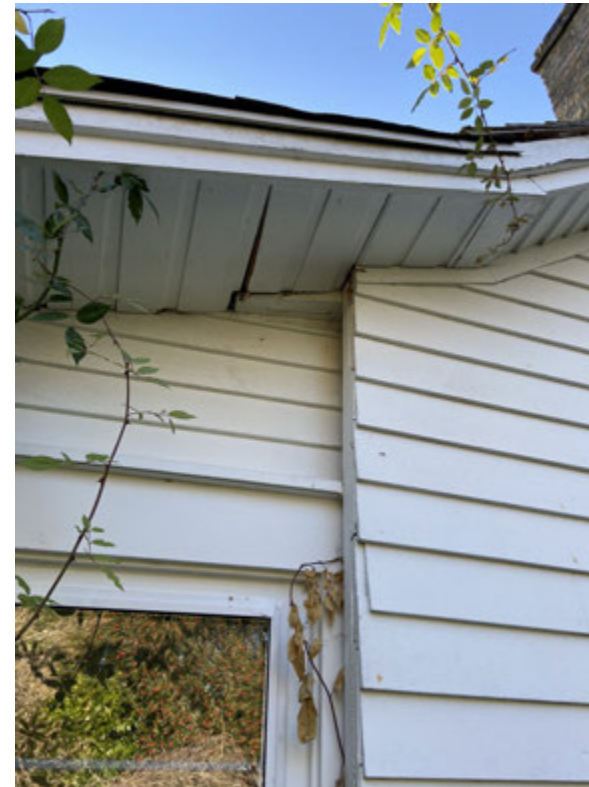
Soffit detail, North Elevation.

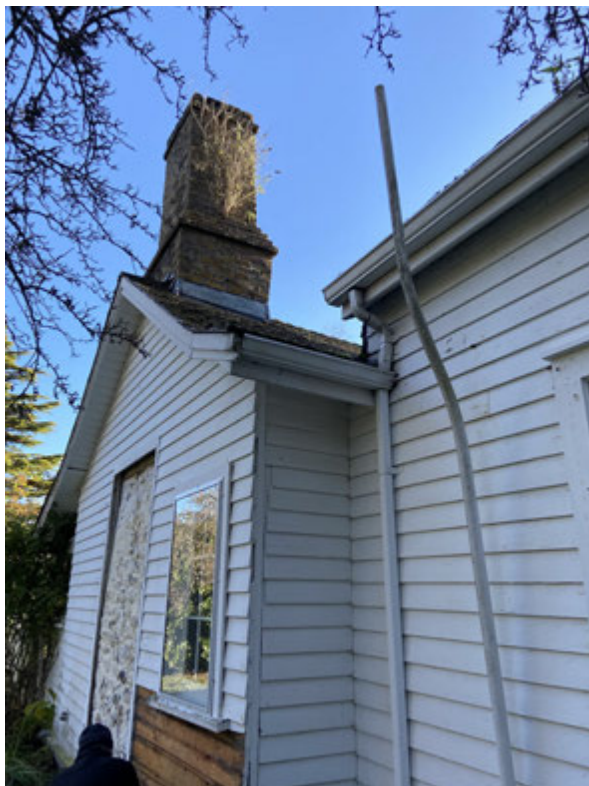
North Elevation rubble and brick chimney with connection to the 1890s addition on the right side of photo .

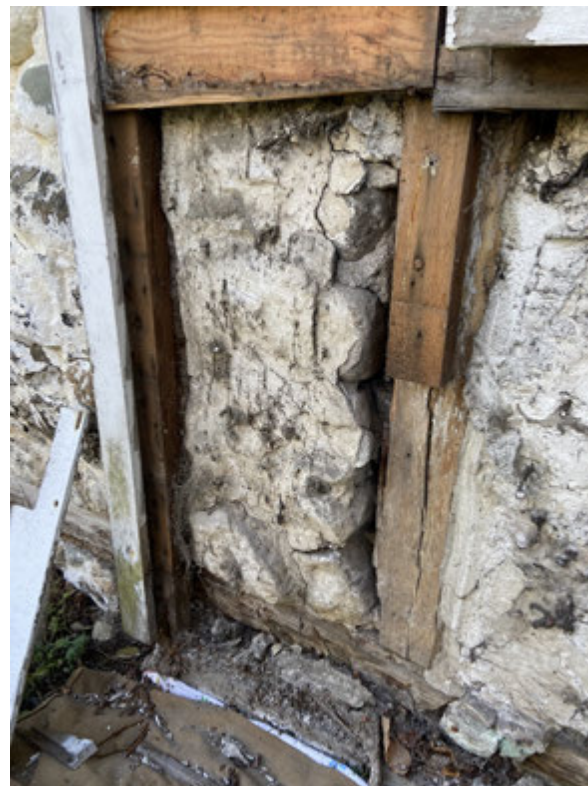
Rubble and lime mortar infill between hewn studs belonging to timber frame.

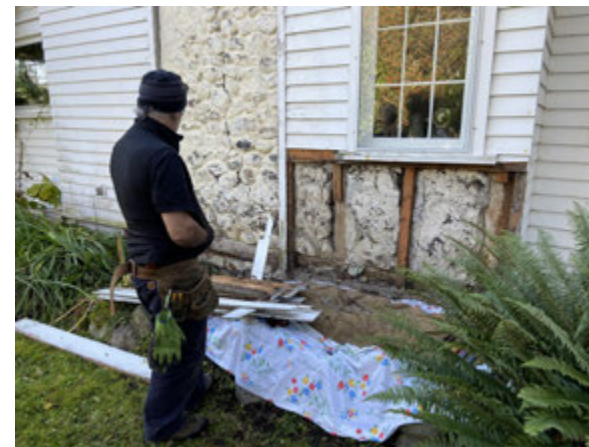
North Elevation outside kitchen. Timber framing exposed in the oldest part of the house.

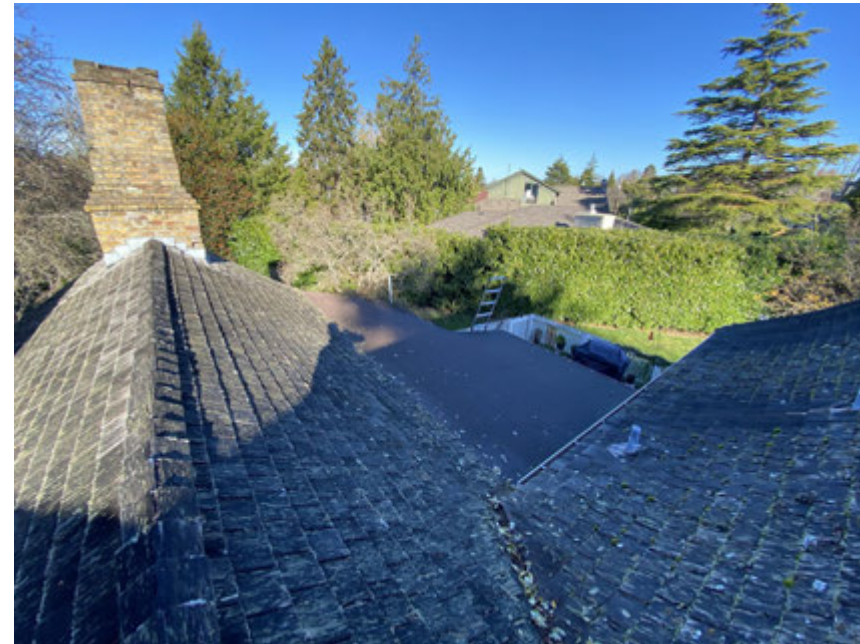
Roof and chimney over 1850s range. Asphalt roof over kitchen extension. Photo facing northeast.

Tod House Category 1 Repairs, Emergency Works	1.1	Replace Roofing <ul style="list-style-type: none"> Strip all exterior roofs to reveal/inspect the condition of underlying sarking boards. Do not remove any of the historic shakes visible within the attic. Repair the minimum amount of sarking necessary using materials that exactly match the historic fabric. Install new split cedar shakes to match the original roofing and exposure to the weather as existing in the attic above the Kitchen/Hall. Fire retardant should be considered but wood preservatives should not be used. Install new metal flashings throughout. Look for evidence of original flashings to determine the correct type. In areas of complex roof intersections (e.g., interior valleys) make such improvements to the flashings as necessary to improve the performance of the roof. Do not impede the breathability of the roof by inserting impermeable 'peel and stick' type membranes. Remove and dispose of all waste. 	High

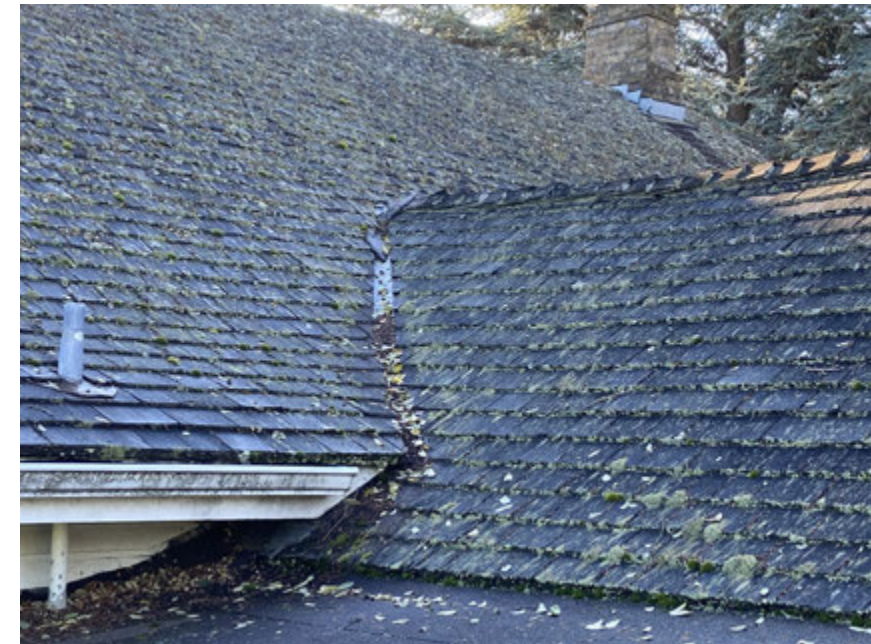
Typical roof valley.

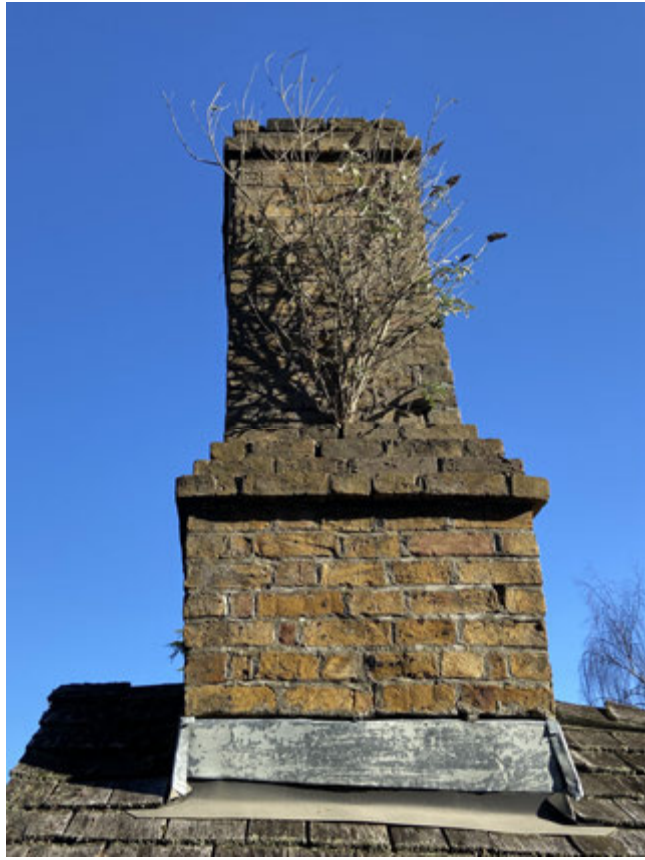
London Stock brick chimney. London bricks are a distinctive yellow/ buff colour and were imported to the new colony in the early years .

1.2	Repoint Chimneys <ul style="list-style-type: none"> Systematically inspect and repoint each of the chimneys with mortar that exactly matches the original. Replace any modern, cementitious mortars/repairs that are encountered, with compatible material. Remove all vegetation. Repair all cracks with mortar. Cap the chimneys with mortar to protect them. Install new metal flashings in reglets as necessary to enable roofing repairs. Replace and reinforce any dislocated bricks. Do not seal the bricks. 	High

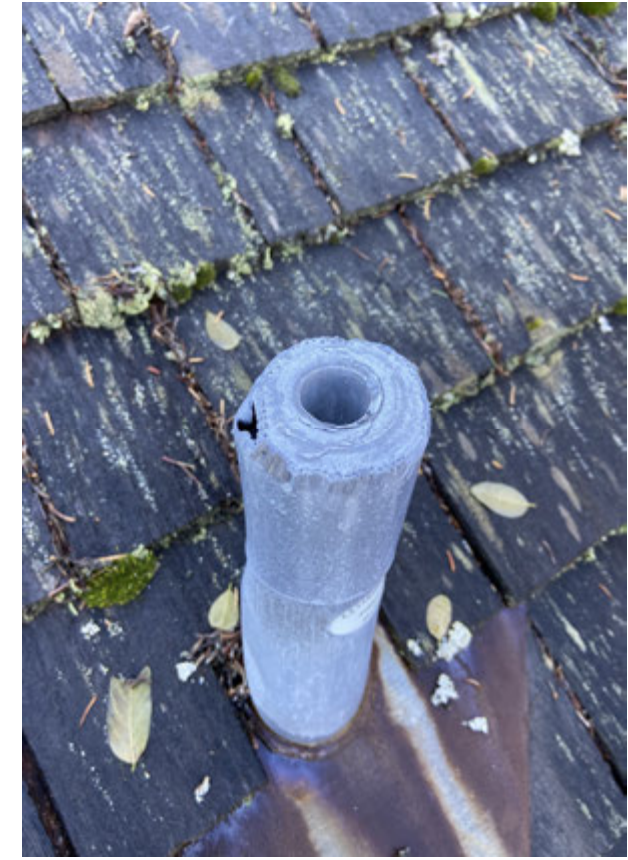
Lead flashing cover on plumbing vent pipe.
