Facility Condition Assessment

2022 - Simple Inflation Update to Report

Oak Bay Marina
1327 Beach Drive, Victoria, British Columbia
March 08, 2022

Project Number **221-02267-00**

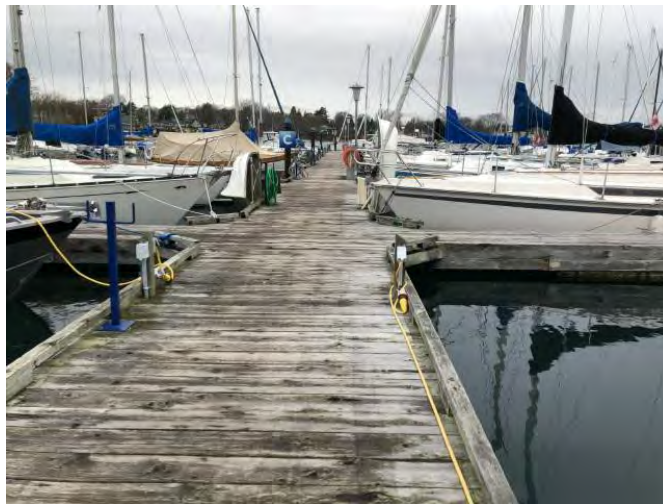
Photo #47: Marina Dock Walkways - Typical.

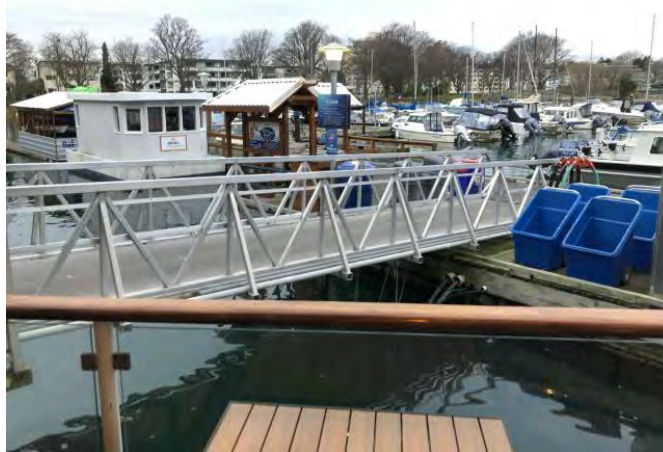
Photo #48: Marina Dock Ramp.

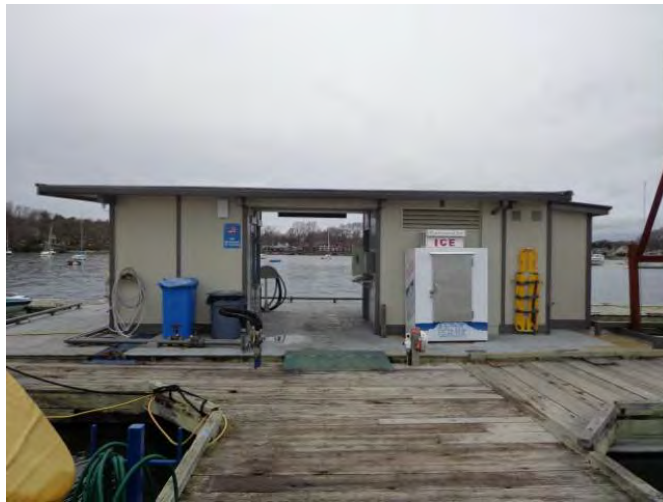
Photo #50: Marina Dock Gas Pump Station

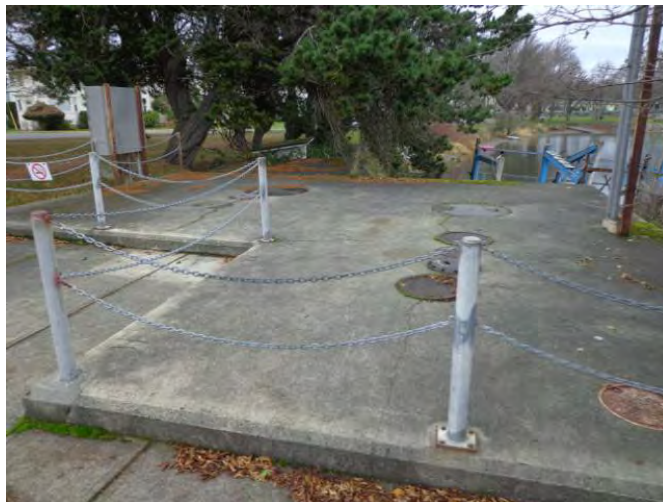
Photo #51: In-ground Gas and Diesel Pumps

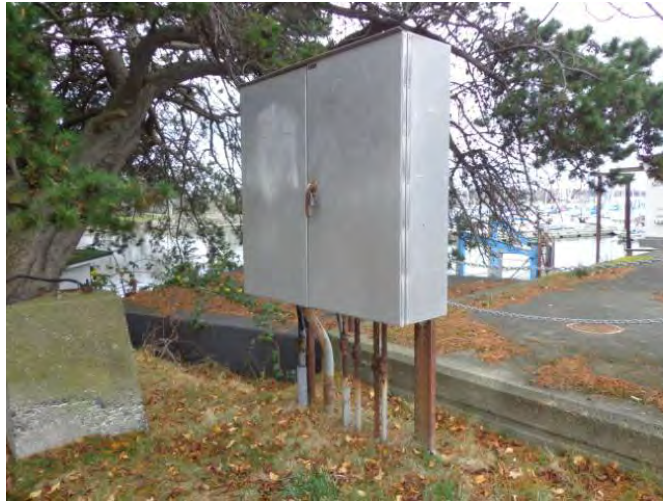
Photo #52: Gas and Diesel Pump Controllers

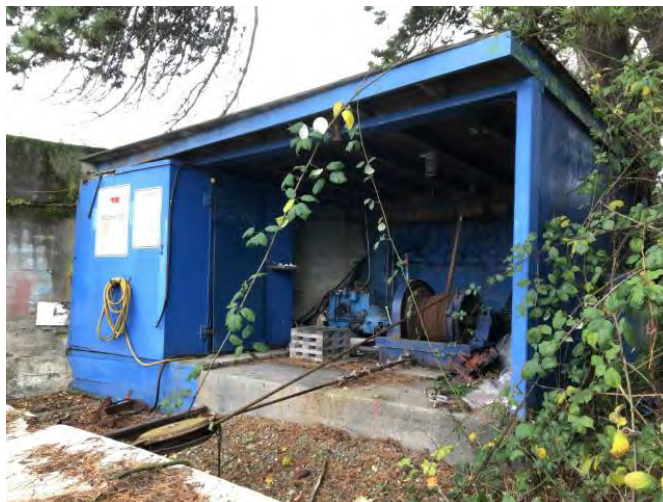
Photo #54: Marina Way Building.

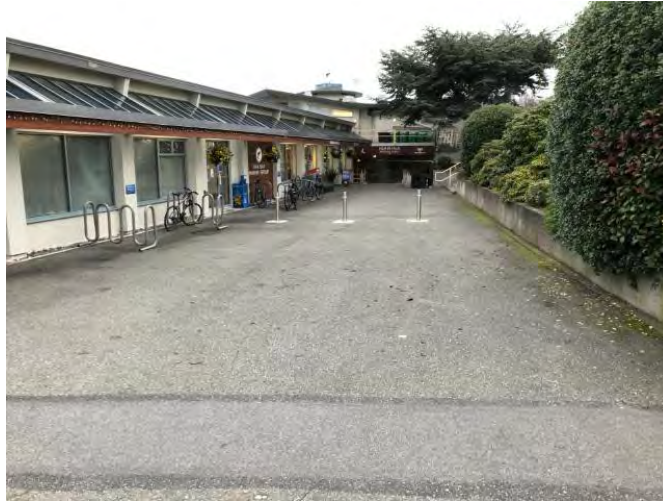
Photo #55: Lower East Drive Aisle.

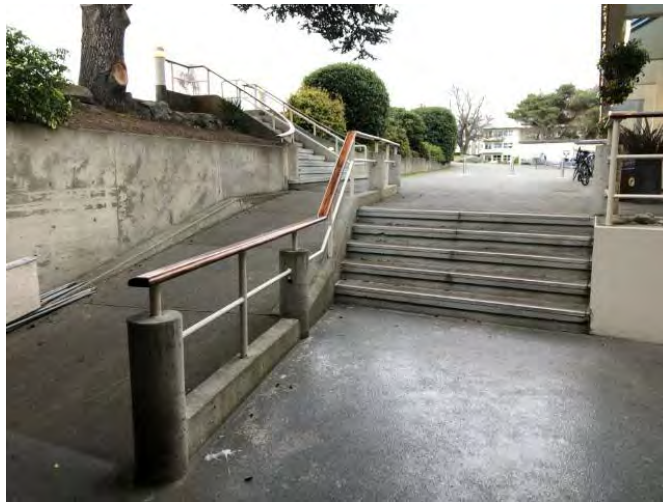
Photo #56: Site Walkways and Staircases - Typical.

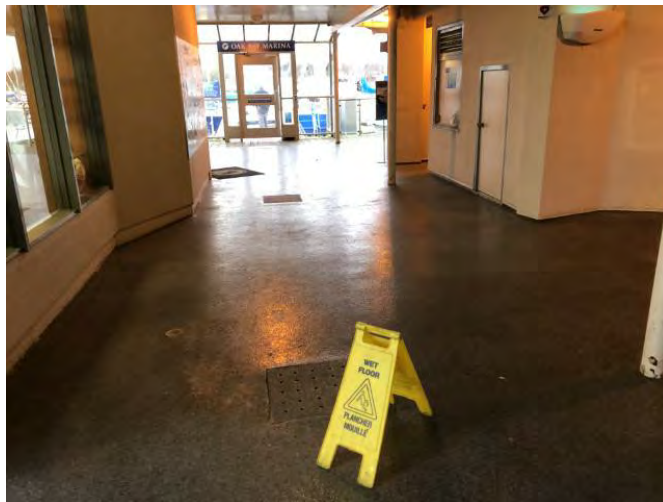
Photo #57: Covered Walkway.

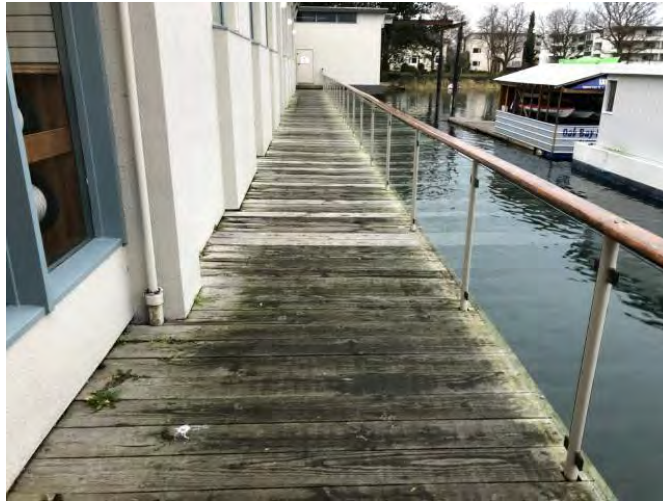
Photo #58: Wood-framed Walkway with Railing - Typical.

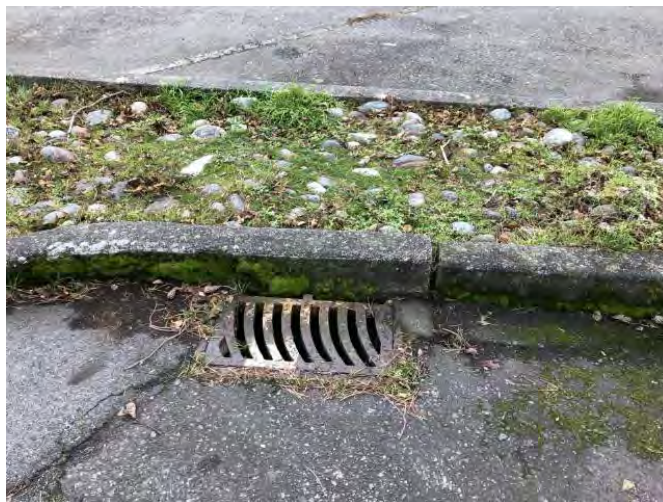
Photo #60: Parking Lot Catch Basin - Typical.

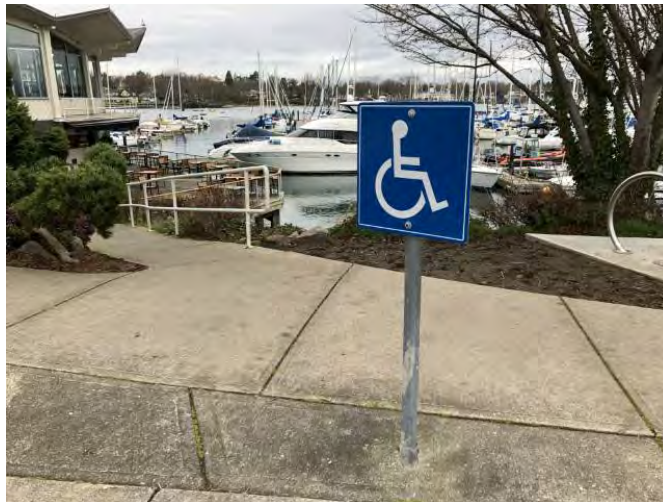
Photo #67: Site Signs - Typical.

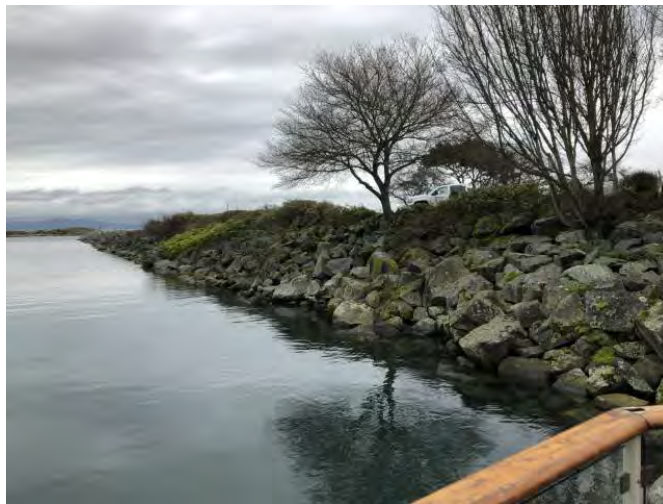
Photo #69: Breakwater - Typical.

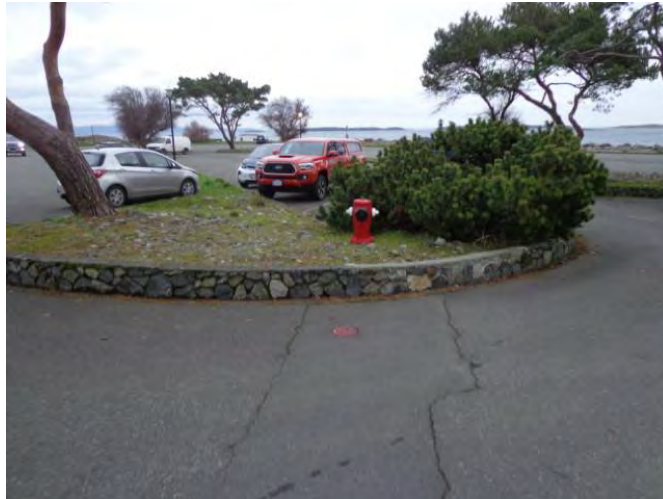
Photo #70: Site Fire Hydrant

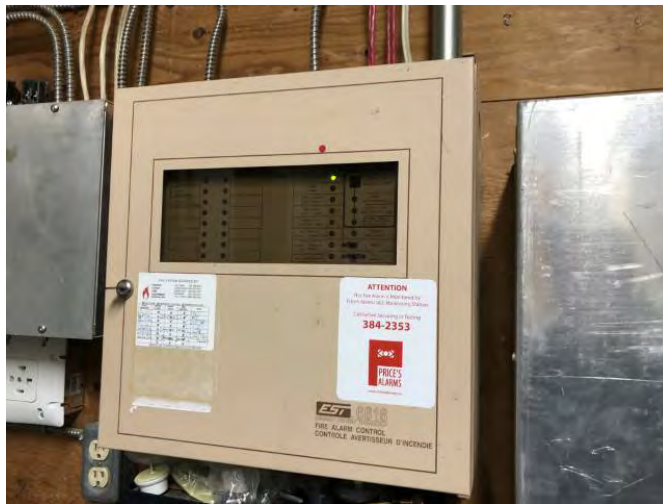
Photo #71: Main Fire Alarm Panel.

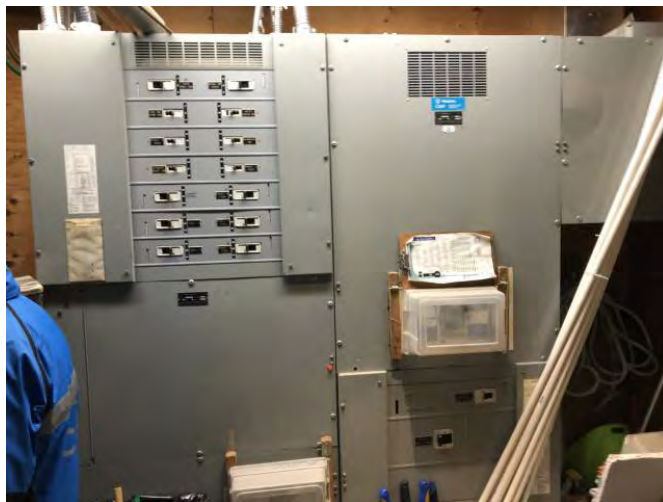
Photo #72: Main Electrical Switchgear.

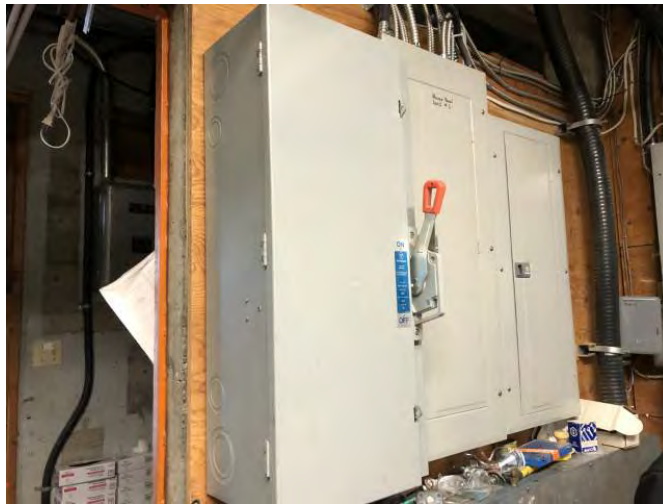
Photo #73: Main Electrical Distribution Panels.

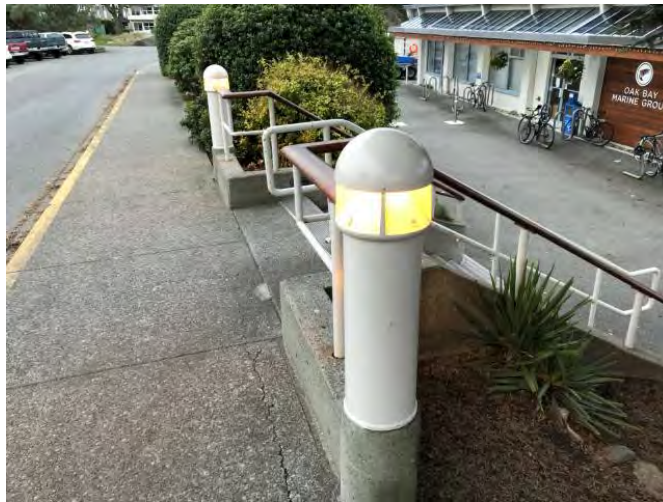
Photo #74: Site Bollard Lights - Typical.

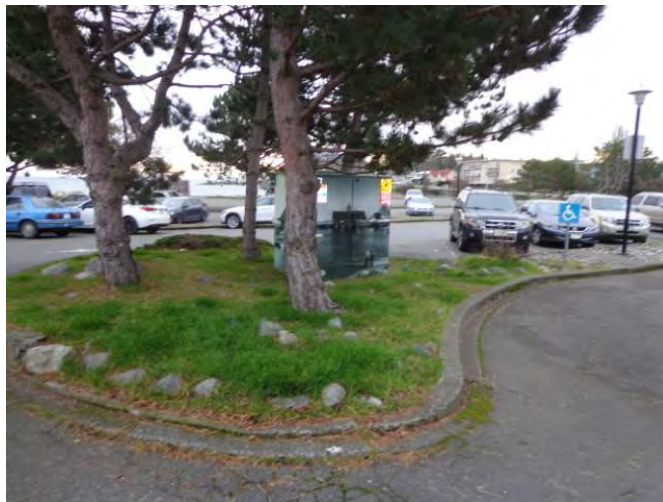
Photo #75: Site Light Posts Typical Landscaping and Transformer

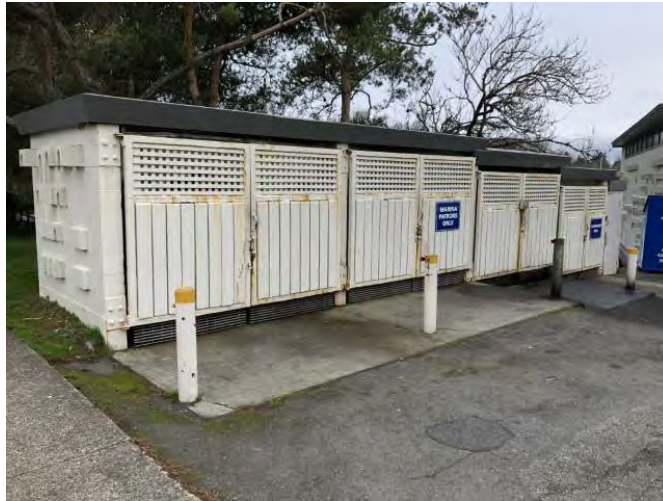
Photo #76: Garbage Enclosure.

9.1.1 Replace Garbage Enclosure Doors
