DISTRICT OF OAK BAY

BUILDING ASSET MANAGEMENT PLAN

MUNICIPAL BUILDINGS ANALYSIS

JULY 2016

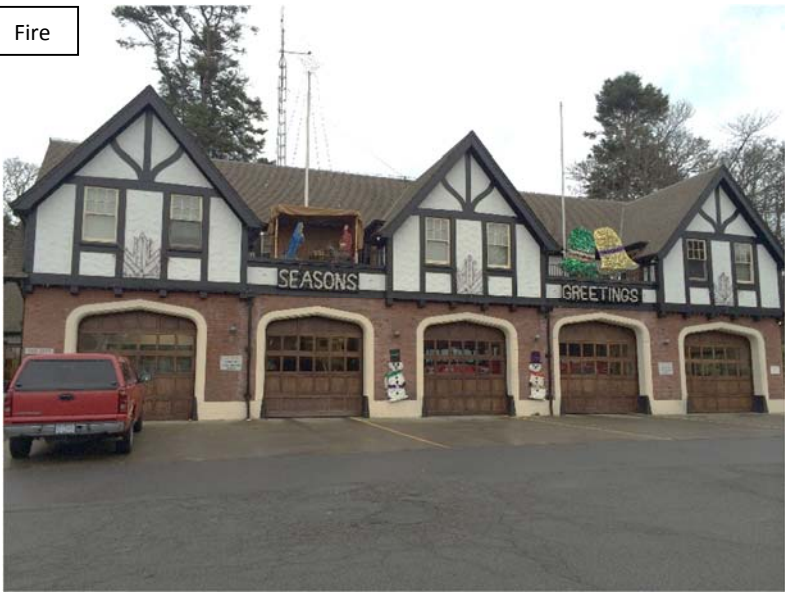
Figure 1 - No. 1a – Fire Station

<p>1703 Monterey Avenue</p> <p>Peak Occupancy: 20 Persons</p> <p>Staffing (avg.): 8-10 Persons</p> <p>Built: 1938</p> <p>Addition(s): 1963, 2002 Seismic Upgrade</p> <p>Current Area: 8,400 sf</p> <p>HVAC: Electric baseboard and roof top units (RTU), Natural gas boiler</p> <p>Fire Suppression: Extinguishers</p> <p>Access: Parking stalls at-grade, no wheelchair access</p>

BUILDING ENVELOPE: The lower level of the building is constructed with multi-wythe bricks while the wood-framed upper-level is clad with Tudor-style, where painted stucco. Wood trim and fascia boards are set between and on stucco panels. Windows are original wood-framed (fixed, single-hung, and casement) on the lower level and recently replaced Pella wood-frames on the upper-level. Exterior doors and motorized roll-up bay doors are original wood. The wood-framed roof features steep-sloped (14/12) asphalt shingle and low-sloped SBS membrane roof and deck areas. Gutters and downspouts connected to perimeter drains run along the north and south lengths of the sloped roof.

The 2002 seismic upgrade consists of the construction of new 100 mm thick concrete walls on one side of the existing masonry walls on the first floor; upper floor upgrades include new wood-framed shear walls, new floor diaphragm and connections to shear walls. The upgrade also added a steel braced frame on the lower floor. The concrete and structural steel design was based on the 1994 editions of the concrete and steel design standards, which lack a lot of the ductility and detailing requirements for post-disaster buildings that are in current editions. In its current condition, the Fire Hall with its stiffer lateral system has the tendency to attract lateral loads from the adjacent Police Station. The Fire Hall has a seismic capacity-to-demand ratio of about 0.2.

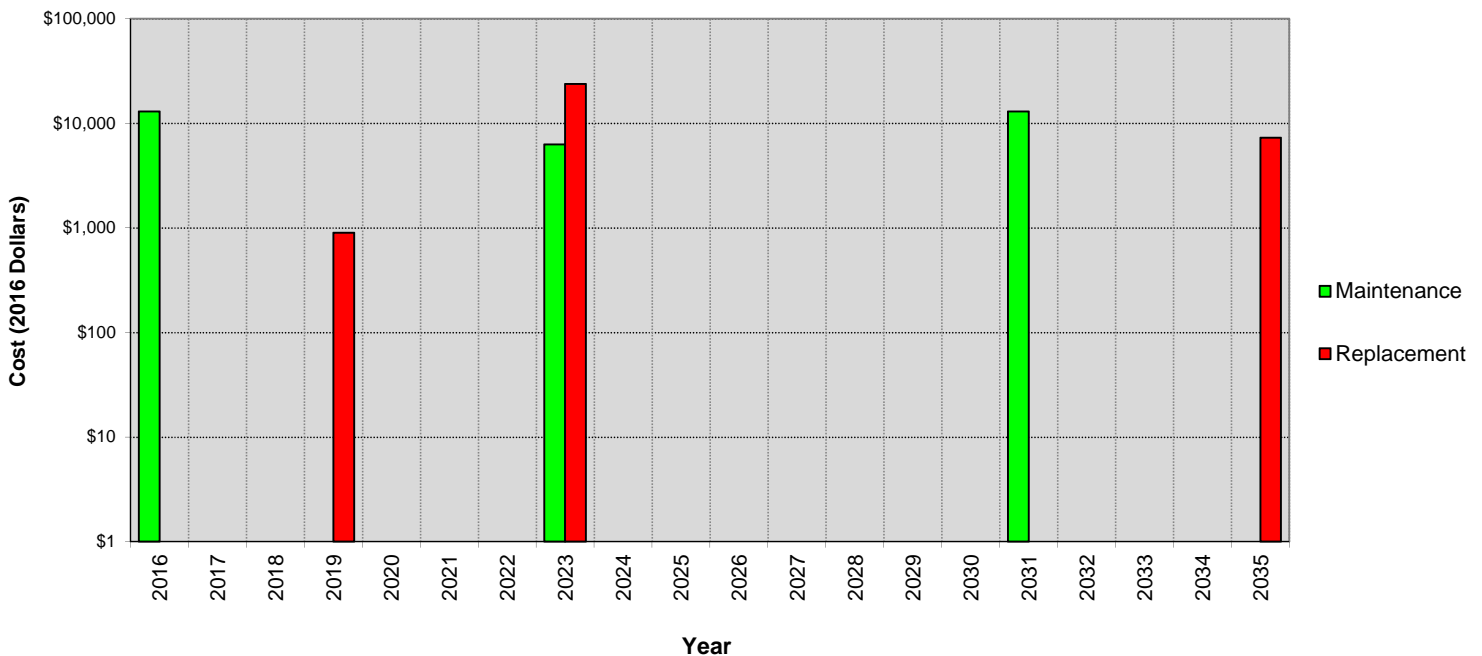
PROJECTED EXPENSES (Present Value)

The dollar axis is in logarithmic scale for ease of presentation.

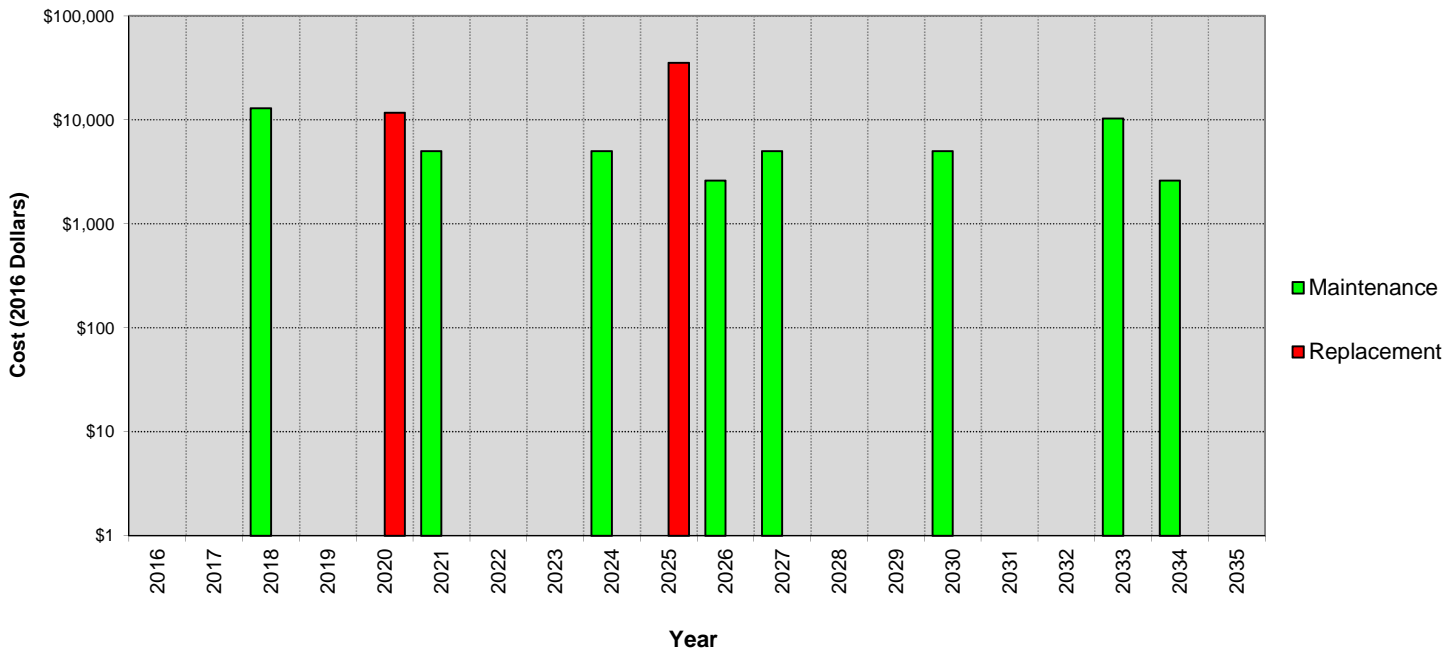
PROJECTED EXPENSES (Present Value)

The graph shows the costs associated with the maintenance and/or replacement of the component over time. The dollar axis is in logarithmic scale for ease of presentation.

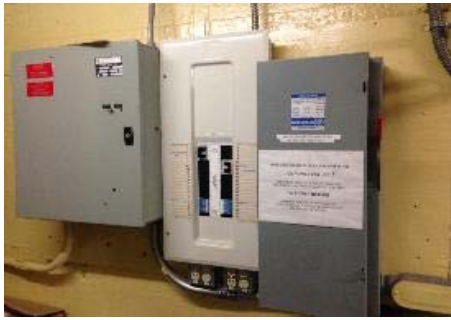
Electrical Distribuion equipment is past expected life expectancy and is recommended for replacement.

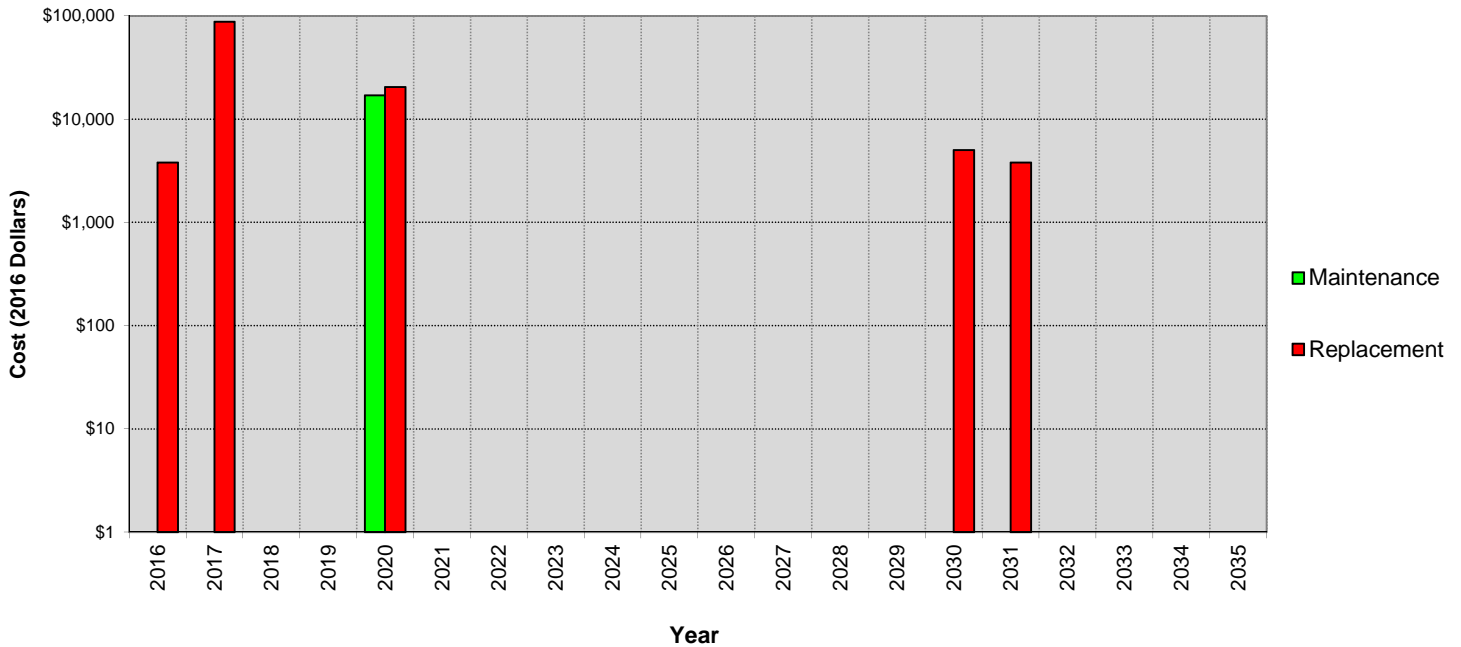
PROJECTED EXPENSES (Present Value)

The dollar axis is in logarithmic scale for ease of presentation.

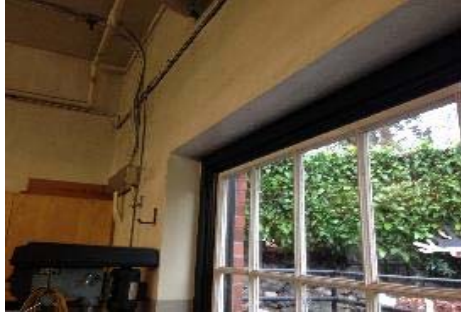
No.1a Fire Station Structural

Seismic upgrade of the entire building which includes the Fire Hall and the Police Station is one option to consider. There are challenges associated with a seismic upgrade to the entire building. Any new lateral system to upgrade the combined building would have to be made as stiff as the existing masonry and concrete walls in the Fire Hall. The addition of such a lateral system would pose significant space challenges in the already tight spaces of the Police Station and the Fire Hall. Floor layout may have to be revised or external lateral supports added to minimize the impact on the use of the available floor space.

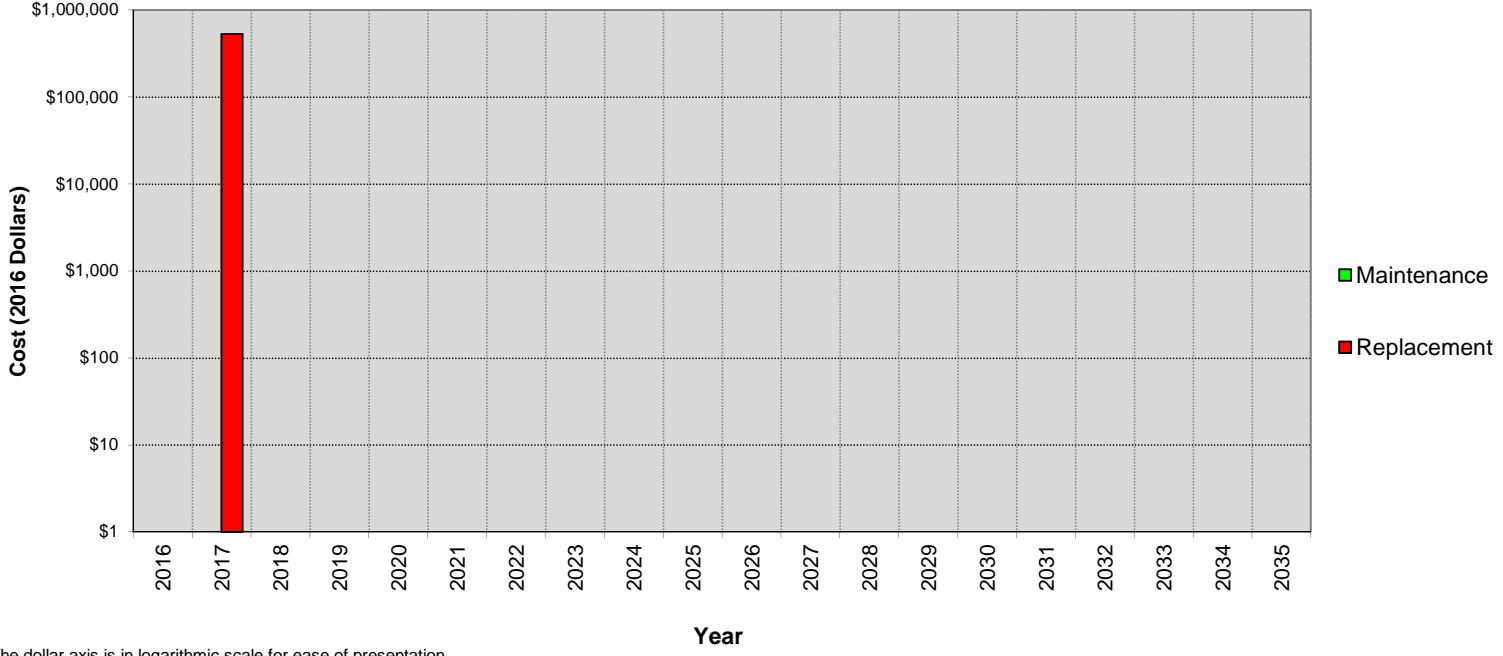
PROJECTED EXPENSES (Present Value)

The dollar axis is in logarithmic scale for ease of presentation.

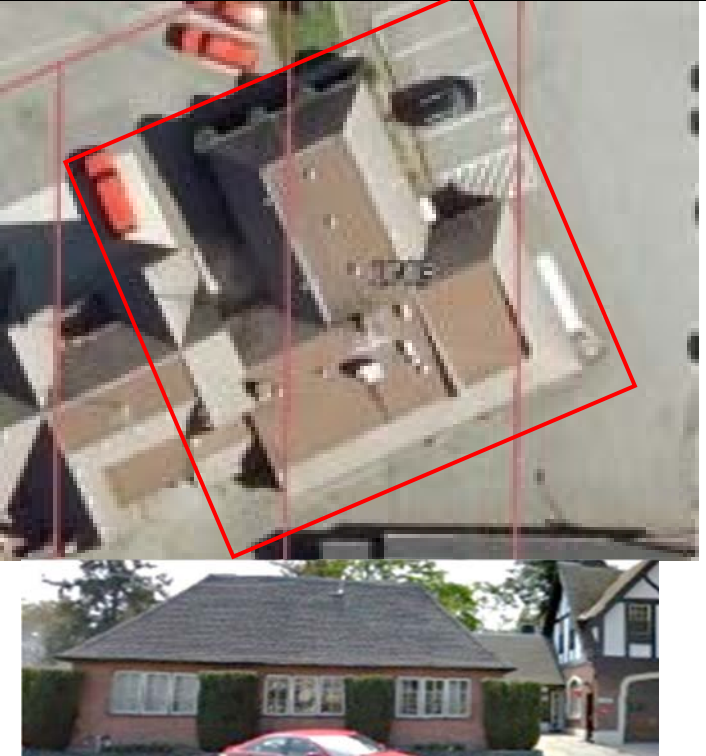
<p><i>Figure 2 - No. 1b – Police Station</i></p>
--	--

<p>1703 Monterey Avenue</p> <p>Peak Occupancy: 30 persons</p> <p>Staffing (avg.): 23 persons</p> <p>Built: 1958</p> <p>Addition(s): 1978</p> <p>Current Area: 7,300 sf</p> <p>HVAC: Electric baseboard and Air handling unit (AHU), Natural gas boiler</p> <p>Fire Suppression: Extinguishers</p> <p>Access: Parking stalls at-grade, no wheelchair access</p>

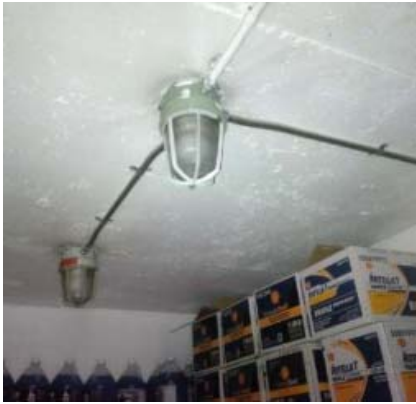
No.1b Police Station Electrical

Fire Warning System consists of 120V Smoke Alarms only. The Generator includes the transfer switch. The Intrusion Detection System needs some minor repairs and part replacements.

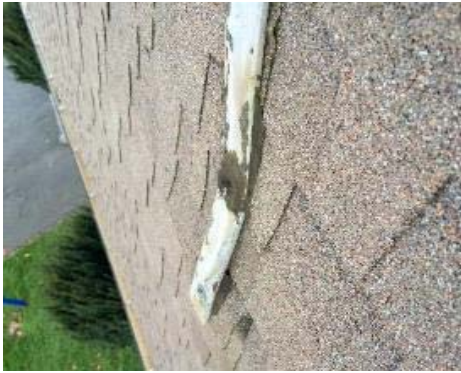
No.1b Police Station Structural

Hold-down anchors at the end of shear walls and proper seismic load paths from the roof diaphragm to the foundations are lacking. Current structure has a seismic capacity-to-demand ratio of about 0.3, which is under current code levels.

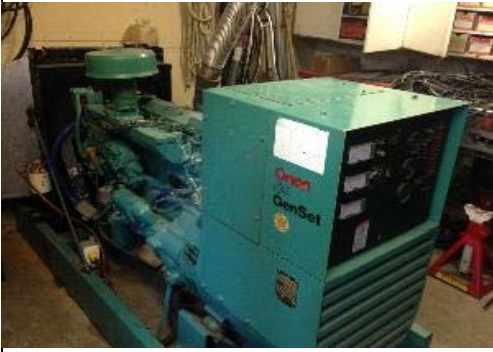
No.1c Garage Electrical

Item		Cost (\$)	Last (Year)	Period (yrs)	Adjusted (yrs)	Next (Year)
Natural Gas Generator	Maintenance Replacement	\$ 20,000	1980	30	8	2018
Diesel Generator	Maintenance Replacement	\$ 65,000	1985	30	2	2017
Diesel Transfer Swtich	Maintenance Replacement	\$ 7,500	1985	30	2	2017

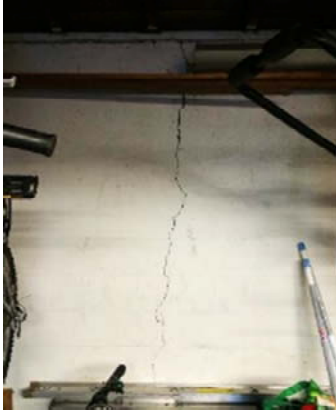
No.1c Garage Structural

Seismic upgrade includes stabilizing south retaining and connecting the wood frame roof to existing concrete walls.

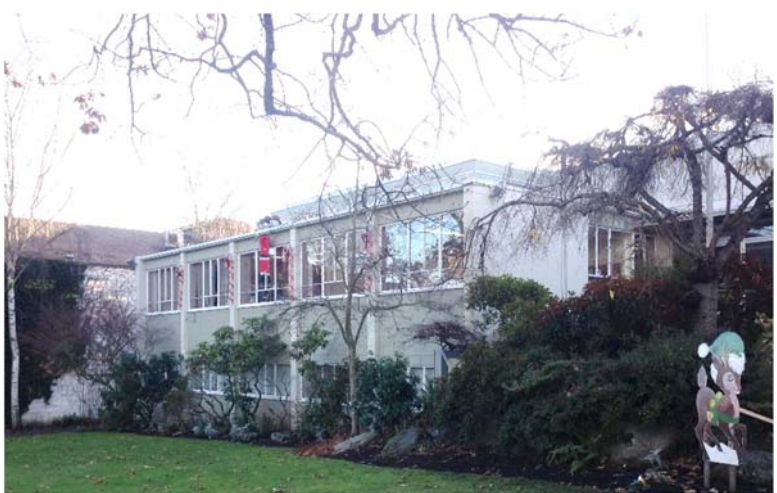
<p>Figure 4 - No. 2 – Municipal Administration Hall</p>

<p>2167 Oak Bay Ave.</p> <p>Peak Occupancy: 100 persons</p> <p>Staffing (avg.): 26 persons</p> <p>Built: 1958</p> <p>Addition(s): None Current Area: 14,897 sf</p> <p>HVAC: Natural gas boilers, AHU, Ductless Split Cooling</p> <p>Fire Suppression: Extinguishers</p> <p>Access: Parking stalls at-grade, wheelchair access</p>

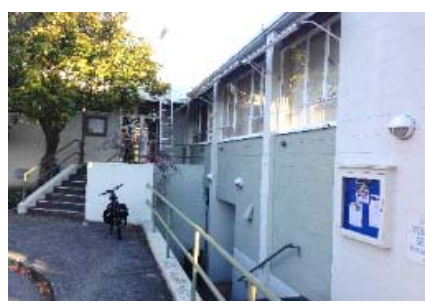
Building Envelope

Aluminum-framed windows are original and single glazed. No gaskets present resulting in movement during wind events and poor air tightness. Estimate provided for replacement with aluminum, double-glazed product.

SBS membrane replacement includes perimeter cap flashing and installation of drain covers.

Roof scupper installation recommended between upper and lower roof levels to more effectively manage rainwater.

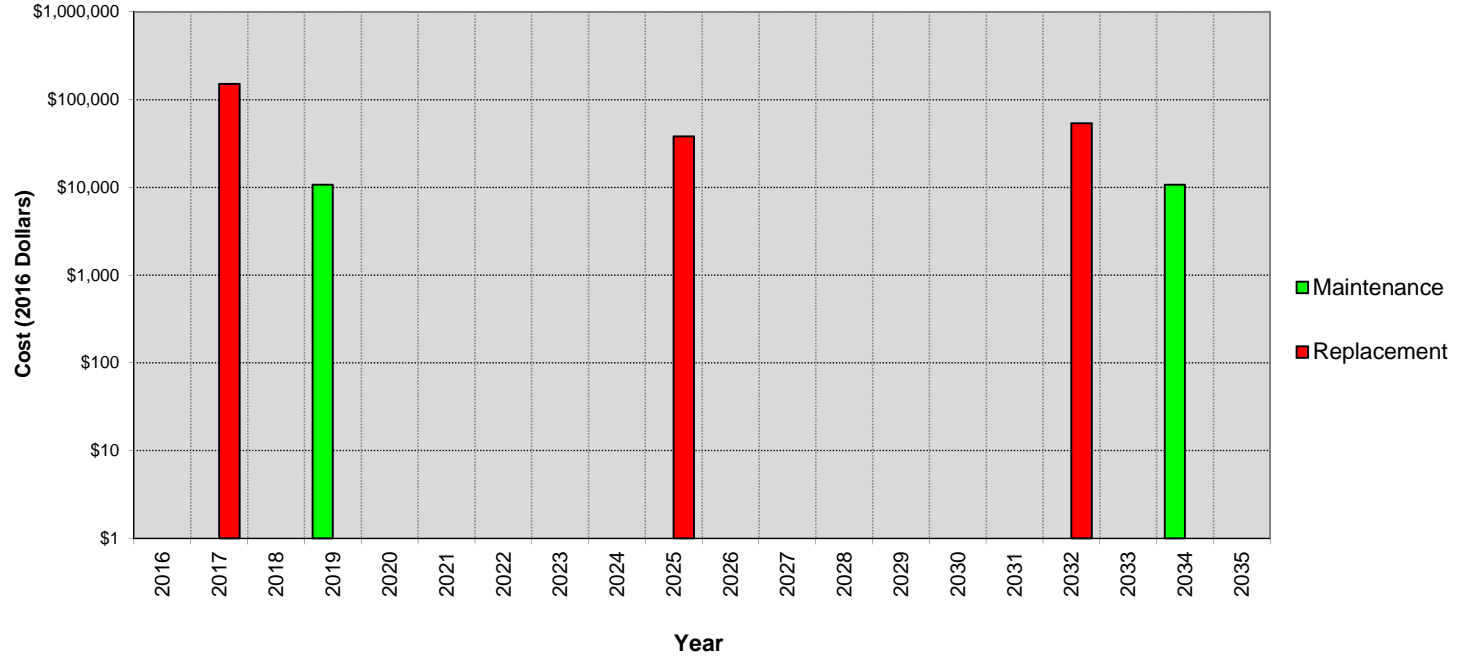
The graph shows the costs associated with the maintenance and/or replacement of the component over time. The dollar axis is in logarithmic scale for ease of presentation.

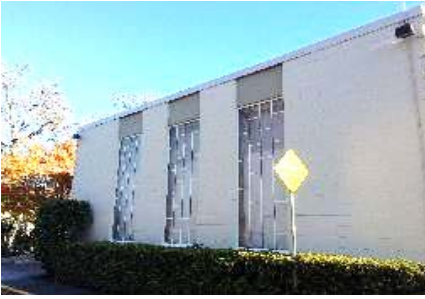
No.2 Municipal Hall Structural

Seismic upgrade includes additional shear walls or steel braced frames with corresponding foundations. These shear walls or braced frames will likely block some of the existing window openings. Additional anchorage of the walls to the roof and floor structures will also be required, in addition to roof and floor diaphragm strengthening.

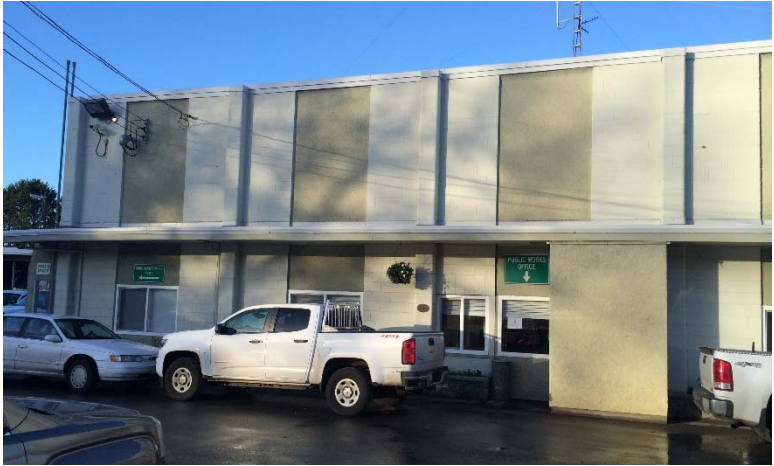
<p><i>Figure 5 - No. 3a – Public Works - Office and Storage Building</i></p>

The utilitarian building is constructed with concrete block at exterior walls and wood-frame at roofs and floors. Wood flooring rests over a 2'-6" crawlspace. The walls and roof are not insulated, and windows are non-thermally broken aluminum frame. The lower level consists of offices, a staff lunch room, lockers, washrooms and a large storage area. The lower level is occupied by approx. 12 staff with workstations and is subject to significant off-site staff traffic. The upper level is under-utilized as it is not suited to any functional needs at this time. The upper level is used primarily as storage, with a former sign shop which has since been discontinued. Parking for the building is designated within the Yard and perpendicular to the south elevation where the main entrance to the building is located.

BUILDING ENVELOPE: Exterior walls are constructed from uninsulated, partially-or fully-grouted painted concrete masonry unit and wood-framed stucco cladding. The upper level features original, single-pane, non-thermally broken metal-framed windows. Lower level office windows were upgraded with double-paned vinyl-framed windows in 2002. Exterior doors are hollow-metal with roll-up garage doors featured on the west elevation to the large storage area and the adjoining Parks building. Roofing is entirely low-sloped with 2-ply SBS membrane except for a portion of built-up-roofing with gravel ballast over the open-air storage area on the adjoining west building. Roof-top drains are present in corners and along the cap-flashed roofing perimeter, and overall ponding and condition was acceptable.

STRUCTURAL: The Office and Storage building features wood roof joists and wood floor joists supported by beams and columns. The exterior walls are constructed from concrete masonry units. Some interior partition walls on the ground floor are also constructed from concrete block masonry units. No significant additions or alterations have been made to the original building. Based on what is observed on site and what is shown on the original drawings, it appears that the perimeter masonry walls are not anchored to the floor and the roof structure adequately. Furthermore, the perimeter masonry walls are not reinforced sufficiently to support the building laterally for current Code-level seismic forces. In its current condition, the Office and Storage building has a seismic capacity-to-demand ratio of about 0.2.

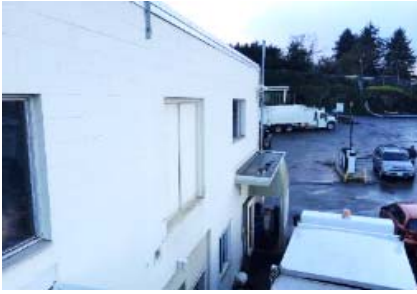
Building Envelope

Exterior door replacement includes hollow-metal (5) and roll-up garage doors (2).

Aluminum window replacement for remaining, original windows. Vinyl-frame replacements installed 2002 are not expected for replacement in the next 20 years.

SBS membrane roof replacement includes perimeter cap flashing renewal also. Built-up roofing replacement over open storage area is estimated with SBS membrane.

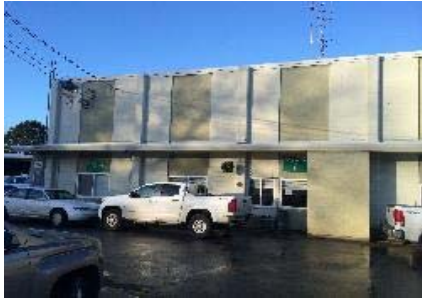
No.3a PW Office & Storage Structural

Seismic upgrade includes upgrading roof and floor diaphragms, additional reinforcing to the existing masonry walls and anchorage of the masonry walls to the roof and floor structures.

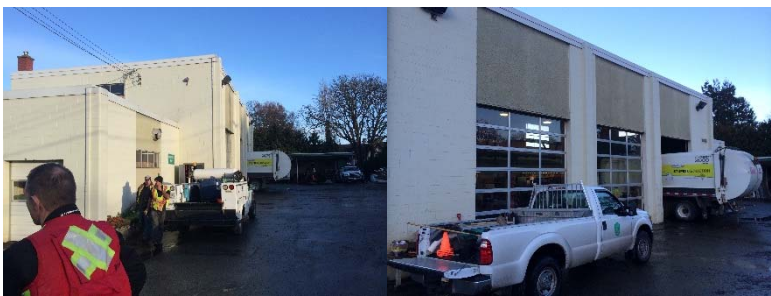
<p>Figure 6 No. 3b – Public Works - Maintenance Building</p>

The Public Works Maintenance building functions as a servicing, repair and fabrication shop for District Works equipment. The single-storey building has three high-ceiling repair bays and division-specific shops including: carpentry, roads, water works, sewer and garbage, and parks. Built in unison with the Office and Storage building, the two buildings share much of the same construction and design: uninsulated, concrete block walls and wood-framed roof. As a maintenance building with shop space and storage, the building serves its purpose as a durable, utilitarian building with high ceiling space. The building is inefficient thermally night and day, frequently with a service bay door open during operating hours, and has equipment mechanical upgrades to meet WorkSafe BC requirements. The paint storage room is fire rated. The garage has a Code non-compliant service pit. As the garage is not fitted out with up to date equipment, the pit is still utilized.

The interior spaces are F3 Classification Building with an 8” - 1.5hr fire resistant concrete block wall dividing the repair garage from the adjacent workshops, office and storage rooms. This wall is required to have a 2hr fire rating by current Code. While the building is durable, the garage spaces are dimensionally insufficient for their functional purpose to accommodate the size of trucks that are being serviced. Should renovations be provided

BUILDING ENVELOPE: Exterior walls are constructed primarily from uninsulated painted partially-or-fully grouted concrete masonry units; portions of wood-framed stucco cladding are present over service bays. All windows are original, single-pane, with non-thermally broken metal-frames. Exterior doors include hollow-metal, 11'-6" metal roll-up doors, and 14'-6" glazed roll-up doors. Roofing is entirely low-sloped with 2-ply SBS membrane and is found at three different roof heights over the building. Roof-top drains are present in corners and along the cap-flashed roofing perimeter. Roof parapet curbs are minimal. There is a mechanic's pit (4 ft. wide x 10 ft. long) 6 ft. below grade with a floor drain that did not exhibit symptoms of moisture, despite much of the site draining towards this location.

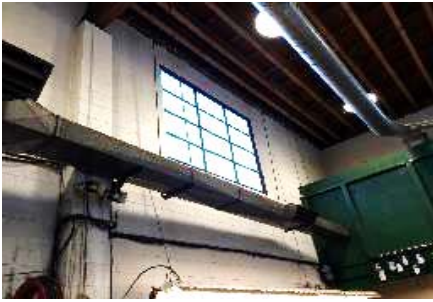
No.3b PW Maintenance Structural

Seismic upgrade includes upgrading roof diaphragms, additional reinforcing to existing masonry walls and anchorage of masonry walls to the roof structure.

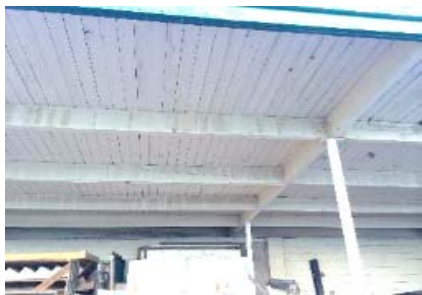
Building Envelope

Item		Cost (\$)	Last (Year)	Period (yrs)	Adjusted (yrs)	Next (Year)
SBS Membrane Roof	Maintenance Replacement	\$ 33,000	2014	20		2034
Wood and Steel Structure	Maintenance Replacement	\$ 2,000	2000	10	7	2017

Steel columns exhibit corrosion and paint on wood framing members was peeling. Maintenance estimate includes sanding and painting all affected areas.

SBS roofing membrane replacement includes all flashing.

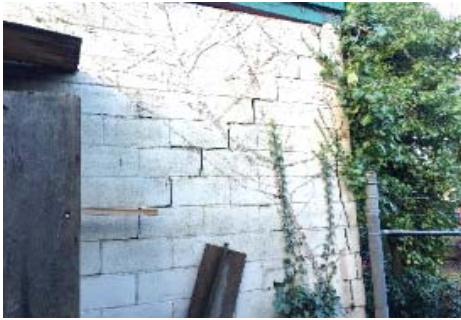
Item		Cost (\$)	Last (Year)	Period (yrs)	Adjusted (yrs)	Next (Year)
Structural Repairs	Maintenance					
	Replacement	\$ 6,000				2016

Structural repairs include: Replace bent steel pipe column, repair steel pipe column pedestals on others, replace damaged roof joists, replace damaged concrete masonry wall running east-west at south end of shelter.

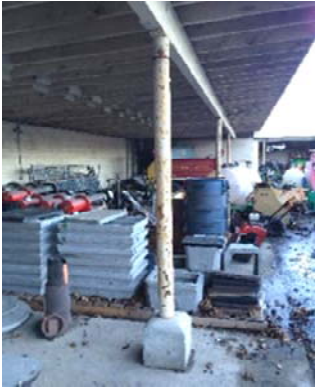
Building Envelope

Item		Cost (\$)	Last (Year)	Period (yrs)	Adjusted (yrs)	Next (Year)
SBS Membrane Roof	Maintenance Replacement	\$ 26,000	2014	20		2034
Wood and Steel Structure	Maintenance Replacement	\$ 2,000	2000	10	7	2017

Steel columns exhibit corrosion and paint on wood framing members was peeling. Maintenance estimate includes sanding and painting all affected areas.

SBS roofing membrane replacement includes all flashing.

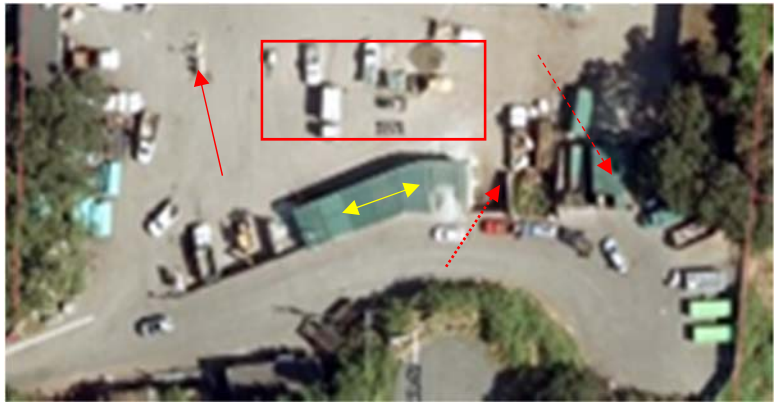
<p>Red rectangle: public and staff parking and vehicle parking changing at 4pm, red arrow: gas pumps, yellow double arrow: covered bays of bulk storage. Dashed arrow: bins. Dotted arrow: transfer station bins.</p> <p><i>Figure 8 - No. 6 - Public Works – Bulk Storage and Transfer Station</i></p>
--	--

BUILDING ENVELOPE / STRUCTURAL: The Transfer Station bins are constructed from concrete foundation walls, steel framed girders, and painted plywood sheathing. The covered bays feature corrugated-metal roofing and steel gates to keep material from sloughing.

1. Plywood sheathing is damaged from impact of materials and exposure to weather.
2. Metal roofing is not fastened securely and is corroded. Barrier to unauthorized access is recommended.
3. Gates exhibit significant corrosion. Corrosion at one east most gate was very significant and requires replacement/ temporary reinforcement for worker safety.

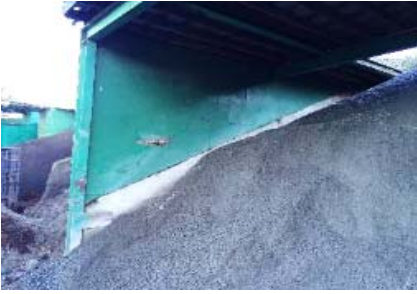
Building Envelope

Item		Cost (\$)	Last (Year)	Period (yrs)	Adjusted (yrs)	Next (Year)
Bin Plywood Cladding	Maintenance Replacement	\$ 2,000	2010	8		2018
Corrugated Metal Roofing	Maintenance Replacement	\$ 5,000	1975	50		2025

Portions of plywood cladding damaged, replacement period scheduled within next five years and then every 8 years thereafter.

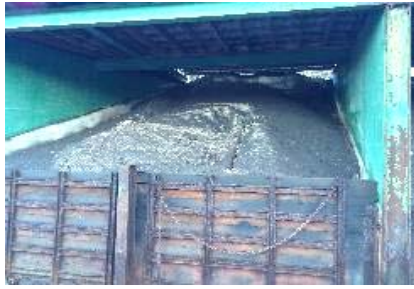
No.6 PW Bulk Transfer Structural

Item		Cost (\$)	Last (Year)	Period (yrs)	Adjusted (yrs)	Next (Year)
Metal Retaining Gates	Maintenance Replacement	\$ 4,500		30		2017

Replacement of corroded, steel, retaining gates, at the base of western bins recommended.

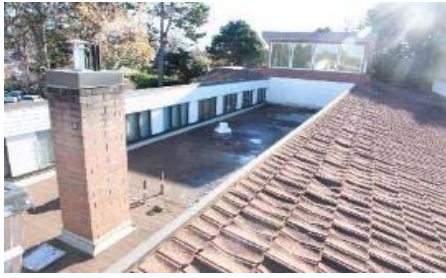
Building Envelope

Item		Cost (\$)	Last (Year)	Period (yrs)	Adjusted (yrs)	Next (Year)
Cedar Fascia Board	Maintenance	\$ 2,200	2010	8		2018
	Replacement	\$ 24,800	1971	40	10	2021
Brick	Maintenance	\$ 4,000	2010	8		2018
	Replacement					
SBS Membrane Roof	Maintenance	\$ 3,000	2015	2		2017
	Replacement	\$ 51,000	2000	25		2025
EPDM Membrane Roof	Maintenance					
	Replacement	\$ 31,000	2000	25		2025
Original Aluminum Windows	Maintenance					
	Replacement	\$ 24,800	1971	40	8	2019
Aluminum Windows	Maintenance					
	Replacement	\$ 41,000	1989	40		2029
Pressure Glazed Skylight	Maintenance					
	Replacement	\$ 24,000	2000	40		2040
T-Bar Skylight	Maintenance					
	Replacement	\$ 13,600	2006	40		2046
Exterior Metal Doors	Maintenance					
	Replacement	\$ 9,100	1971	50		2021

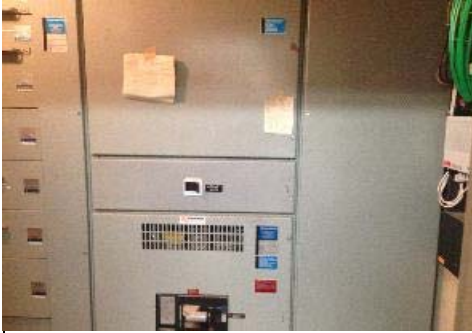
No.7a Monterey Centre Electrical

Item		Cost (\$)	Last (Year)	Period (yrs)	Adjusted (yrs)	Next (Year)
Breaker Panel Main	Maintenance Replacement	\$ 55,000	1971	35	10	2016
Breaker Panel Secondary	Maintenance Replacement	\$ 110,000	1971	35	10	2016
Lighting Emergency Exit	Maintenance Replacement	\$ 25,000	1990	30		2020
Lighting Battery Emergency	Maintenance Replacement	\$ 6,800	1990	25	2	2017
Lighting Exterior	Maintenance Replacement	\$ 35,000	2000	25		2025
Lighting Interior	Maintenance Replacement	\$ 83,000	1990	25	2	2017
Alarm Panel	Maintenance Replacement	\$ 25,000	1990	25	2	2017
Baseboard	Maintenance Replacement	\$ 6,300	1990	30		2020
Receptacle Duplex	Maintenance Replacement	\$ 11,300	1990	30		2020
Intrusion Detection	Maintenance Replacement	\$ 10,000	1990	20	7	2017
Paging System	Maintenance Replacement	\$ 15,000	1990	25	2	2017
Sound System	Maintenance Replacement	\$ 12,500	2010	15		2025
Theatre Lighting	Maintenance Replacement	\$ 12,500	2010	20		2030

The main electrical distribution and panels are at their end of life and should be replaced.

ELECTRICAL: The main electrical service provides power to the Library and Apartments. The equipment is reaching the end of its expected life and consideration should be given to replace the equipment. Some of the electrical equipment is made by Commander and is no longer in production; replacement parts may become difficult to source.

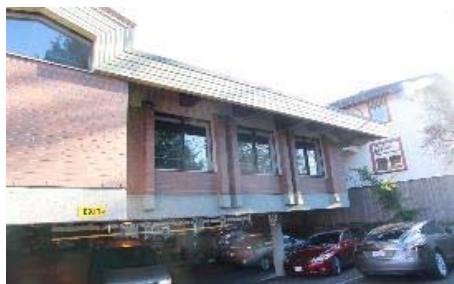
Structural

Item		Cost (\$)	Last (Year)	Period (yrs)	Adjusted (yrs)	Next (Year)
Seismic Upgrade	Maintenance Replacement	\$ 1,430,000				2019

To upgrade the building to the minimum life-safety level, additional concrete or masonry shear walls, or steel braced frames with corresponding foundations will be required. These shear walls or braced frames can replace existing partition walls so the floor layout is not affected. Additional anchorage of the masonry walls to the roof structure will also be required.

A seismic upgrade is recommended. To upgrade the building to the minimum life-safety level, additional concrete or masonry shear walls, or steel braced frames with corresponding foundations will be required. These shear walls or braced frames can replace existing partition walls so the floor layout is not affected. Additional anchorage of the masonry walls to the roof structure will also be required.

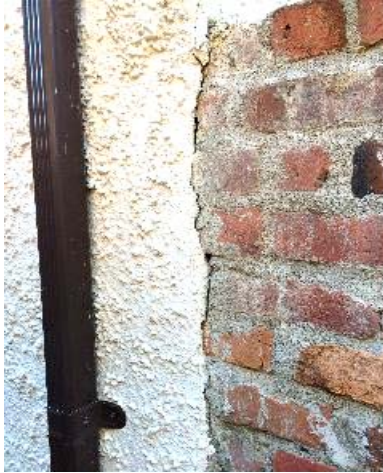
Building Envelope

Item		Cost (\$)	Last (Year)	Period (yrs)	Adjusted (yrs)	Next (Year)
Brick	Maintenance Replacement	\$ 2,700	2010	8		2018
Stucco	Maintenance Replacement	\$ 5,700	2010	20		2030
Tonkin House						
Cedar Board Siding & Trim	Maintenance Replacement	\$ 1,800	2010	8		2018
		\$ 14,600	1971	40	20	2031
Aluminum Windows	Maintenance Replacement	\$ 22,600	1999	45		2044
Aluminum Windows - Single	Maintenance Replacement	\$ 6,100	1971	45	5	2021
Wood Windows	Maintenance Replacement	\$ 22,200	1935	45	41	2021
Tonkin Home						
SBS Membrane Roof	Maintenance Replacement	\$ 2,000	2015	2		2017
		\$ 49,200	1999	20		2019
EPDM Membrane Roof	Maintenance Replacement	\$ 5,300	1999	20		2019
Asphalt Shingles Roof	Maintenance Replacement	\$ 9,700	1999	20		2019
Gutters & Downspouts	Maintenance Replacement	\$ 3,800	1999	25		2024

Cedar board siding and trim replacement for pre-1998 areas only (north and east).

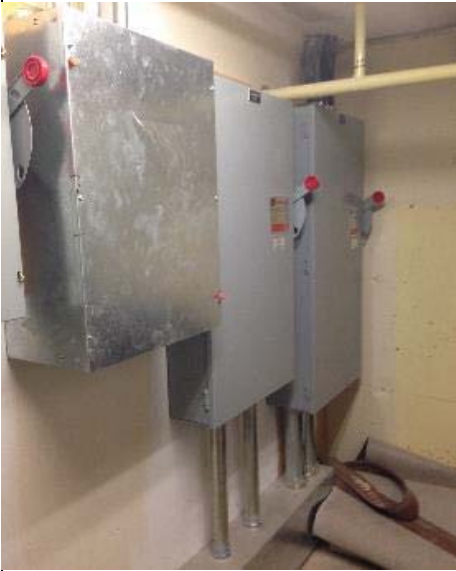
Electrical

Item		Cost (\$)	Last (Year)	Period (yrs)	Adjusted (yrs)	Next (Year)
Breaker Panel Main	Maintenance Replacement	\$ 25,000	2010	35		2045
Fire Alarm Panel	Maintenance Replacement	\$ 15,000	1990	25	4	2019
Lighting Exit Emergency	Maintenance Replacement	\$ 3,500	2010	30		2040
Lighting Battery Emergency	Maintenance Replacement	\$ 2,300	2010	30		2040
Lighting Exterior	Maintenance Replacement	\$ 5,300	1990	25	4	2019
Lighting Interior	Maintenance Replacement	\$ 20,700	1990	25	4	2019
Sound System	Maintenance Replacement	\$ 7,500	2010	20		2030
Communication System	Maintenance Replacement	\$ 15,000	2010	25		2035
Intrusion Detection	Maintenance Replacement	\$ 7,500	1990	20	6	2016

The Fire Alarm system is at the end of its expected servicable life; consideration for its replacement should be undertaken.

Main breaker panel not expected for replacement in the next 20 years.

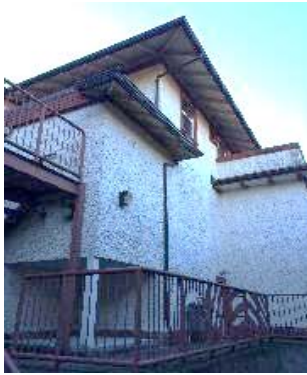
No.7b Oak Bay Library Structural

Item		Cost (\$)	Last (Year)	Period (yrs)	Adjusted (yrs)	Next (Year)
Seismic Upgrade	Maintenance Replacement	\$ 310,000				2019

To upgrade the building to the minimum life-safety level, additional concrete or masonry shear walls, or steel braced frames with corresponding foundations will be required. These shear walls or braced frames can replace existing partition walls so the floor layout is not affected. Additional anchorage of the masonry walls to the roof structure will also be required.

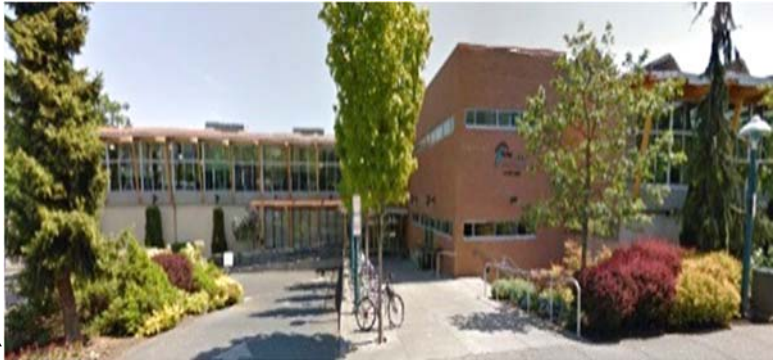
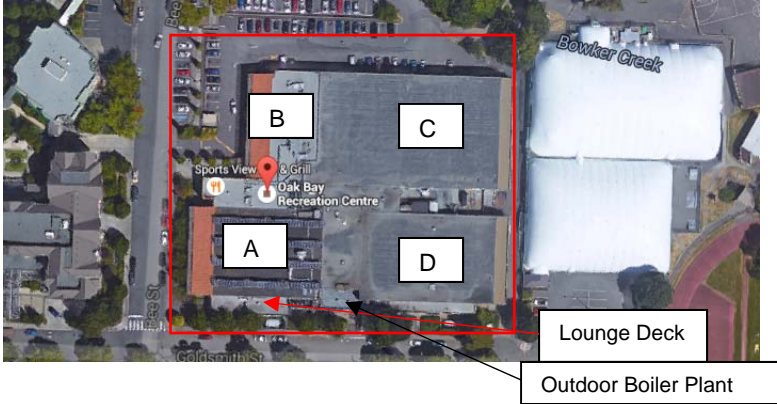
Figure 11 No. 8 - Oak Bay Recreation Centre

<p>1975 Bee Street</p> <p>Peak Occupancy: 500</p> <p>Staffing (avg.): 40</p> <p>Built: 1975</p> <p>Addition(s): 2003</p> <p>Current Area: 89,200 sf</p> <p>HVAC: Boilers, heat pumps, HRV, Solar HW</p> <p>Fire Suppression: Sprinklers (Wet & Dry)</p> <p>Access: Parking stalls at-grade, wheelchair access, elevator</p> <p>(A) BUR Roof, Pool (B) SBS Roof, Gym (NW) (C) SBS Roof, Rinks (E) (D) SBS Roof, Mechanical & Lounge</p>

BUILDING ENVELOPE: Exterior walls are constructed from 8" concrete masonry unit on lower levels and steel stud framing on the upper. The 2003 renovation and addition added glulam beams and columns, brick veneer and exposed concrete to the west elevation main entrance. Metal and cedar siding, both original and from 2003, are other types of cladding found on the building. Fenestration includes a 600 ft² pressure glazed skylight over the main lobby, aluminum-framed windows are single-pane from 1971 and double-pane from 2003, storefront entrance assemblies, and hollow-metal utility room doors. The roof is sectioned into several different materials and ages. Approximately 75% of the total roofing area is 2-ply SBS membrane; age of installation ranges from 1986-2003. In the south west corner, a built-up gravel-ballast roof spans the pool with solar hot water arrays mounted to curbs at several hundred locations. Sloped, standing-seam, metal roofing (red-coloured) is found along east and west elevations; the west elevation was installed during the 2003 renovation while the east is original 1975 construction. Along the south of the building an SBS membrane deck extends back from the lounge, providing outdoor seating and further room for mechanical/ventilation equipment.

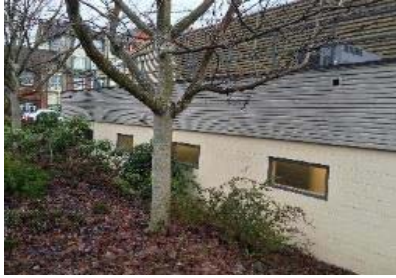
Building Envelope

Item		Cost (\$)	Last (Year)	Period (yrs)	Adjusted (yrs)	Next (Year)
BUR Over Pool	Maintenance Replacement	\$ 230,000	1986	30	2	2018
SBS Membrane North West	Maintenance Replacement	\$ 78,000	2003	25		2028
SBS Membrane East	Maintenance Replacement	\$ 408,000	1987	25	5	2017
SBS Membrane Mechanical&Lounge	Maintenance Replacement	\$ 59,000	2010	25		2035
Standing Seam Metal	Maintenance Replacement	\$ 56,000	1975	50		2025
Pressure Glazed Skylight	Maintenance Replacement	\$ 53,000	2013	30		2043
Cedar Board Siding	Maintenance Replacement	\$ 27,500	1975	40	10	2025
Aluminum Windows - Single	Maintenance Replacement	\$ 14,000	1975	45		2020
Exterior Doors Metal & Storefront	Maintenance Replacement	\$ 41,000	1975	50		2025
Exterior Painting	Maintenance Replacement	\$ 4,800	2014	3		2017

BUR over the pool is recommended to be replaced and redesigned with 2-ply SBS membrane.

SBS membrane east includes southeast and northeast areas from 1987 and 1989. Replacement within the next 3-5 years recommended. Installation of 220 feet of control joint cap flashing included. Standing seam metal roof replacement expected for original 1975 areas only.

Cedar siding replacement extended up to 10 years given current condition. CMU, brick, and metal siding not expected for replacement in the next 20 years.

Original, single-pane, aluminum-framed windows, on west elevation, expected to be replaced in the next 5 years.

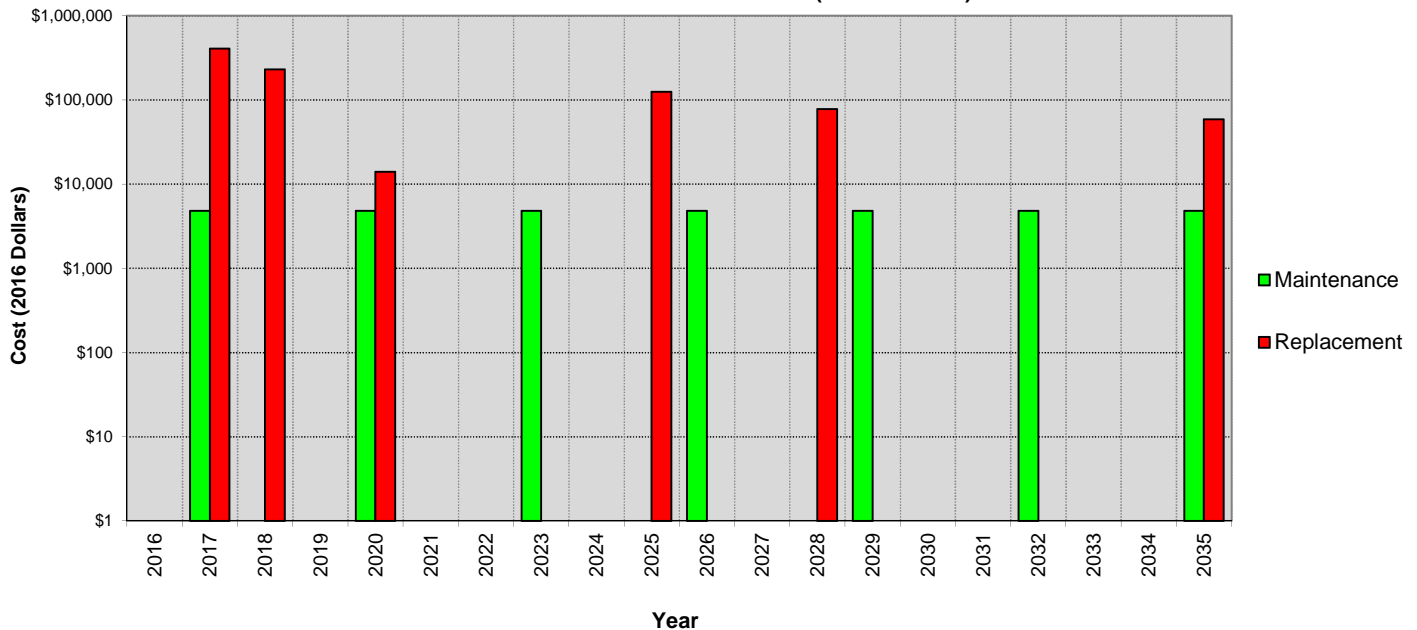
PROJECTED EXPENSES (Present Value)

The graph shows the costs associated with the maintenance and/or replacement of the component over time. The dollar axis is in logarithmic scale for ease of presentation.

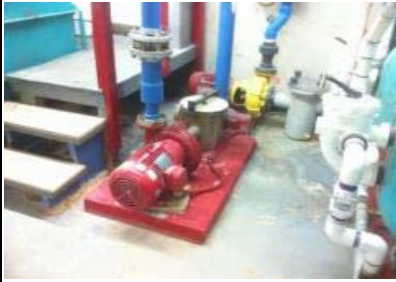
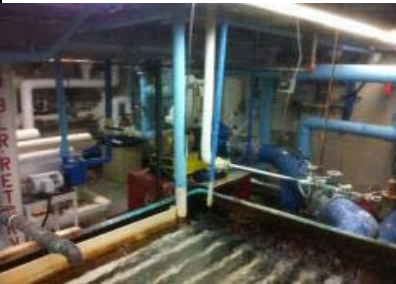
Mechanical

Item		Cost (\$)	Last (Year)	Period (yrs)	Adjusted (yrs)	Next (Year)
Boiler 1	Maintenance Replacement	\$ 35,000	2012	25		2037
Boiler 2	Maintenance Replacement	\$ 35,000	1973	25	22	2020
Pumps - Pool	Maintenance Replacement	\$ 5,000	2004	20		2024
5 pumps						
Pumps - Ice Rink	Maintenance Replacement	\$ 5,000	1973	20	27	2020
3 pumps						
Pumps - Heating	Maintenance Replacement	\$ 6,000	1973	20	27	2020
6 pumps						
Compressor 1	Maintenance Replacement	\$ 50,000	2014	23		2037
Ice Rink						
Compressor 2&3	Maintenance Replacement	\$ 100,000	1973	23	27	2023
Ice Rink						
Chiller Barrel	Maintenance Replacement	\$ 50,000	1973	24	27	2024
Ice Rink						
Heat Exchangers	Maintenance Replacement	\$ 25,000	1973	24	27	2024
5 heat exchangers						
Main Pool Filter	Maintenance Replacement	\$ 30,000	1973	20	27	2020
DE Filter						
Pool Filters	Maintenance Replacement	\$ 20,000	2004	15		2019
Learners & Hot						
Controls	Maintenance Replacement	\$ 10,000	2015	15		2030

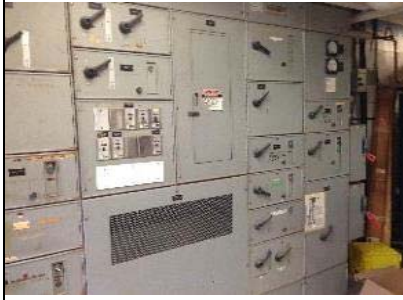
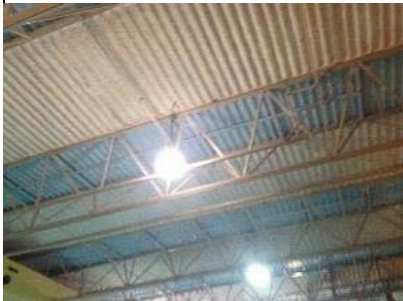
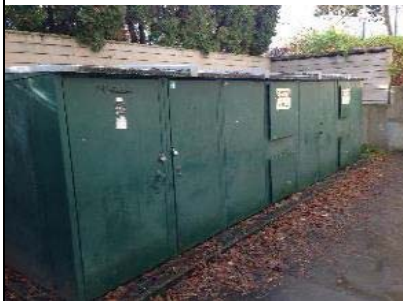
Electrical

Item		Cost (\$)	Last (Year)	Period (yrs)	Adjusted (yrs)	Next (Year)
Breaker Panel Main	Maintenance Replacement	\$ 150,000	1990	35		2025
Breaker Panel Secondary	Maintenance Replacement	\$ 175,000	1990	30		2020
Breaker Panel Sub	Maintenance Replacement	\$ 45,000	1970	30	17	2017
Gen Diesel Emergency	Maintenance Replacement	\$ 25,000	1976	30	10	2016
Gen Natural Gas Emergency	Maintenance Replacement	\$ 25,000	1980	30	6	2016
Transfer Switch	Maintenance Replacement	\$ 20,000	1976	30	10	2016
Baseboard	Maintenance Replacement	\$ 6,300	1976	35	7	2018
Lighting Exit Emergency	Maintenance Replacement	\$ 26,300	1990	30		2020
Lighting Exterior	Maintenance Replacement	\$ 22,800	1976	25	17	2018
Lighting Interior	Maintenance Replacement	\$ 87,500	1990	25	3	2018
Alarm Panel	Maintenance Replacement	\$ 65,000	2002	20		2022
Receptacle Duplex	Maintenance Replacement	\$ 18,800	1976	30	10	2016
Lighting Controls	Maintenance Replacement	\$ 12,500	2010	15		2025

UPS Units	Maintenance Replacement	\$ 6,500	2010	15		2025
Paging System	Maintenance Replacement	\$ 35,000	2010	25		2035
CCTV	Maintenance Replacement	\$ 50,000	2010	20		2030
Audio/Visual System	Maintenance Replacement	\$ 7,500	2010	20		2030
Communication System	Maintenance Replacement	\$ 75,000	2010	25		2035
Intrusion Detection	Maintenance Replacement	\$ 25,000	2010	25		2035

Several electrical pieces of equipment need to be replaced as they are well past their expected servicable life.

The Generators are past their expected servicable life and need to be replaced.

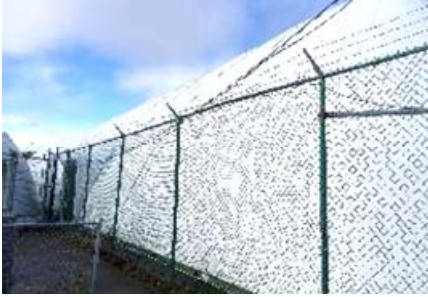
Building Envelope

Item		Cost (\$)	Last (Year)	Period (yrs)	Adjusted (yrs)	Next (Year)
Four Court Bubble	Maintenance Replacement	\$ 370,000	2013	20		2033
Three Court Bubble	Maintenance Replacement	\$ 280,000	2008	20		2028

Bubble replacement involves deflation, protection of interior lighting, removal and replacement. Bubble replacement includes exterior doors (revolving, swing) and cable reinforcement where required. Doors and cabling are expected to last two bubble periods.

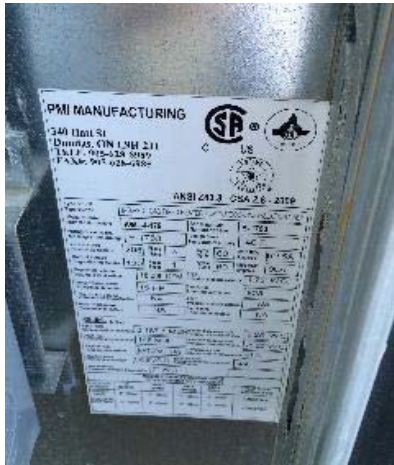
Mechanical

Item		Cost (\$)	Last (Year)	Period (yrs)	Adjusted (yrs)	Next (Year)
Furnace Inflation Unit	Maintenance Replacement	\$ 65,000	2013	25		2038
Standby Inflation Unit	Maintenance Replacement	\$ 50,000	1998	25		2023
Sump Pumps (2)	Maintenance Replacement	\$ 500	2013	10		2023

Primary and standby inflation units are fueled by natural gas. Replacement cost includes furnace and fan. Replacement often occurs with bubble replacement by The Farley Group.

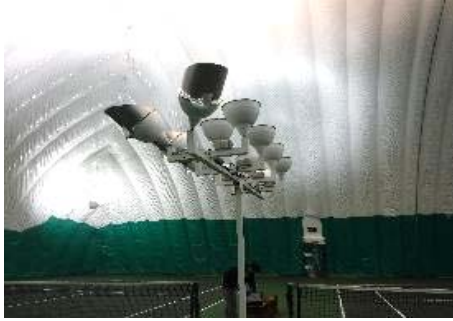
Electrical

Item		Cost (\$)	Last (Year)	Period (yrs)	Adjusted (yrs)	Next (Year)
Main Power Distribution	Maintenance Replacement	\$ 17,800	1978	50	10	2038
Controls	Maintenance Replacement	\$ 500	2013	20		2033
Wiring Devices	Maintenance Replacement	\$ 800	2013	30		2043
Electric Heating	Maintenance Replacement	\$ 200	2013	30		2043
Lighting Emergency	Maintenance Replacement	\$ 800	1985	25	10	2020
Emergency Generator	Maintenance Replacement	\$ 3,500	2005	20		2025
Lighting - Interior HID	Maintenance Replacement	\$ 22,800	2013	12		2025
Surveillance Cameras (3)	Maintenance Replacement	\$ 500	2013	20		2033
Pressure Fan Motor	Maintenance Replacement	\$ 2,500	2013	10	5	2028
Back Up Fan Motor	Maintenance Replacement	\$ 1,500	2005	10	2	2017

Pressure fan motor and back-up scheduled to be renewed together, however back-up motor service life may be extended.

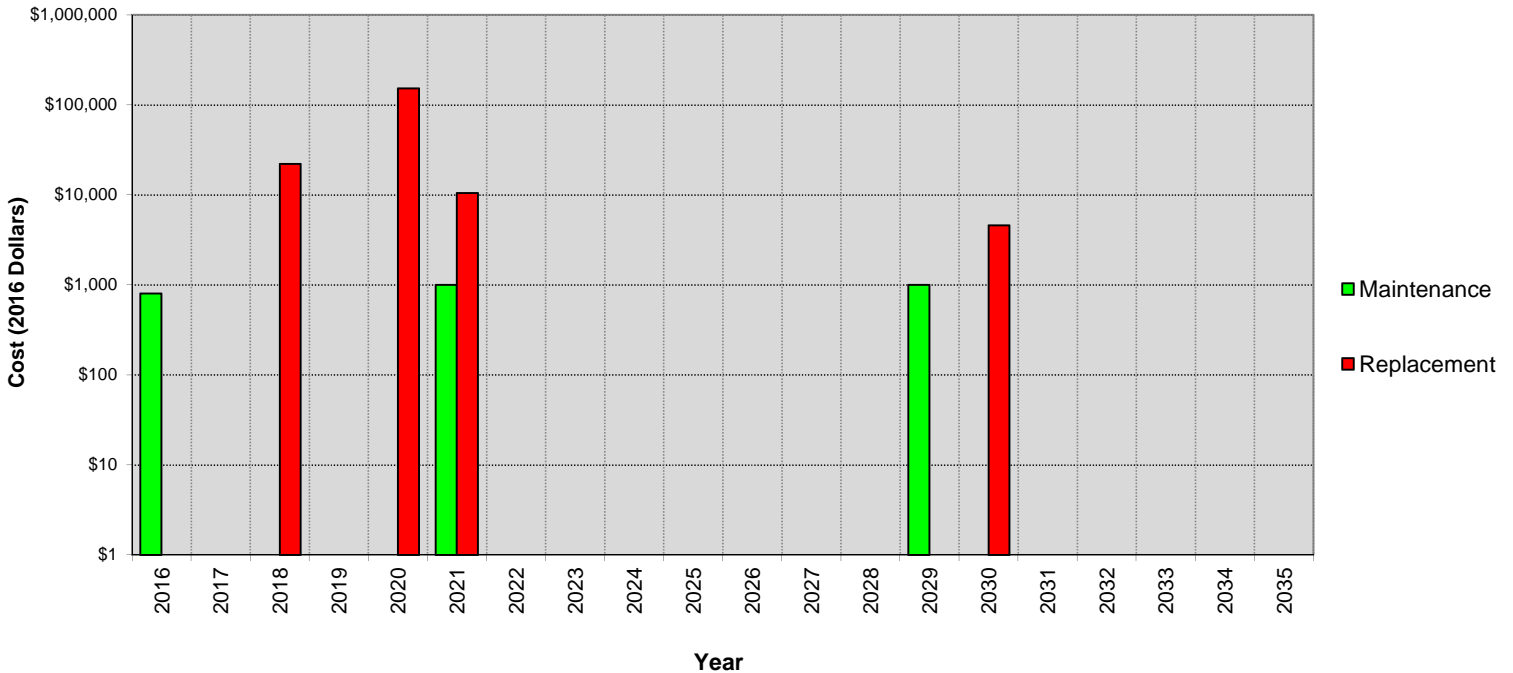
PROJECTED EXPENSES (Present Value)

The graph shows the costs associated with the maintenance and/or replacement of the component over time. The dollar axis is in logarithmic scale for ease of presentation.

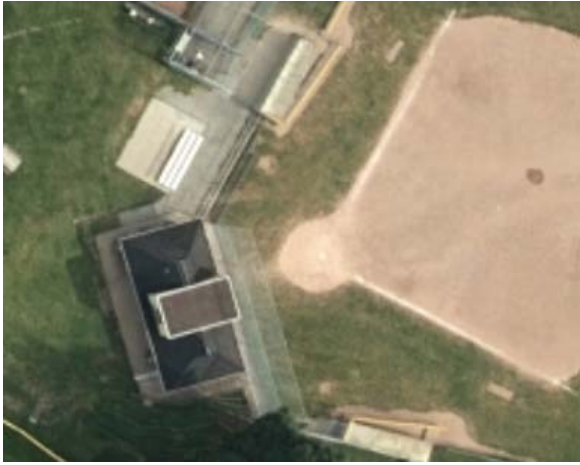
<p style="text-align: center;"><i>Figure No. 11 – Jack Groves Fieldhouse</i></p>
--	---

<p>1709 Monterey Avenue – Oak Bay Fireman’s Park</p> <p>Peak Occupancy: 10</p> <p>Staffing (avg.): 2-5 during operation</p> <p>Built: 1989 Current Area: 800 sf</p> <p>Addition(s): None</p> <p>HVAC: Baseboard heat, electric hot water tank</p> <p>Fire Suppression: Extinguisher</p> <p>Access: Parking stalls located 200m to west. Wheelchair access to lower floor only.</p>
