DISTRICT OF OAK BAY

BUILDING ASSET MANAGEMENT PLAN

MUNICIPAL BUILDINGS ANALYSIS

JULY 2016

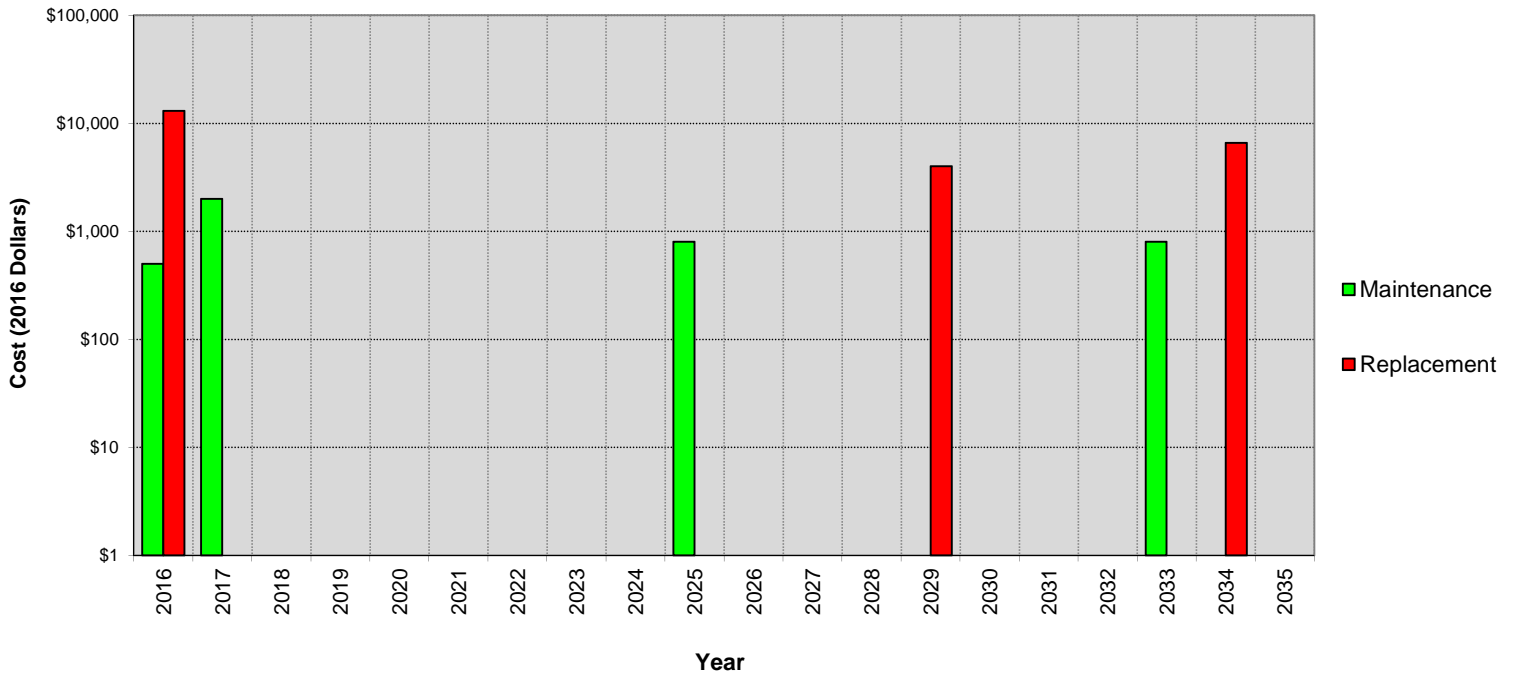
PROJECTED EXPENSES (Present Value)

The graph shows the costs associated with the maintenance and/or replacement of the component over time. The dollar axis is in logarithmic scale for ease of presentation.

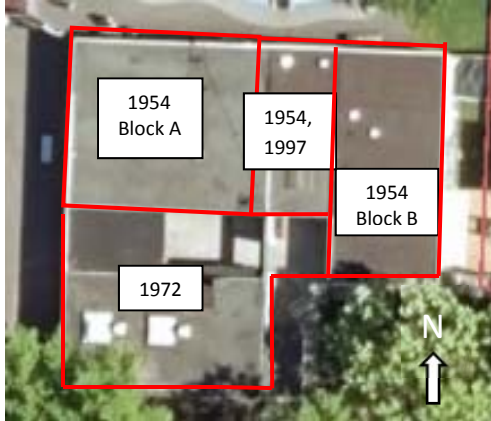
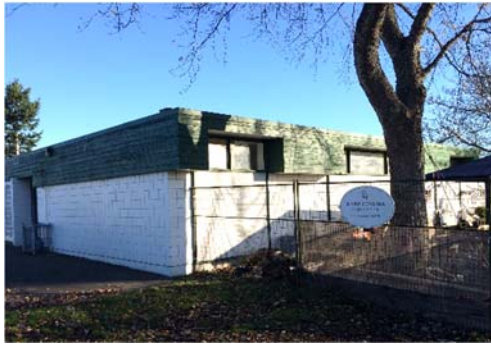
<p><i>Figure No. 12 – Carnarvon</i></p>
--	--

<p>2801 Henderson Road</p> <p>Peak Occupancy: 50</p> <p>Staffing (avg.): 0</p> <p>Built: 1970</p> <p>Addition(s): 1997 (now 4,523 sf)</p> <p>HVAC: Natural gas boiler, electric baseboard and DHW.</p> <p>Fire Suppression: Extinguishers</p> <p>Access: Parking stalls at-grade, wheelchair access</p>

BUILDING ENVELOPE: Exterior walls are constructed primarily from concrete masonry block with wood-framed stucco clad walls on the north and east elevations. Windows are mostly original wood-framed with the exception of vinyl-frame replacement on the east elevation. Original exterior doors are solid fir with a few hollow-metal replacements occurring throughout the buildings life. There are two polycarbonate drop-on skylights on the south building providing daylight. The roofing consists of a low-sloped 2-ply SBS membrane with a small portion of built-up gravel-ballast canopy on the north building. Roof-top drains transport runoff to storm drains.

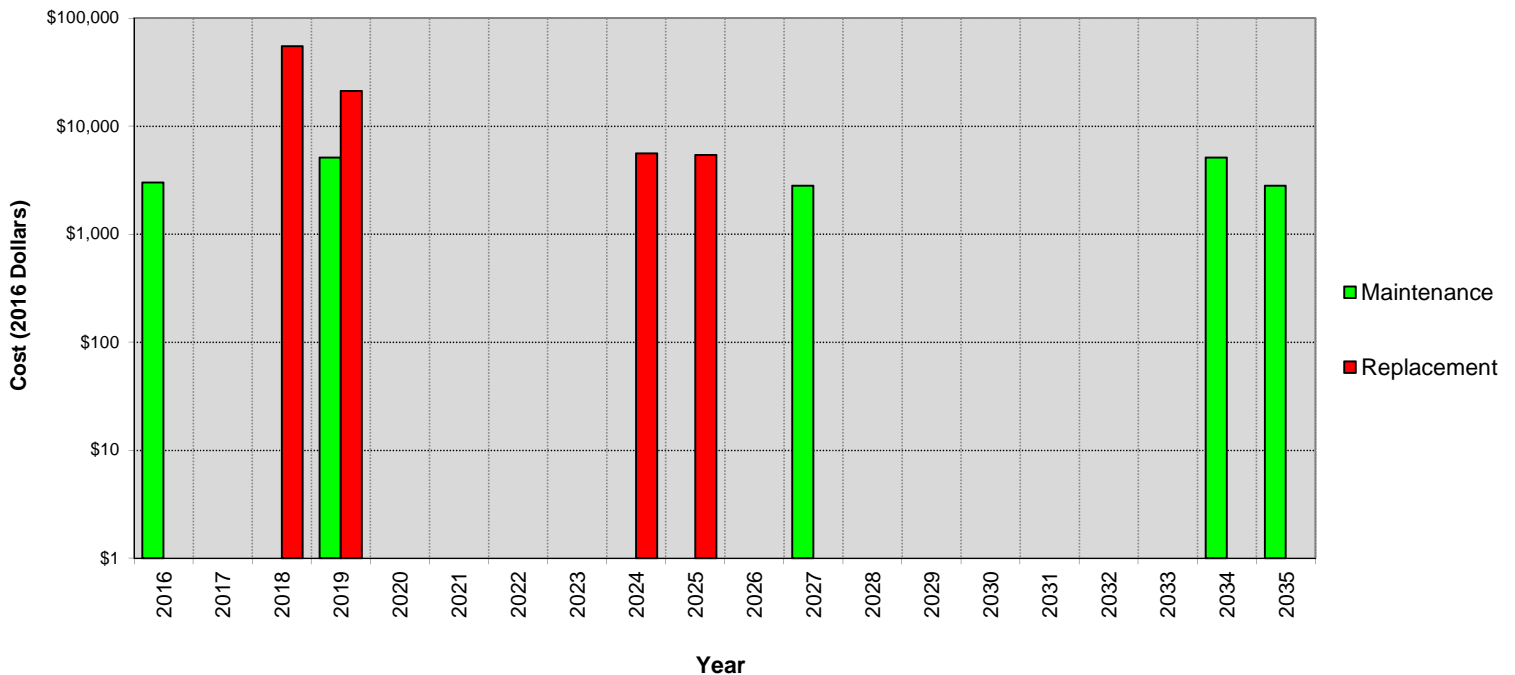
PROJECTED EXPENSES (Present Value)

The graph shows the costs associated with the maintenance and/or replacement of the component over time. The dollar axis is in logarithmic scale for ease of presentation.

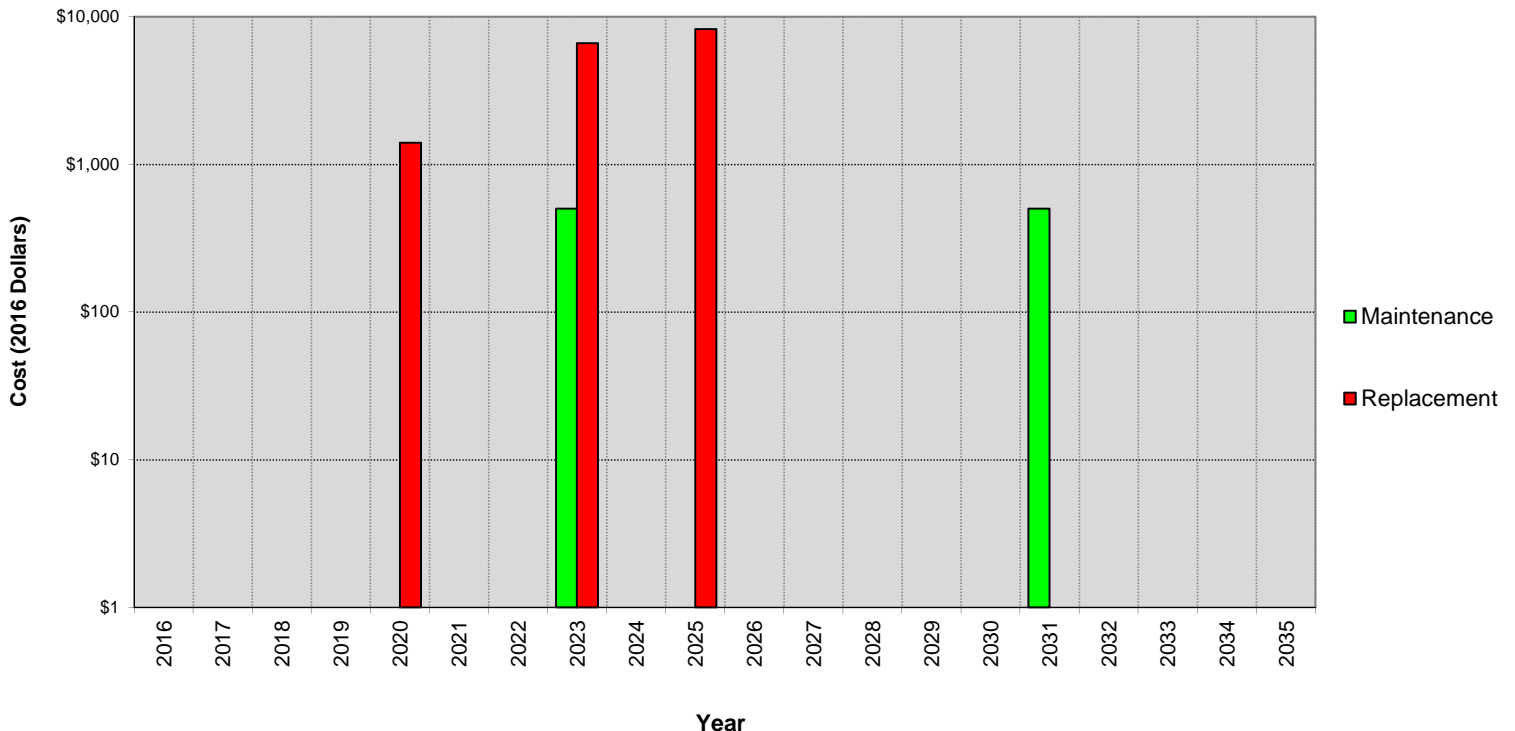
PROJECTED EXPENSES (Present Value)

The graph shows the costs associated with the maintenance and/or replacement of the component over time. The dollar axis is in logarithmic scale for ease of presentation.

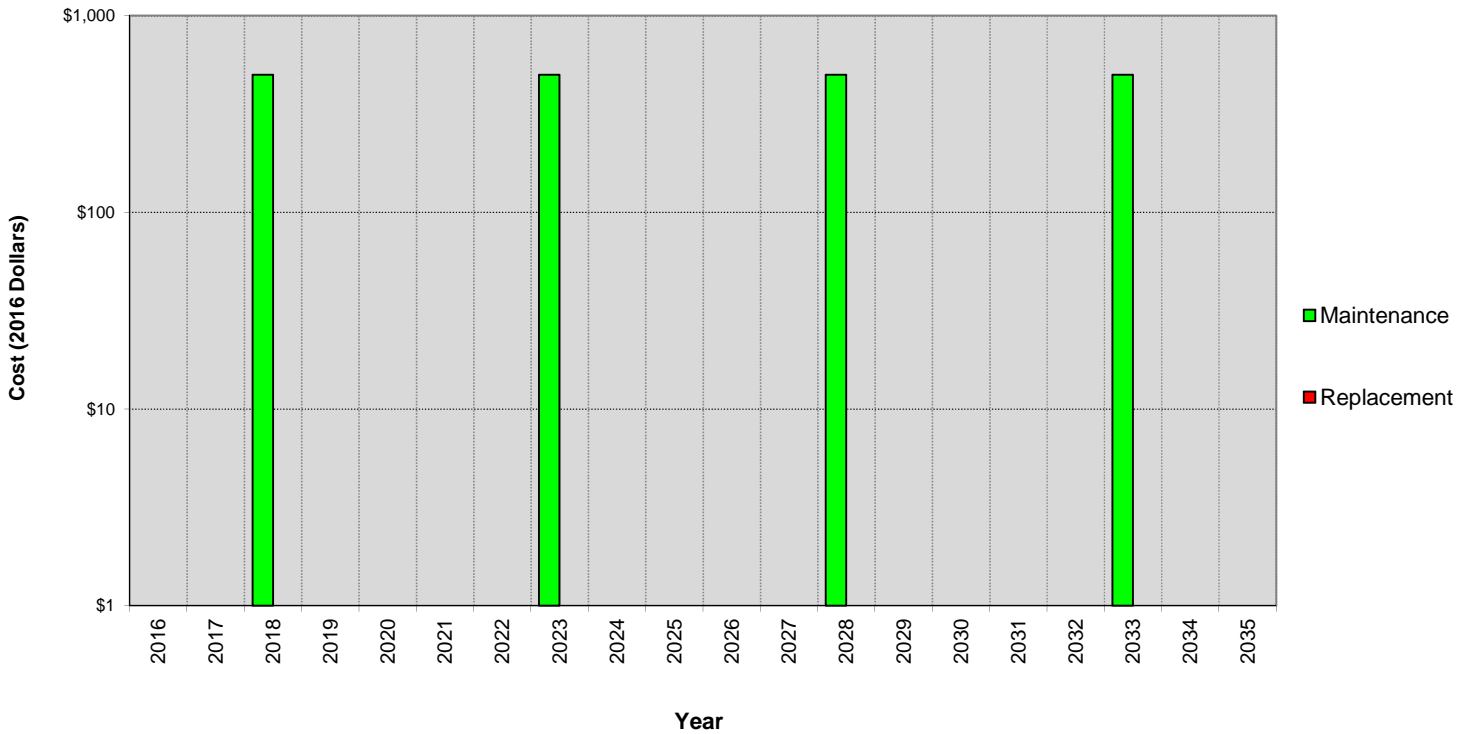
PROJECTED EXPENSES (Present Value)

The dollar axis is in logarithmic scale for ease of presentation.

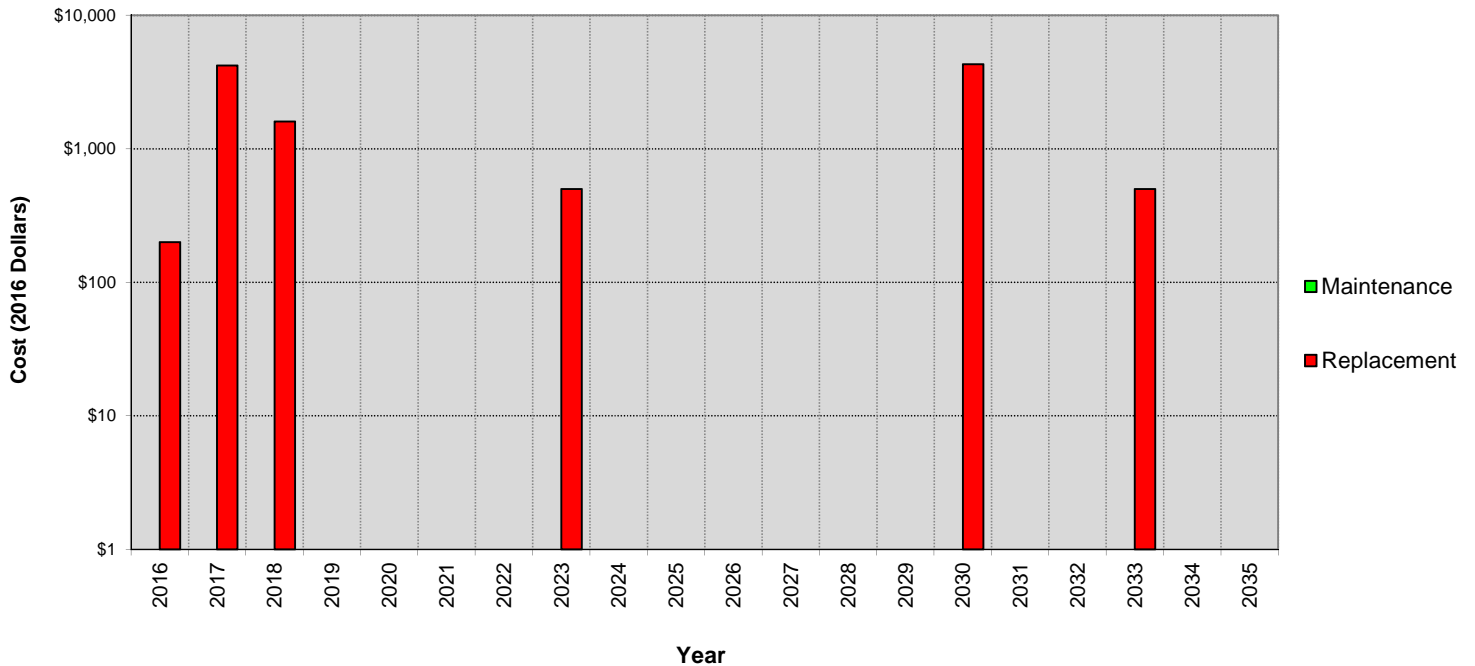
PROJECTED EXPENSES (Present Value)

The dollar axis is in logarithmic scale for ease of presentation.

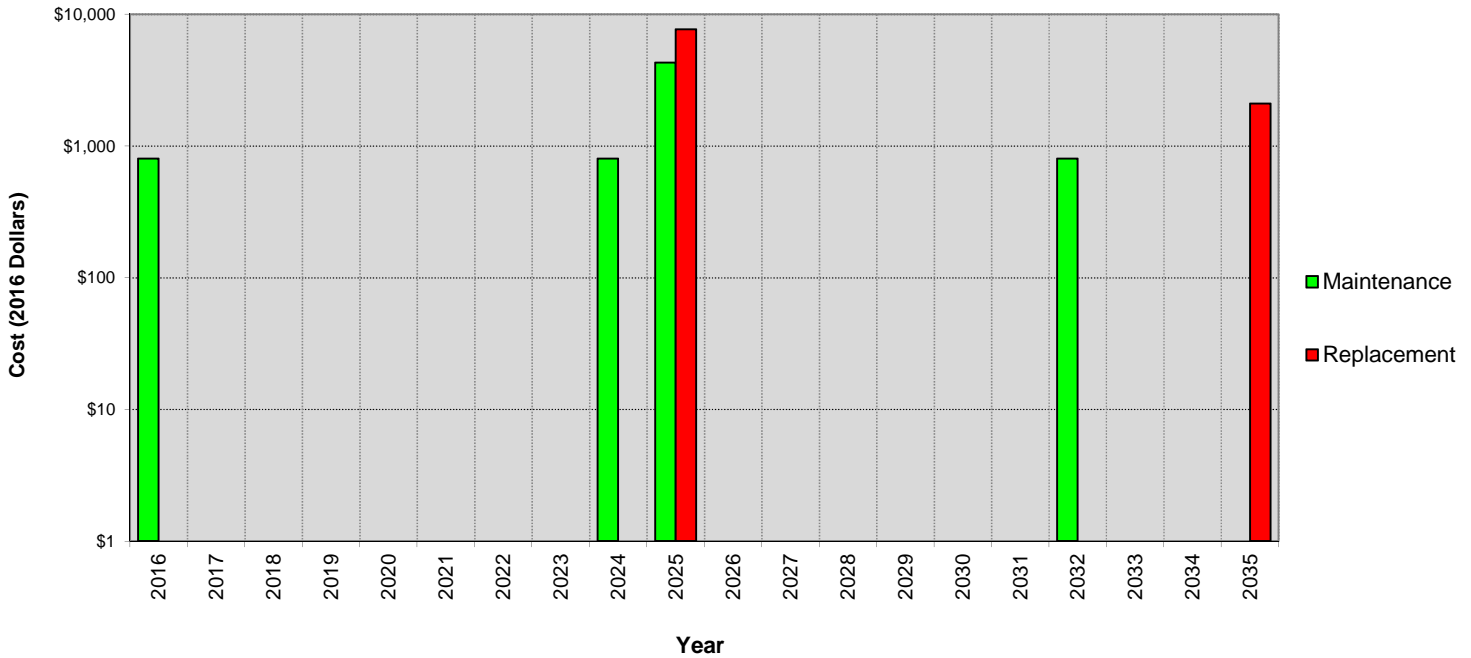
PROJECTED EXPENSES (Present Value)

The graph shows the costs associated with the maintenance and/or replacement of the component over time. The dollar axis is in logarithmic scale for ease of presentation.

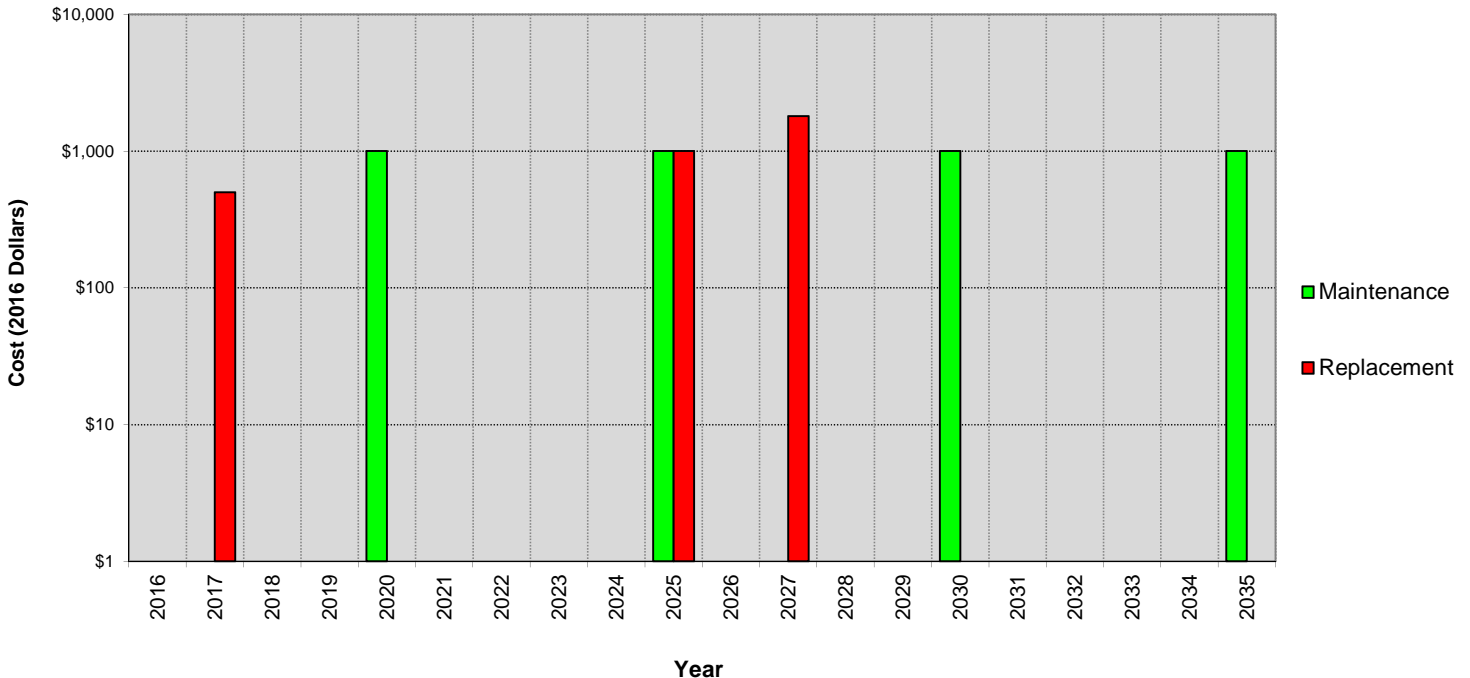
PROJECTED EXPENSES (Present Value)

The dollar axis is in logarithmic scale for ease of presentation.

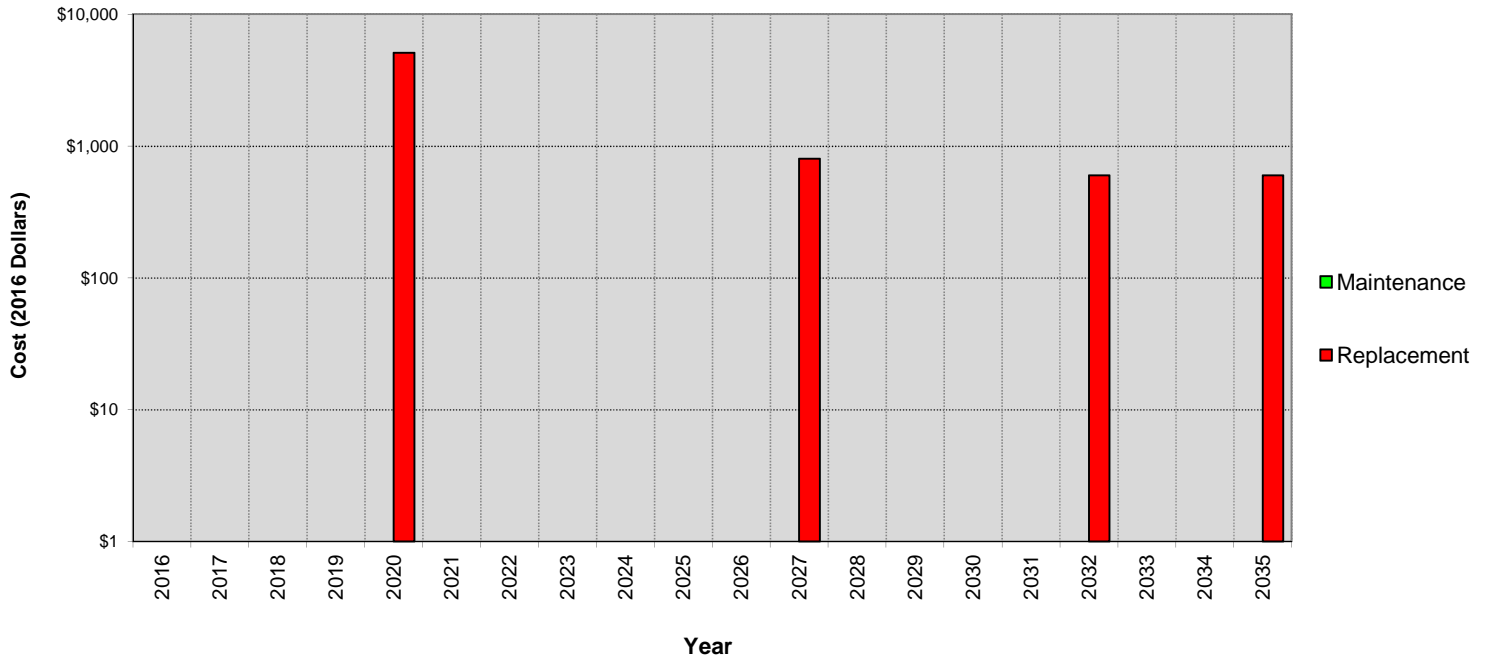
PROJECTED EXPENSES (Present Value)

The dollar axis is in logarithmic scale for ease of presentation.

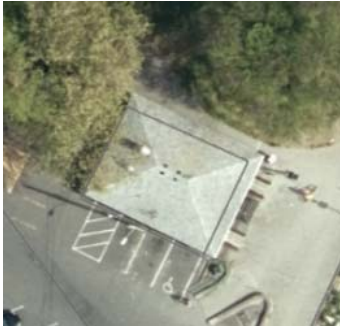
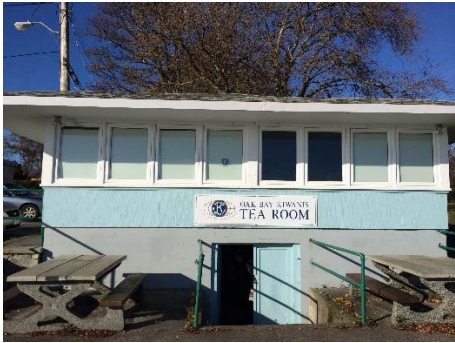
<p><i>Figure No. 15 – Willows Park Pavilion “The Teahouse”</i></p>
--	--

<p>Willows Park Esplanade</p> <p>Peak Occupancy: 30</p> <p>Staffing (avg.): 5-10 volunteers</p> <p>Built: 1949 (1,928 sf)</p> <p>Addition(s): None</p> <p>HVAC: Electric baseboard, DHW</p> <p>Fire Suppression: Extinguishers</p> <p>Access: Parking stalls at-grade, wheelchair access</p>

BUILDING ENVELOPE: Exterior walls are wood-framed and clad with an exterior plywood product similar to CREZON® with wood trim. Original wood-framed windows were replaced in 2012 with vinyl-framed, sealed glazing unit assemblies. The roof is sloped 4/12 with asphalt shingles and does not feature gutters and downspouts, and generously overhangs the walls below.

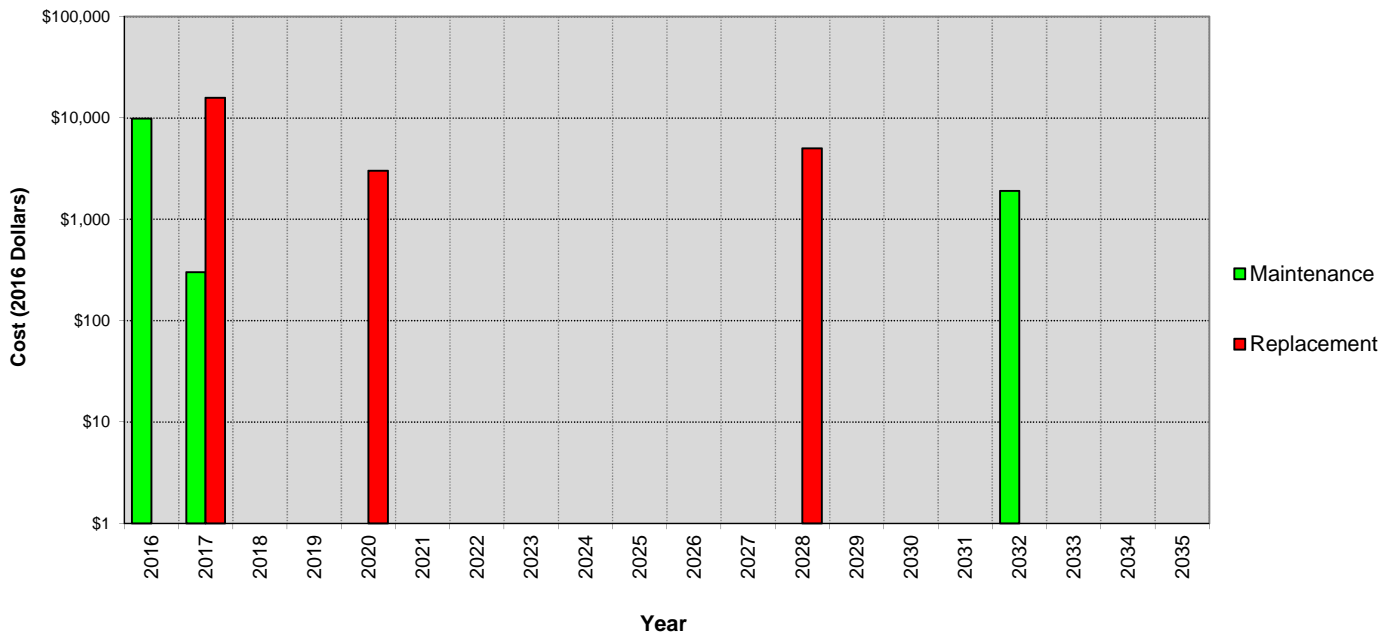
PROJECTED EXPENSES (Present Value)

The graph shows the costs associated with the maintenance and/or replacement of the component over time. The dollar axis is in logarithmic scale for ease of presentation.

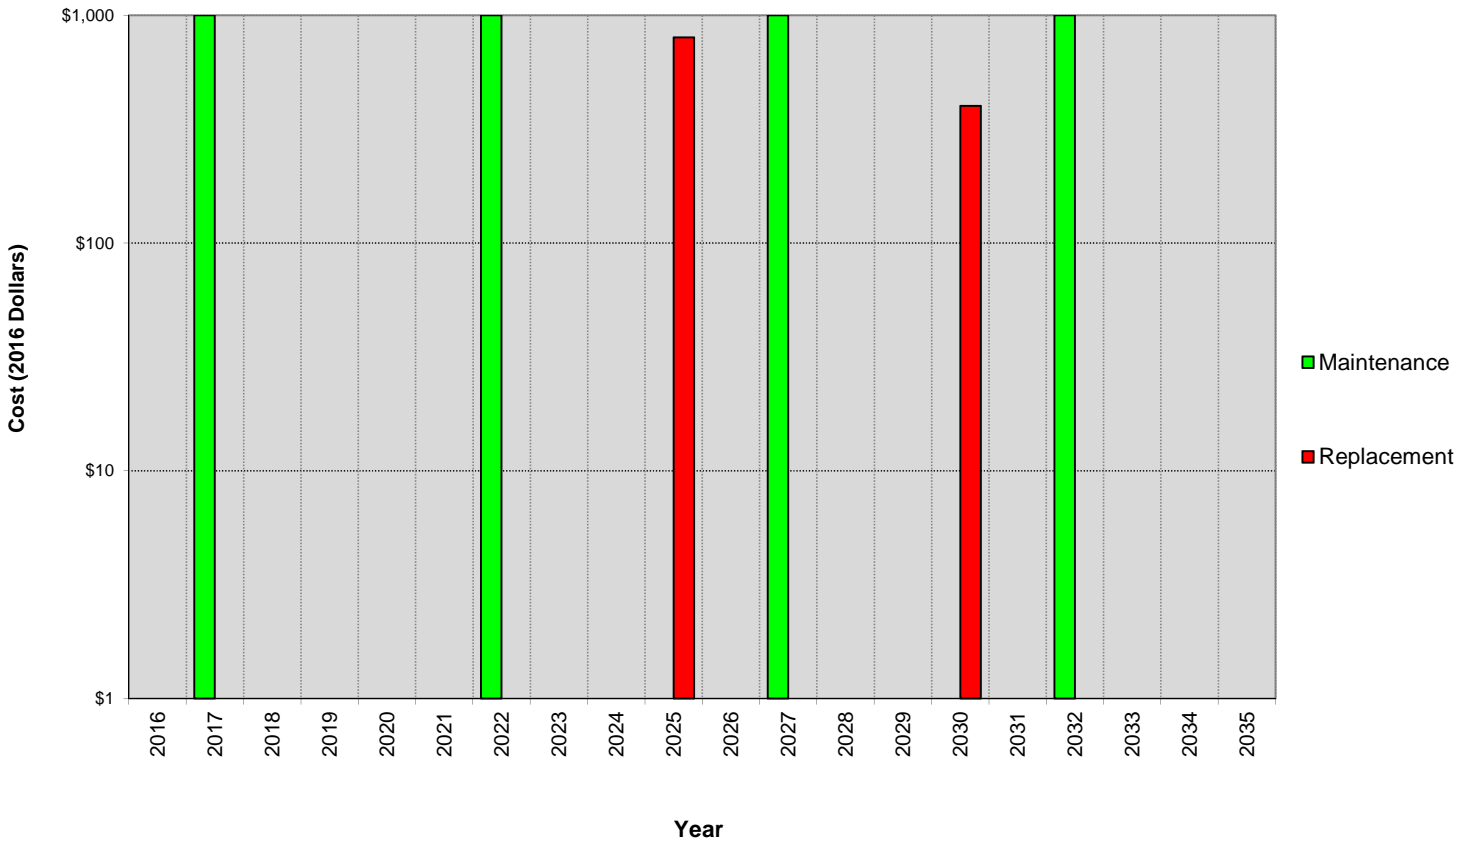
PROJECTED EXPENSES (Present Value)

The dollar axis is in logarithmic scale for ease of presentation.

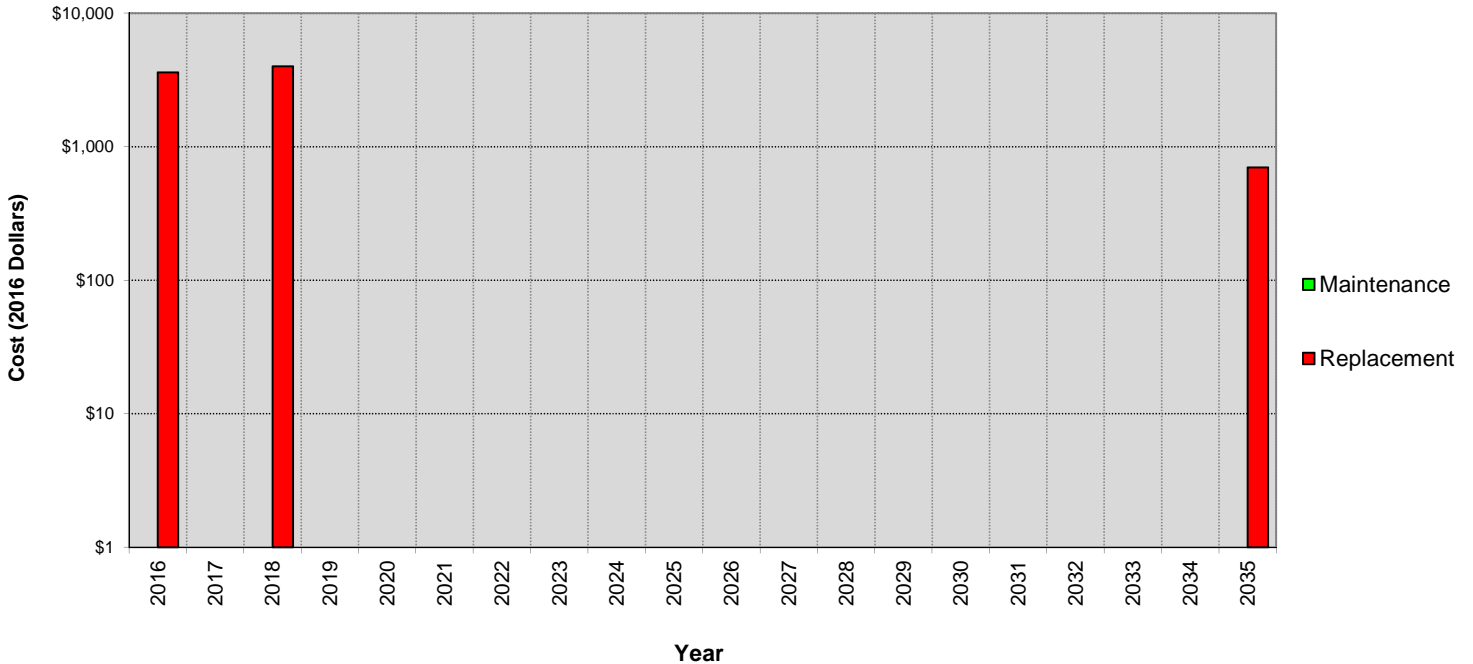
PROJECTED EXPENSES (Present Value)

The dollar axis is in logarithmic scale for ease of presentation.

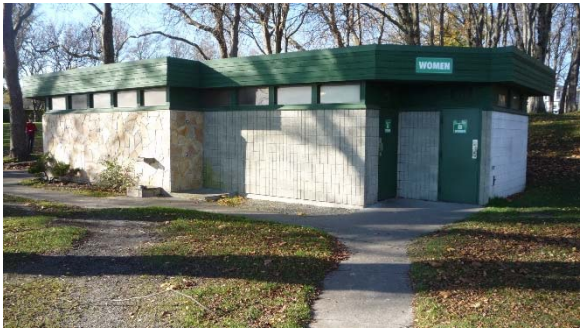
<p><i>Figure No. 16 – Willows Park Washroom</i></p>

<p>Willows Park Esplanade</p> <p>Peak Occupancy: 5-10</p> <p>Staffing (avg.): 0</p> <p>Built: 1982 (951 sf)</p> <p>Addition(s): None</p> <p>HVAC: Electric baseboard, DHW</p> <p>Fire Suppression: None</p> <p>Access: Wheelchair access</p>

BUILDING ENVELOPE: The building’s exterior walls are constructed with concrete masonry block to a height of 7’; a further 3’8” is wood-framed with wood-framed windows and cedar board siding to the height of the roof parapet. Portions of concrete block are faced with stone tile on the east elevation. Exterior doors are all hollow-metal. The original roof was built-up with gravel ballast, but it has since been replaced with 2-ply SBS membrane with rooftop drains. All assemblies are not insulated.

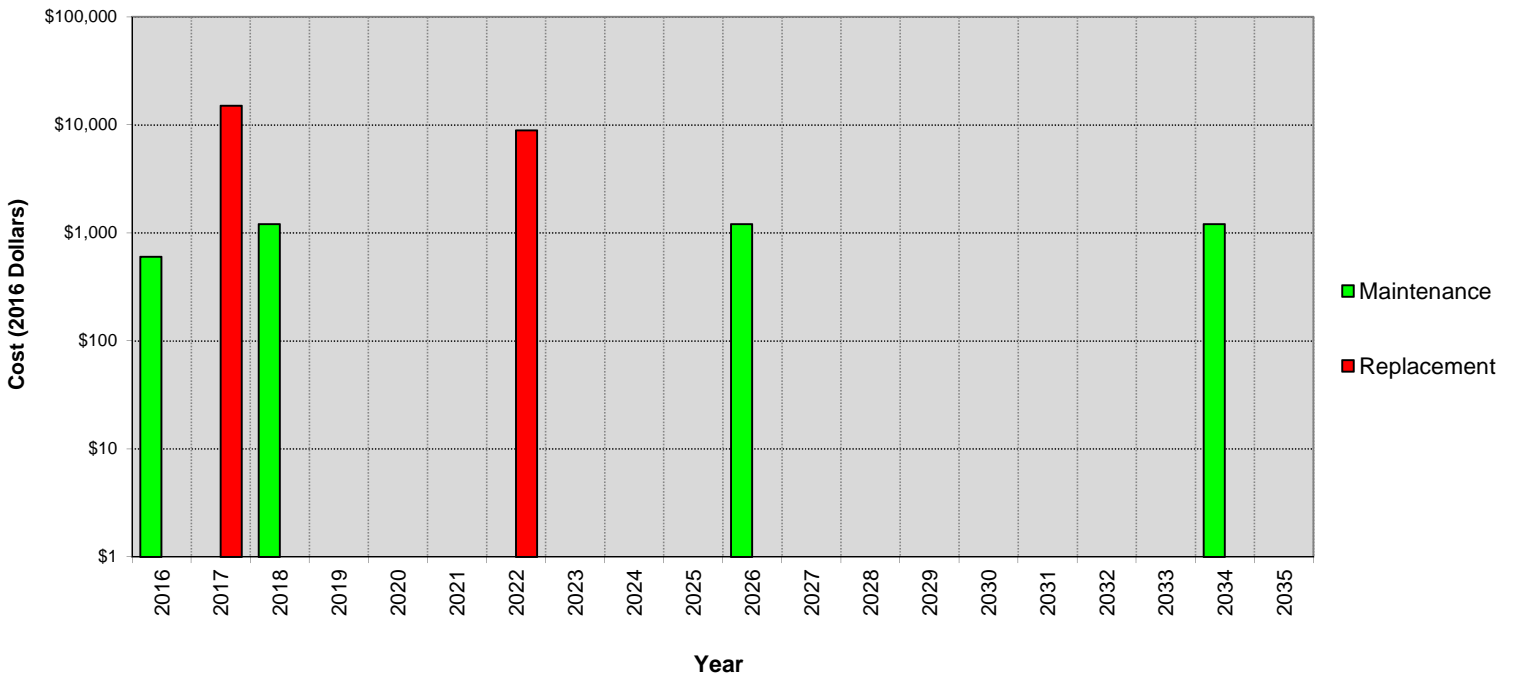
PROJECTED EXPENSES (Present Value)

The graph shows the costs associated with the maintenance and/or replacement of the component over time. The dollar axis is in logarithmic scale for ease of presentation.

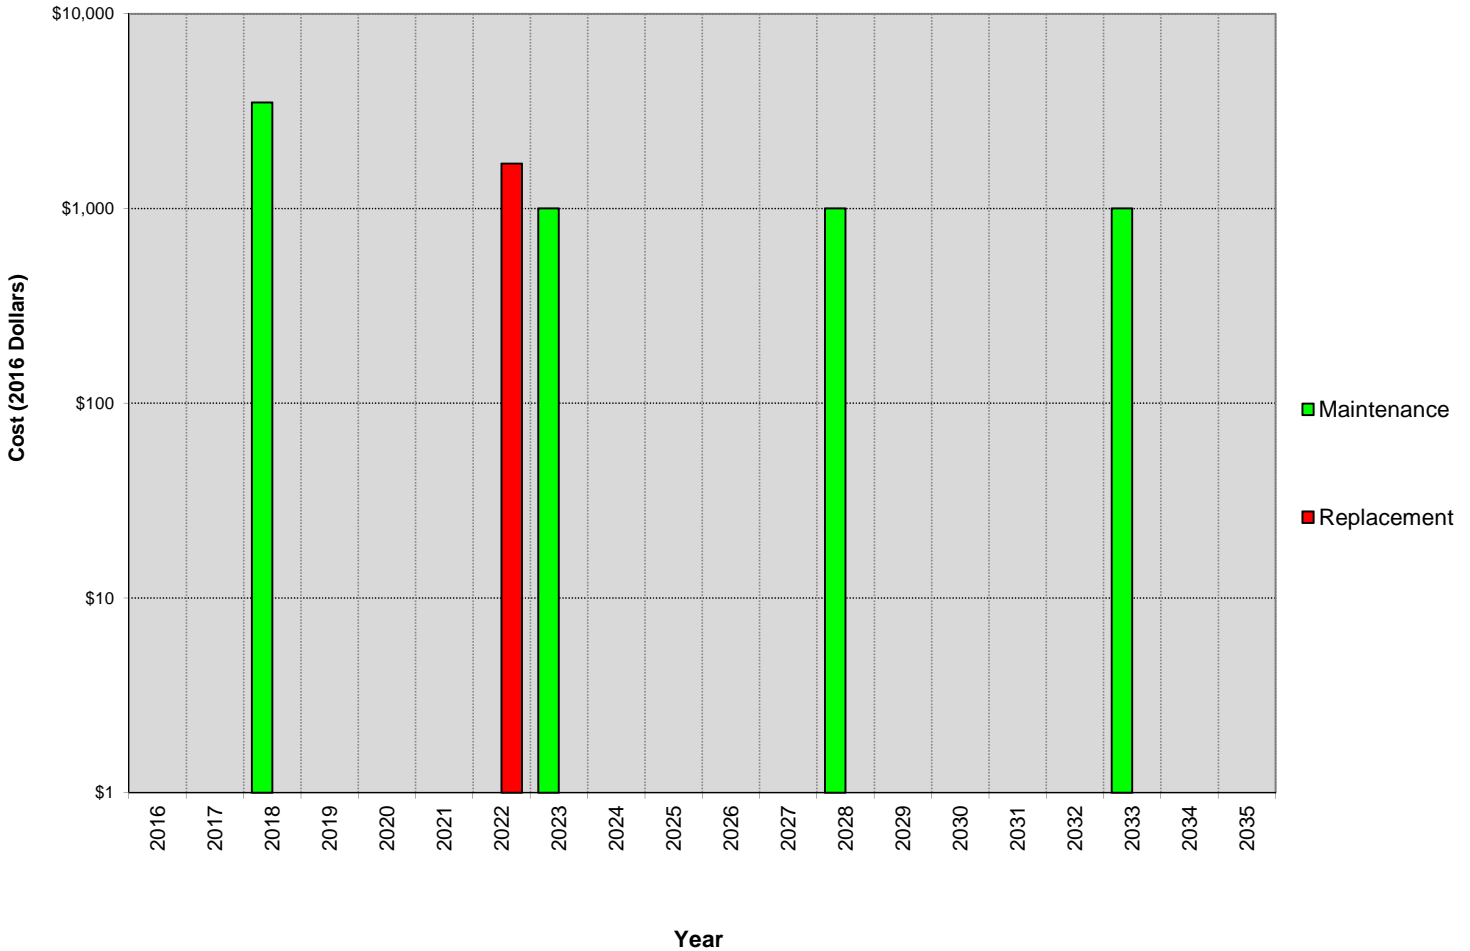
PROJECTED EXPENSES (Present Value)

The dollar axis is in logarithmic scale for ease of presentation.

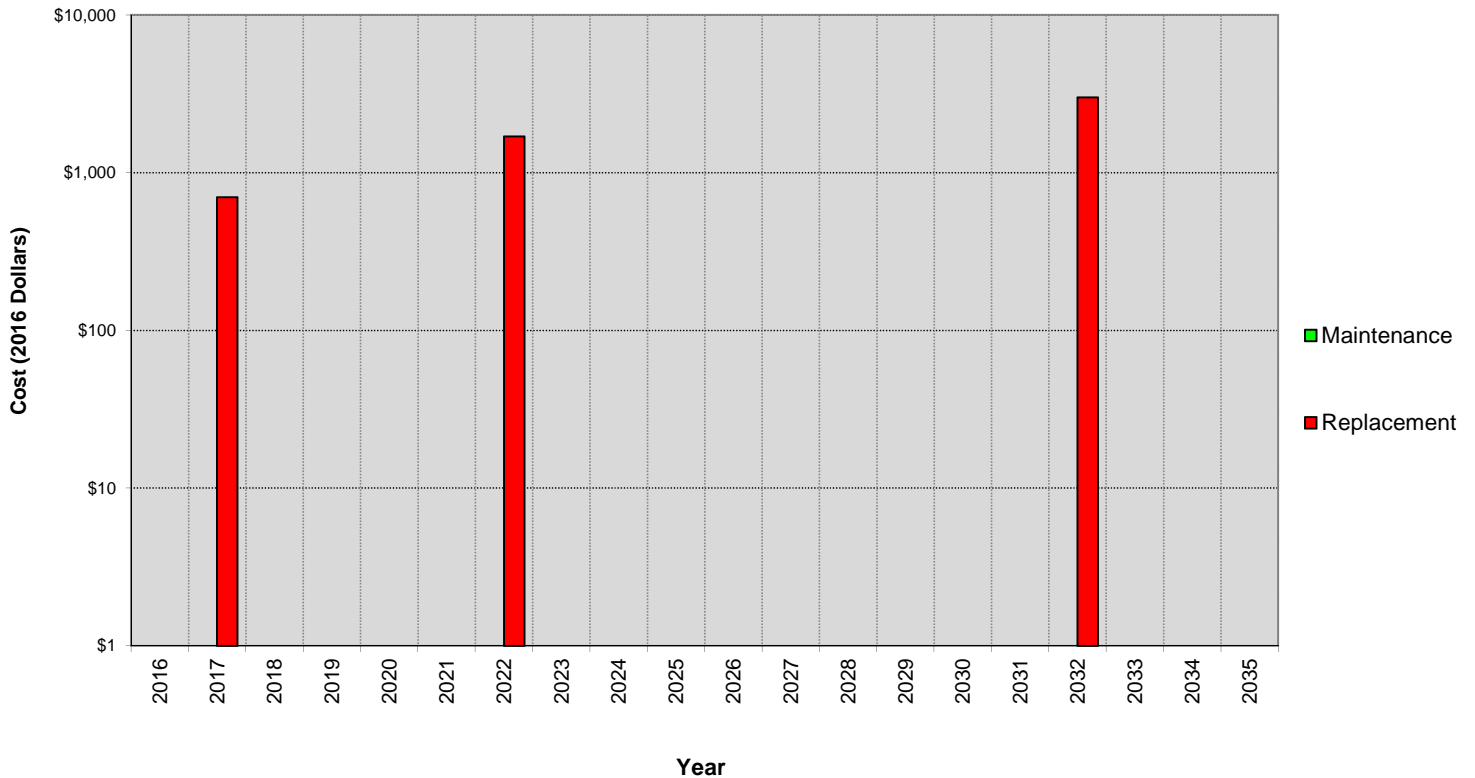
PROJECTED EXPENSES (Present Value)

The dollar axis is in logarithmic scale for ease of presentation.

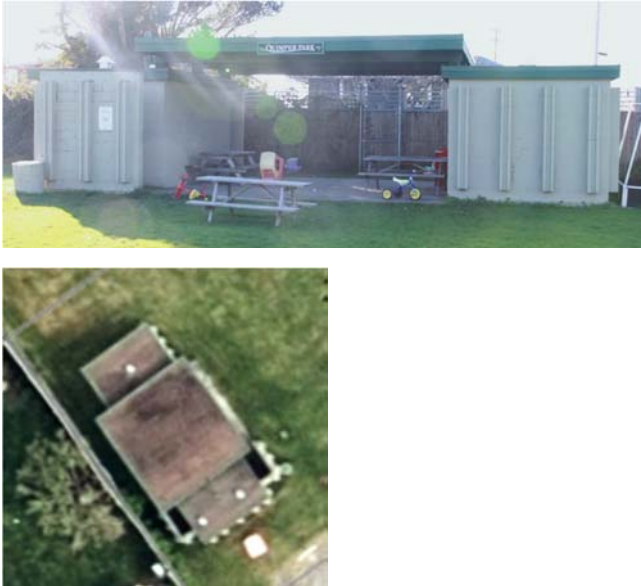
<p style="text-align: center;"><i>Figure No. 17 – Quimper Park Washroom</i></p>
--	--

<p>2115 Quimper Street</p> <p>Peak Occupancy: 5-10</p> <p>Staffing (avg.): 0</p> <p>Built: 1970 (318 sf)</p> <p>Addition(s): None</p> <p>HVAC: None</p> <p>Fire Suppression: None</p> <p>Access: Wheelchair access</p>

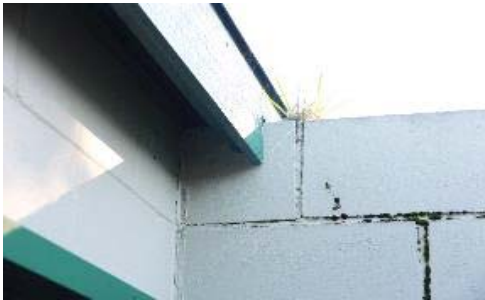
Building Envelope

Item		Cost (\$)	Last (Year)	Period (yrs)	Adjusted (yrs)	Next (Year)
Cedar Board	Maintenance Replacement	\$ 200	2010	8		2018
Exterior Doors Metal	Maintenance Replacement	\$ 2,400	1970	50		2020
SBS Membrane Roof	Maintenance Replacement	\$ 2,000				2017
		\$ 7,600	2010	25		2035
CMU	Maintenance Replacement	\$ 1,300	2010	16		2026
Cap Flashing	Maintenance Replacement	\$ 500				2016

Install cap flashing over top of wall (photo, left) to address organic growth/ deterioration due to rain penetration.

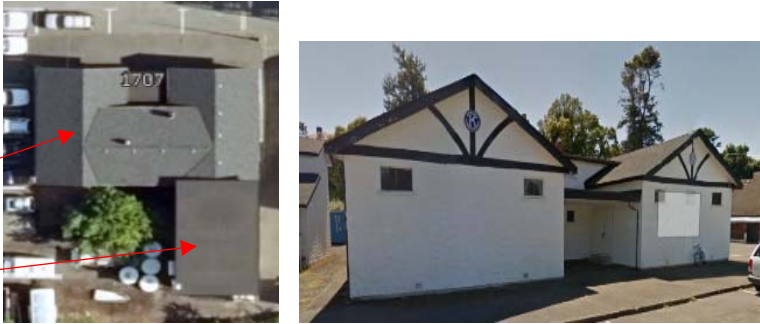
<p style="text-align: center;"><i>Figure No.19 – Boy Scout Hall</i></p>
--	--

<p>1703 Monterey Avenue – Oak Bay Firemans Park</p> <p>Peak Occupancy: 100</p> <p>Staffing (avg.): 0</p> <p>Built: 1954 (4,868 sf)</p> <p>Addition(s): c.1987</p> <p>HVAC: Oil Furnace, DHW</p> <p>Fire Suppression: Extinguishers</p> <p>Access: Parking stalls at-grade, wheelchair access</p>

BUILDING ENVELOPE: The wood-frame floor assembly is raised above grade with an uninsulated crawlspace on a concrete foundation. Exterior walls are wood-frame construction and clad with Spanish-style stucco finish. Wood trim and fascia board finish gable ends, rooflines and windows. Windows are original metal-frame (fixed,

1. Stucco extends down to grade, visible wetting near grade. Visible staining and wetting where south elevation of original building meets west elevation of addition. Extensive cracking noted, leaving the face sealed assembly susceptible to water ingress. A pencil was easily inserted into the wood at the base of wall along the east elevation without much resistance, indicating wall assembly is compromised.

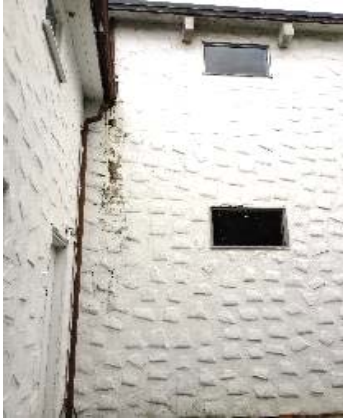
Building Envelope

Item		Cost (\$)	Last (Year)	Period (yrs)	Adjusted (yrs)	Next (Year)
Stucco	Maintenance Replacement	\$ 55,000	1954	60	3	2017
Cedar Trim & Fascia	Maintenance Replacement	\$ 600	2017	8		2025
		\$ 2,400				2017
Soffit Wood	Maintenance Replacement	\$ 2,000				2017
Exterior Doors Metal	Maintenance Replacement	\$ 6,300	2014	40		2054
Windows Aluminum	Maintenance Replacement	\$ 12,400	1954	45	18	2017
Asphalt Shingles	Maintenance Replacement	\$ 10,100	2005	20		2025
Gutters & Downspouts	Maintenance Replacement	\$ 2,400	2005	20		2025
SBS Membrane Roof	Maintenance Replacement	\$ 11,500	2005	20		2025

A building envelope condition assessment is recommended on the building to determine the full condition. From visual review only, replacement of stucco, cedar trim, wood soffit, and single-pane windows are scheduled together within the next 5 years. An allowance of 1/3 the replacement cost is budgeted to refurbish existing.

Roof replacement to include asphalt shingles, SBS membrane and gutters/downspouts.

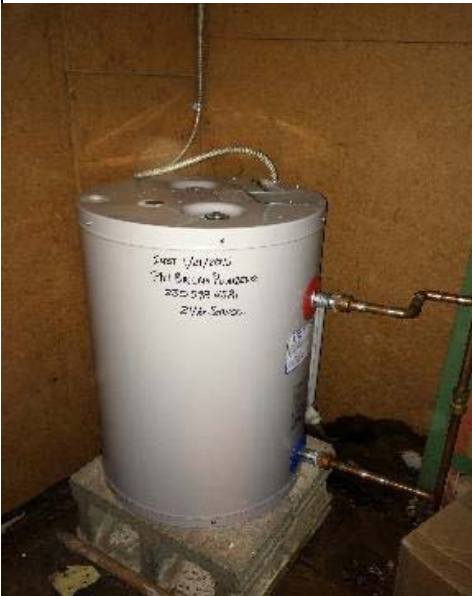
Mechanical

Item		Cost (\$)	Last (Year)	Period (yrs)	Adjusted (yrs)	Next (Year)
Oil Fired Furnace	Maintenance Replacement	\$ 7,000	2000	25		2025
Hot Water Tank	Maintenance Replacement	\$ 800	2015	10		2025
Plumbing Fixtures	Maintenance Replacement	\$ 1,000	2013	5		2018
Exhaust Fans Washrooms	Maintenance Replacement	\$ 800	2000	20		2020
Perimeter Drains	Maintenance Replacement	\$ 25,000				2019

Oil furnace serviced every 5 years. Oil storage tank not expected to require replacement.

Building lacks perimeter drainage which is contributing to deteriorating base of wall. Estimate is to excavate and install perimeter drains with connection to municipal storm line (Pacific Group Developments).

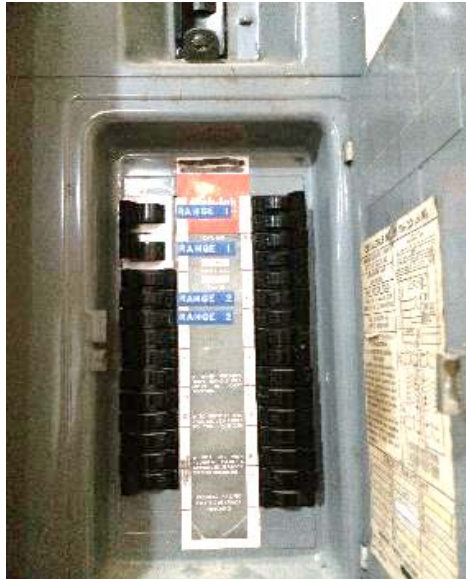
Electrical

Item		Cost (\$)	Last (Year)	Period (yrs)	Adjusted (yrs)	Next (Year)
Power Distribution Main	Maintenance Replacement	\$ 3,500	1954	50	15	2019
Lighting - Interior	Maintenance Replacement	\$ 2,800	2000	35		2035
Wiring Devices	Maintenance Replacement	\$ 800	2000	30		2030
Electric Heating Baseboard	Maintenance Replacement	\$ 2,000	2000	30		2030

Interior lighting may require replacement in the next 20 years. Scheduled at the end of the 20-year period for consideration.

Original distribution panel is beyond it's expected service life.

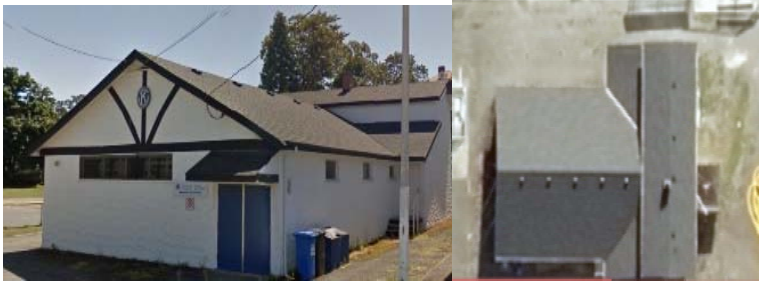
<p style="text-align: center;"><i>Figure No.20 – Girl Guides Hall</i></p>
---	--

<p>1703 Monterey Avenue – Oak Bay Fireman’s Park</p> <p>Peak Occupancy: 100</p> <p>Staffing (avg.): 0</p> <p>Built: 1970</p> <p>Addition(s): 1987 Area (current): 2,644 sf</p> <p>HVAC: Oil-fired furnace, electric baseboard and DHW</p> <p>Fire Suppression: Extinguishes</p> <p>Access: Parking stalls at-grade, wheelchair access</p>

BUILDING ENVELOPE: The building envelope is very similar in construction to the Boy Scout Hall with an exception being resting on a slab-on-grade versus over a crawlspace. Exterior walls are wood-frame construction and clad with Tudor-style stucco. Wood trim and fascia board finish gable ends, rooflines and windows. Windows are original non-thermally broken metal-frame (fixed, single-pane), while exterior doors

1. Similar to No.19 Boy Scout Hall, stucco extends down to grade with visible wetting near grade. Extensive cracking noted, leaving the face sealed assembly susceptible to potential water ingress. Further potential water ingress where the lean-to shed meets the south elevation; notable gap between stucco and low sloped roof that drains back into wall. Walls are assumed to be “at-risk” pending BECA study.
2. Asphalt shingles exhibited significant amounts of organic growth on north and west facing areas.
3. Downspouts are not connected to perimeter drains.
4. Three-step staircase at west elevation entrance/exit is severely deteriorated and requires replacement.
5. Oil furnace not accessible to review during site visit, was located in locked shed.
6. While the drawings indicate perimeter drains, visual review revealed that they were not installed.

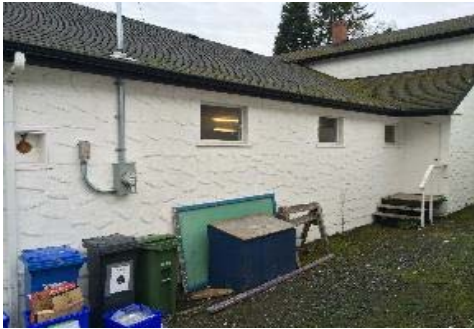
Building Envelope

Item		Cost (\$)	Last (Year)	Period (yrs)	Adjusted (yrs)	Next (Year)
Stucco	Maintenance					
	Replacement	\$ 55,000	1970	60	-12	2018
Cedar Trim	Maintenance					
	Replacement	\$ 1,500	1970	60	-12	2018
Soffit Wood	Maintenance					
	Replacement	\$ 700	1970	60	-12	2018
Exterior Doors Metal	Maintenance					
	Replacement	\$ 2,100	1970	60		2030
Windows Aluminum	Maintenance					
	Replacement	\$ 16,500	1970	45	2	2017
Asphalt Shingles	Maintenance					
	Replacement	\$ 7,300	2005	20		2025
Gutters & Downspouts	Maintenance					
	Replacement	\$ 1,600	2005	20		2025
Exterior Staircase	Maintenance					
	Replacement	\$ 800				2016

Asphalt shingles exhibited substantial organic growth which is recommended for cleaning as annual maintenance to maintain shingle integrity.

A building envelope condition assessment (BECA) is recommended on the building to determine the underlying condition. From visual review, replacement of stucco, cedar trim, wood soffit, and single-pane windows is scheduled together within the next five years. An allowance of 1/3 the replacement cost is budgeted to refurbish existing.

Small exterior staircase on east side of building is deteriorated and unsafe. Recommended for replacement ASAP.

Windows are scheduled for renewal with either the refurbishment or rainscreen upgrade.

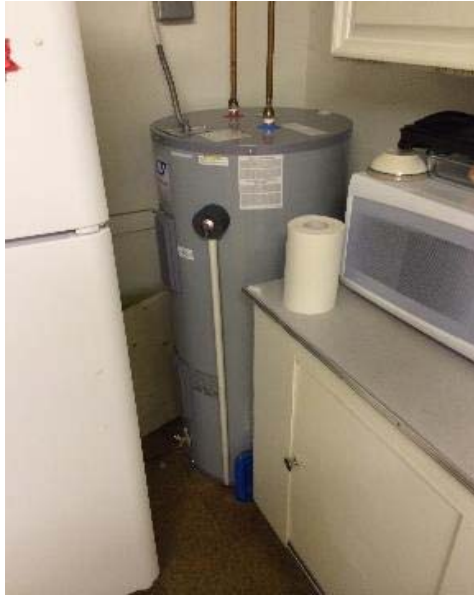
Mechanical

Item		Cost (\$)	Last (Year)	Period (yrs)	Adjusted (yrs)	Next (Year)
Oil Fired Furnace	Maintenance Replacement	\$ 7,000	1990	25	5	2020
Hot Water Tank	Maintenance Replacement	\$ 800	2013	10		2023
Plumbing Fixtures	Maintenance Replacement	\$ 1,000	2013	5		2018
Exhaust Fans	Maintenance Replacement	\$ 1,500	2000	20		2020
Perimeter Drains	Maintenance Replacement	\$ 25,000				2017

Oil storage tank not scheduled for replacement in the next 20 years. Confirm with insurance provider who may require upgrade.

Building is without perimeter drainage. Inadequate drainage appears to be contributing to deteriorating base of wall. Estimate is to excavate and install perimeter drains with connection to municipal storm line (Pacific Group Developments).

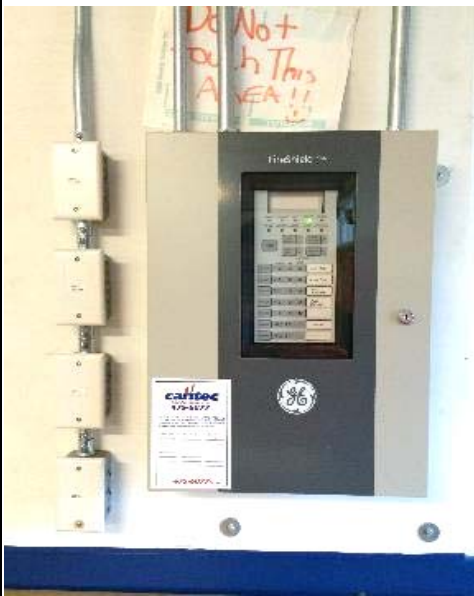
Electrical

Item		Cost (\$)	Last (Year)	Period (yrs)	Adjusted (yrs)	Next (Year)
Lighting-Interior	Maintenance Replacement	\$ 2,500	1990	35		2025
Wiring Devices	Maintenance Replacement	\$ 800	2000	30		2030
Electric Heating Baseboard	Maintenance Replacement	\$ 2,000	2000	30		2030
Fire Warning System	Maintenance Replacement	\$ 12,000	2014	20		2034

Distribution panel not expected for replacement in the next 20 years.

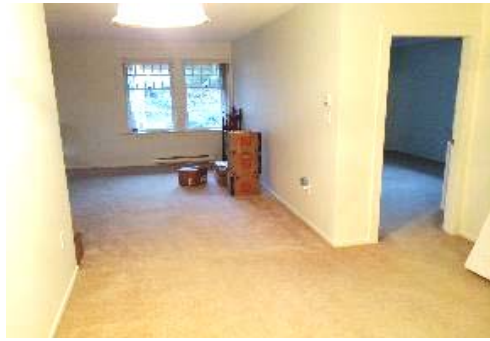
Interior Finishes

Item		Cost (\$)	Last (Year)	Period (yrs)	Adjusted (yrs)	Next (Year)
Interior Walls	Maintenance Replacement	\$ 8,000	2010	10		2020
Vinyl Sheet	Maintenance Replacement	\$ 4,800	1999	20		2019
Carpet	Maintenance Replacement	\$ 6,500	2010	10		2020
Int. Doors	Maintenance Replacement	\$ 500	2015	3		2018

Interior door maintenance includes adjustment and hardware replacement as required every 3 years.

Vinyl sheet flooring in suite washrooms and kitchens.

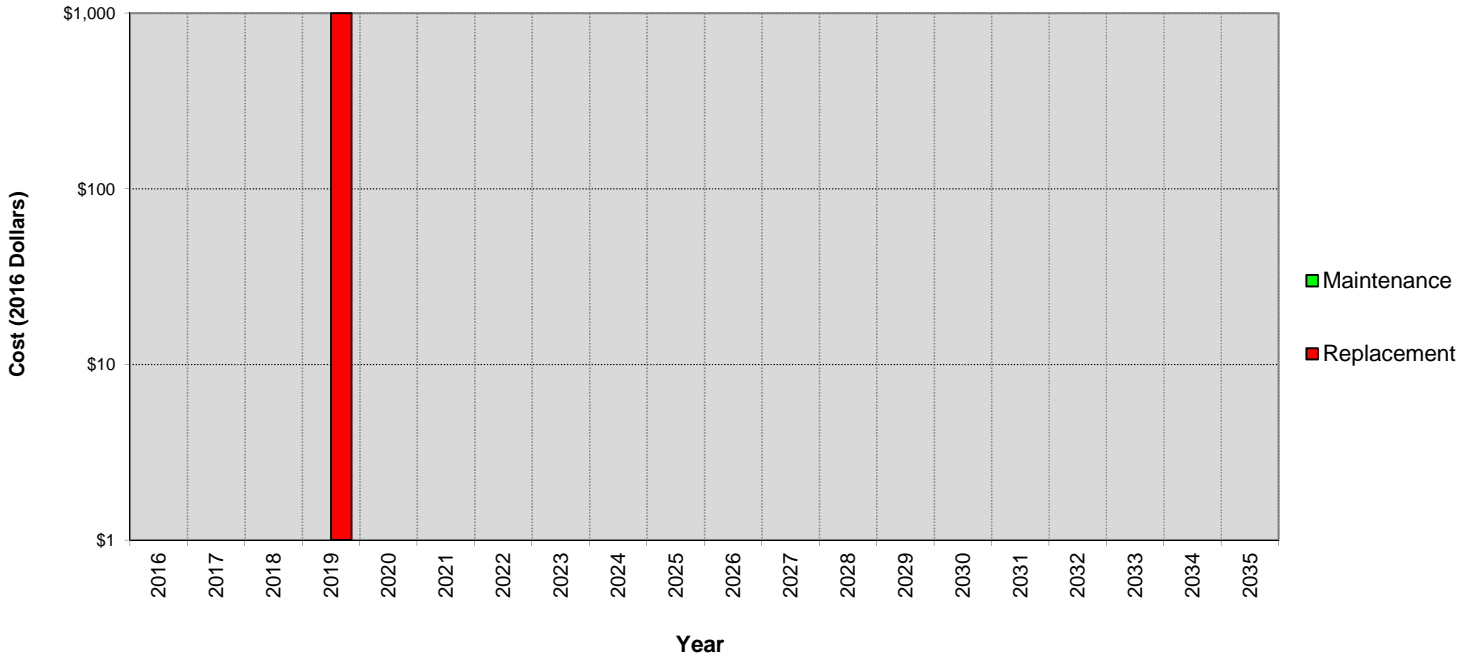
PROJECTED EXPENSES (Present Value)

The graph shows the costs associated with the maintenance and/or replacement of the component over time. The dollar axis is in logarithmic scale for ease of presentation.
