DISTRICT OF OAK BAY

BUILDING ASSET MANAGEMENT PLAN

MUNICIPAL BUILDINGS ANALYSIS

JULY 2016

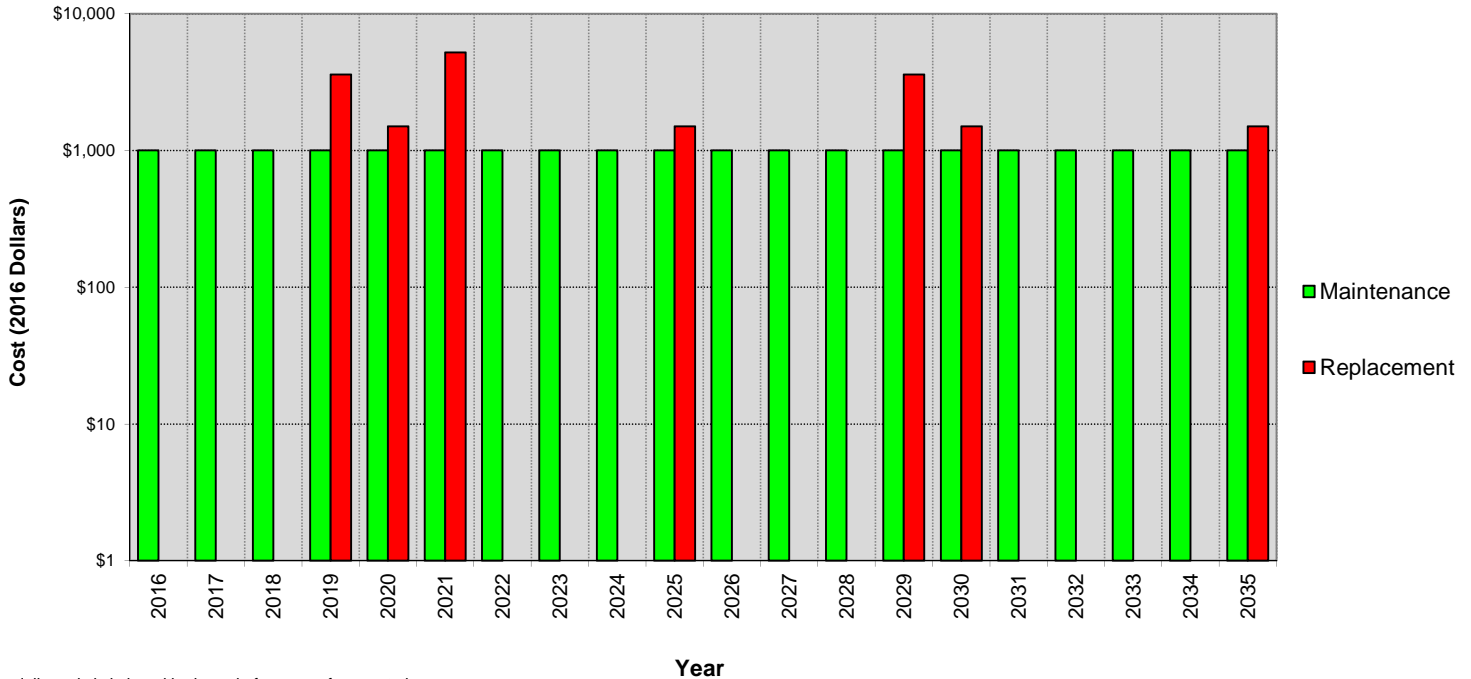
PROJECTED EXPENSES (Present Value)

The dollar axis is in logarithmic scale for ease of presentation.

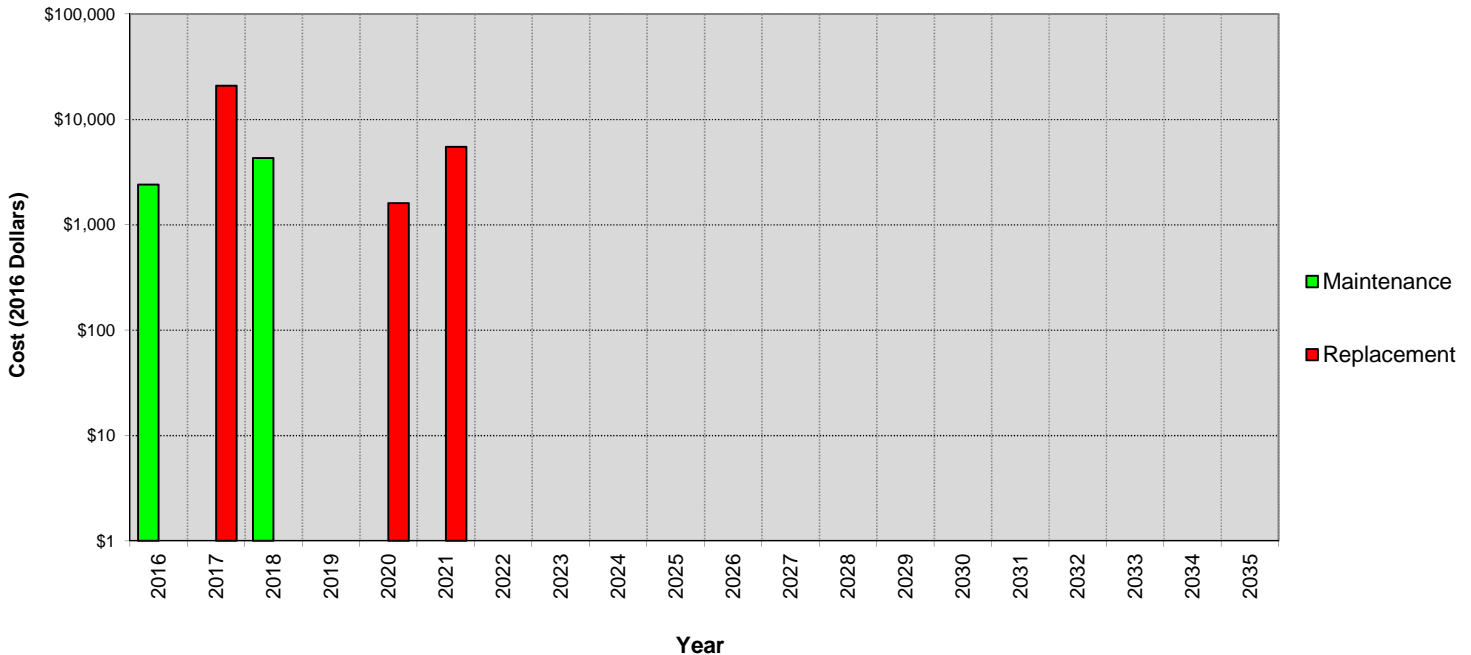
PROJECTED EXPENSES (Present Value)

The graph shows the costs associated with the maintenance and/or replacement of the component over time. The dollar axis is in logarithmic scale for ease of presentation.

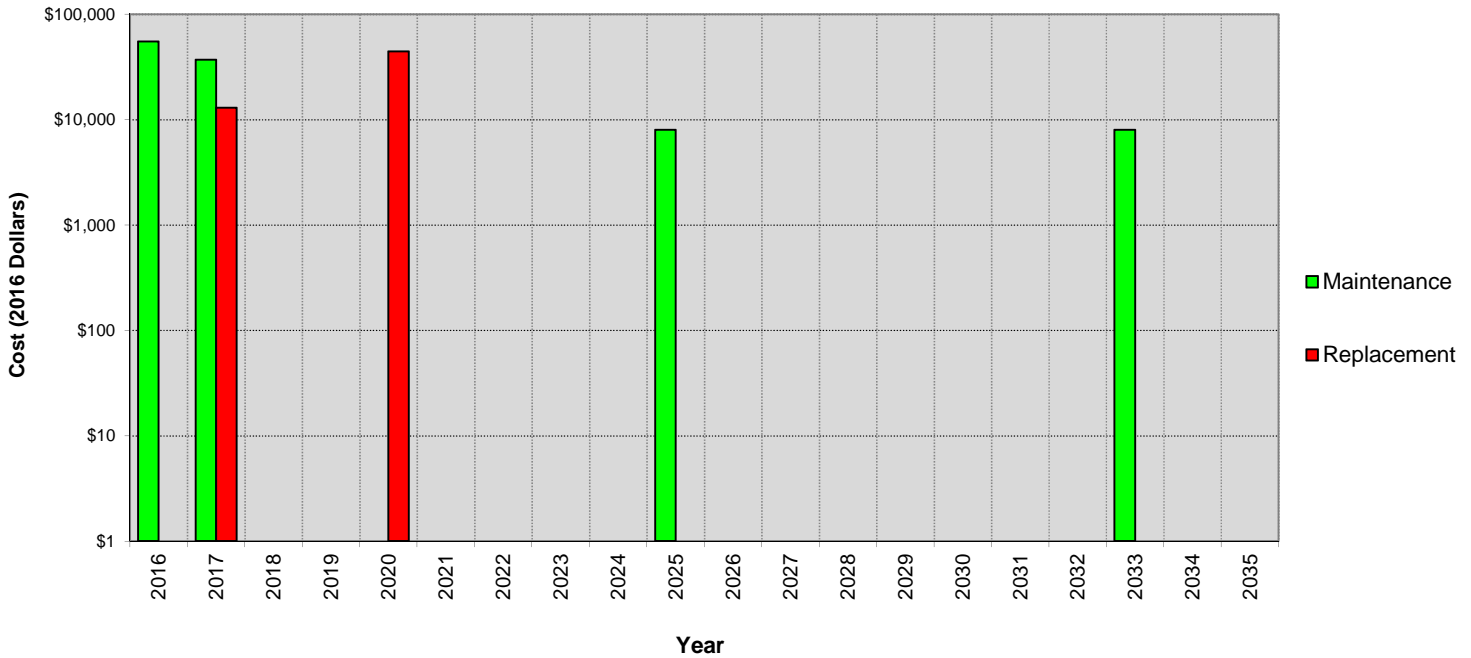
PROJECTED EXPENSES (Present Value)

The graph shows the costs associated with the maintenance and/or replacement of the component over time. The dollar axis is in logarithmic scale for ease of presentation.

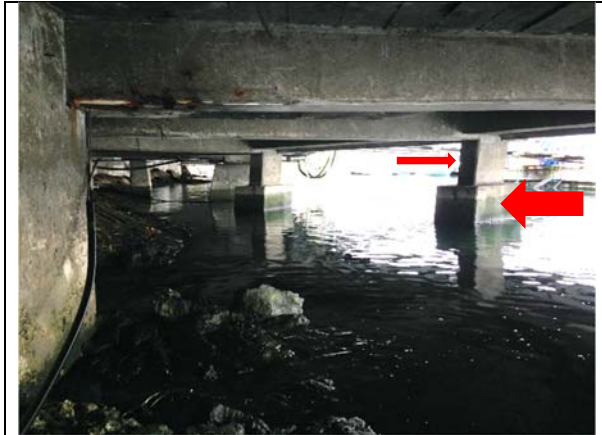
Figure 25-A: Radial beams supporting boardwalk and restaurant.

The majority of the reinforced concrete columns (thin arrow, Fig 25-A) appear to have been jacketed with a concrete shell (thick arrow, Fig 25-A) as the original drawings showed a much more slender column profile. This repair was likely completed to address reinforcement corrosion and spalling of concrete cover on the columns. The longevity of the repair is not known at this time, as no historical records related to the design and construction of the repair have been provided.

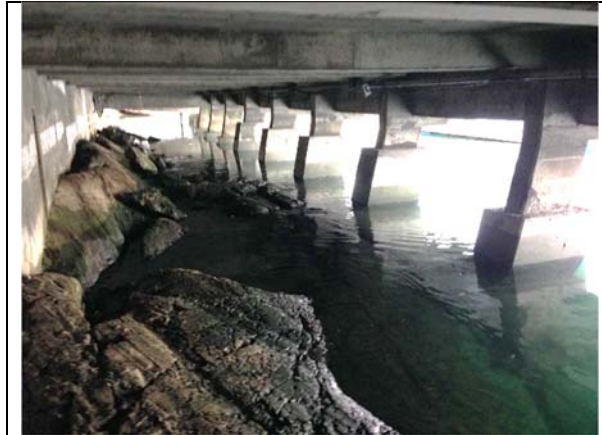
Figure 25-B: East-West concrete beams supporting building 25 offices.

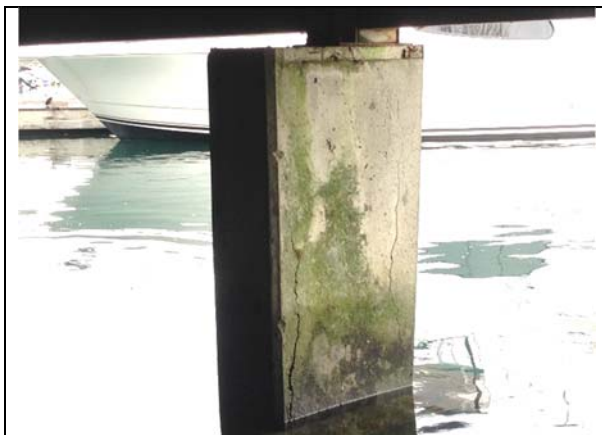
Figure 25-C: Cracks and saltwater ingress at column supporting restaurant has reduced strength and accelerated corrosion.

Active corrosion of the reinforcing steel was noted. Repair of spalled concrete and installation of additional reinforcement is required at discrete locations. Protection of the beams from chloride ingress is recommended increase the service life of the structure.

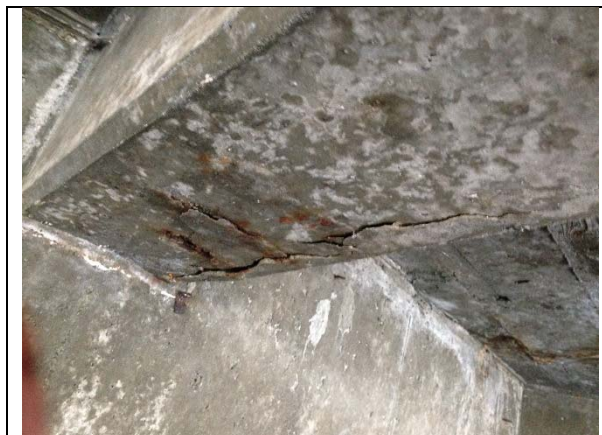
Figure 25-D: Sample of spalling concrete.

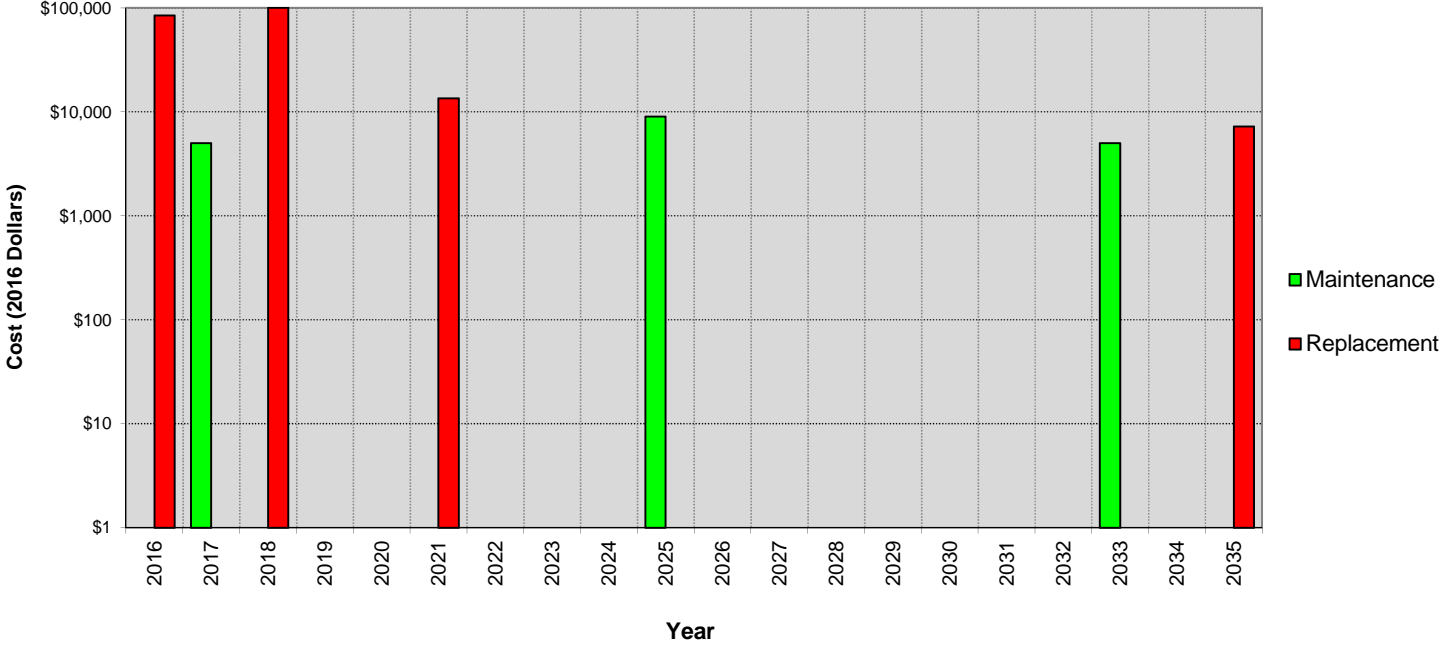
PROJECTED EXPENSES (Present Value)

The graph shows the costs associated with the maintenance and/or replacement of the component over time. The dollar axis is in logarithmic scale for ease of presentation.

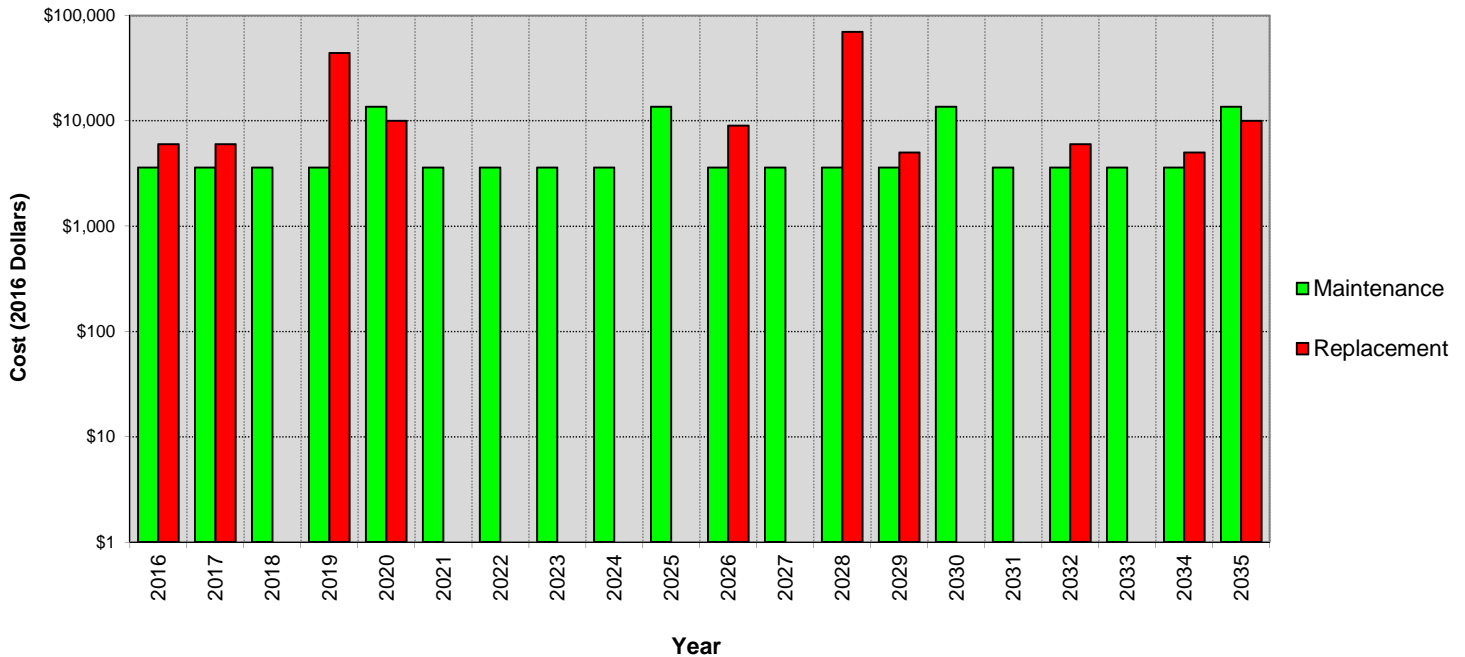
PROJECTED EXPENSES (Present Value)

The dollar axis is in logarithmic scale for ease of presentation.

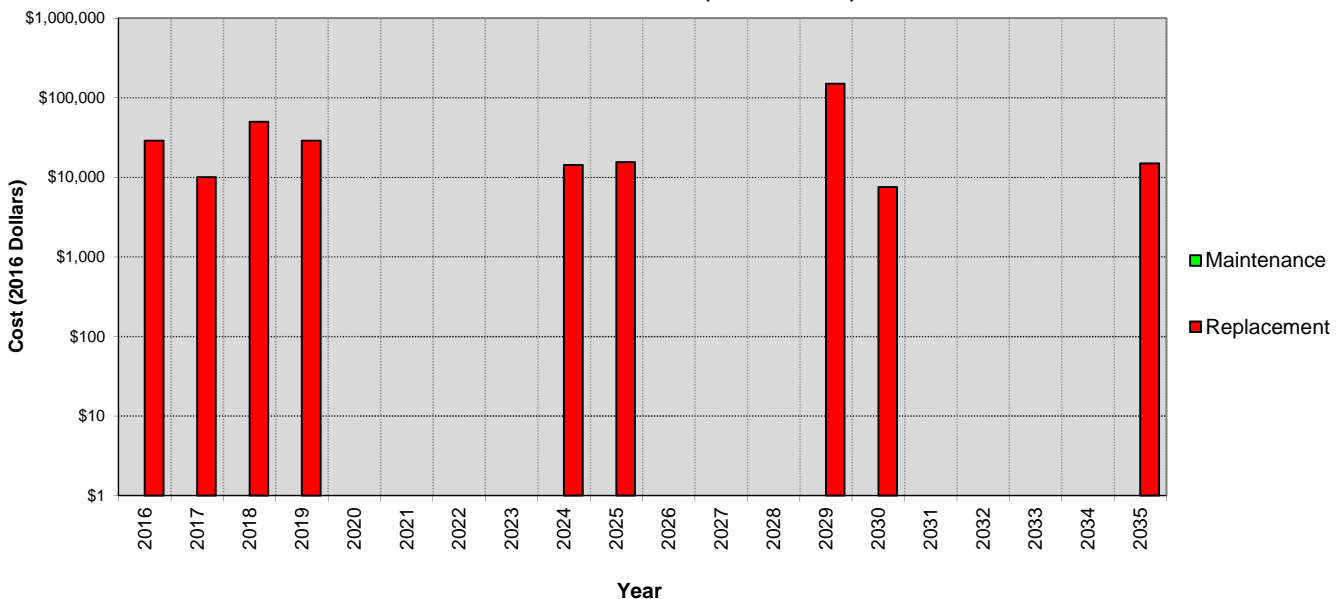
PROJECTED EXPENSES (Present Value)

The dollar axis is in logarithmic scale for ease of presentation.

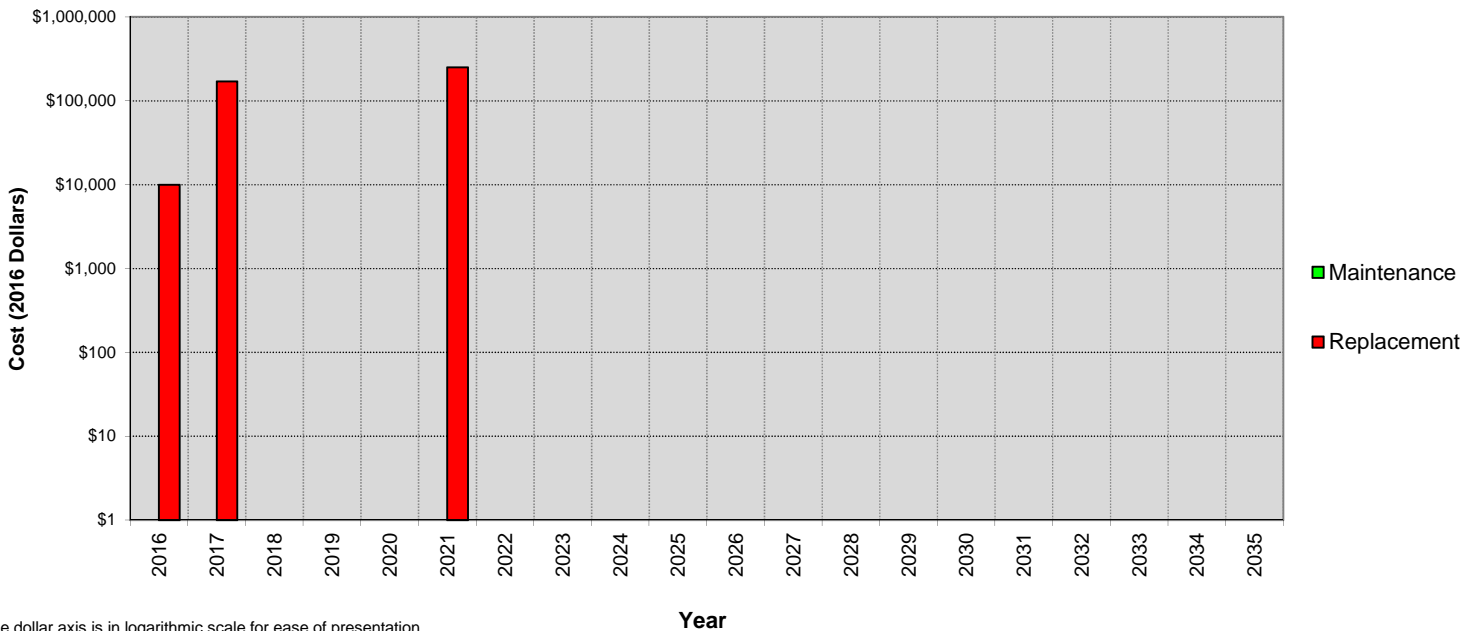
PROJECTED EXPENSES (Present Value)

The dollar axis is in logarithmic scale for ease of presentation.

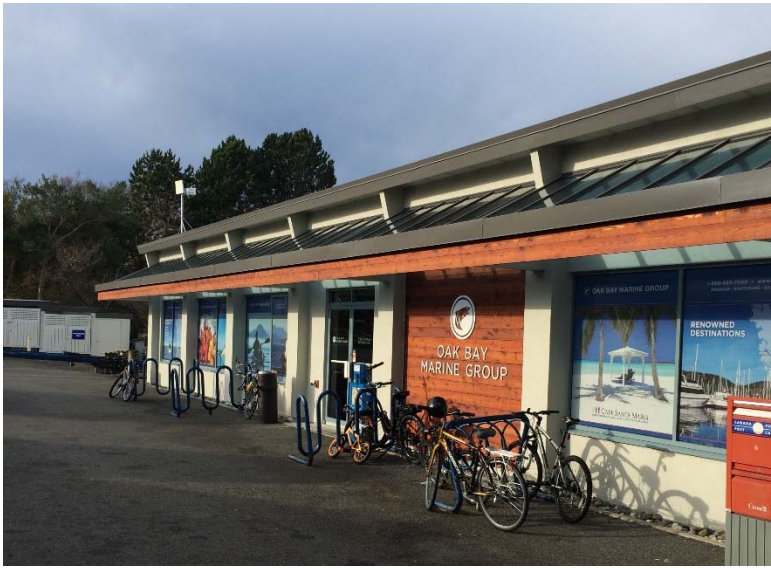
Figure 13 No. 25 – Marina Office

<p>1327 Beach Drive</p> <p>Peak Occupancy: 50 Persons</p> <p>Staffing (avg.): 20 Persons</p> <p>Built: 1962</p> <p>Addition(s): None Area (current): 4,564</p> <p>HVAC: Fan coil units (3), condensing units (3)</p> <p>Fire Suppression: Extinguishers</p> <p>Access: Parking stalls at-grade, wheelchair access</p>

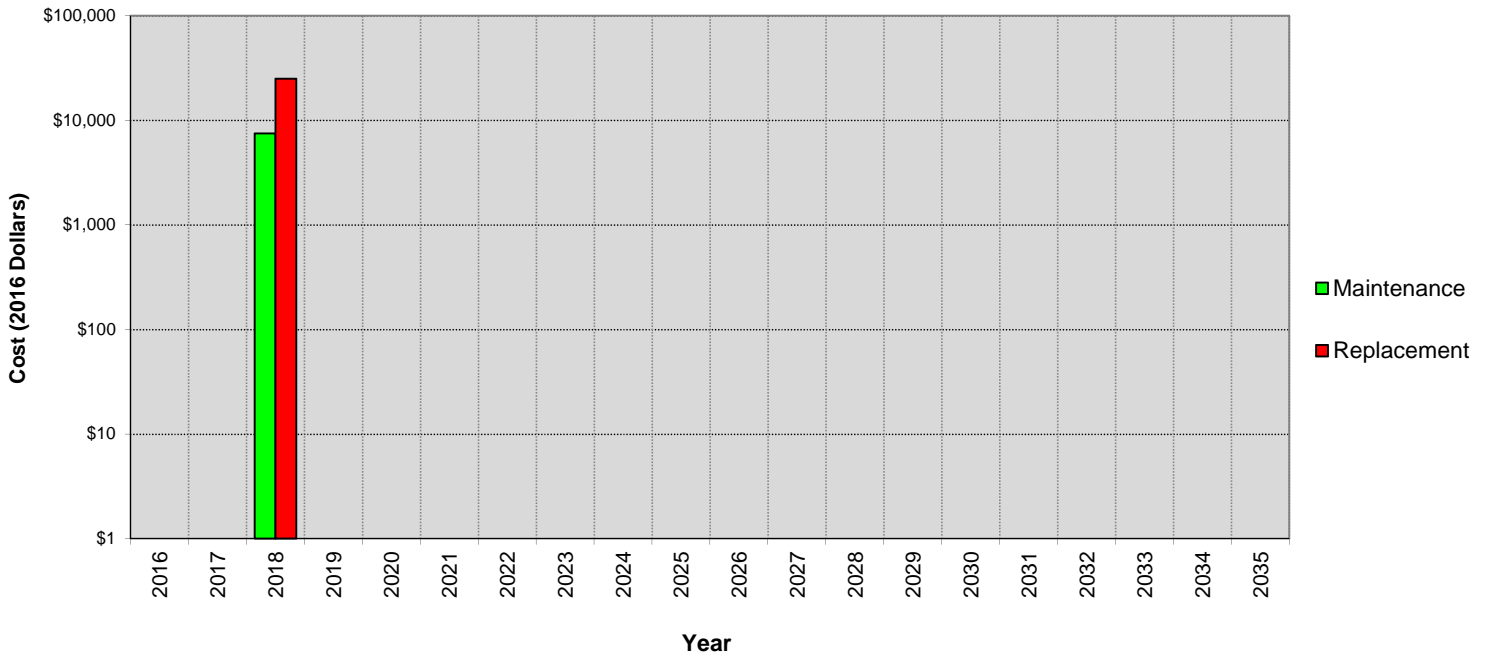
PROJECTED EXPENSES (Present Value)

The dollar axis is in logarithmic scale for ease of presentation.

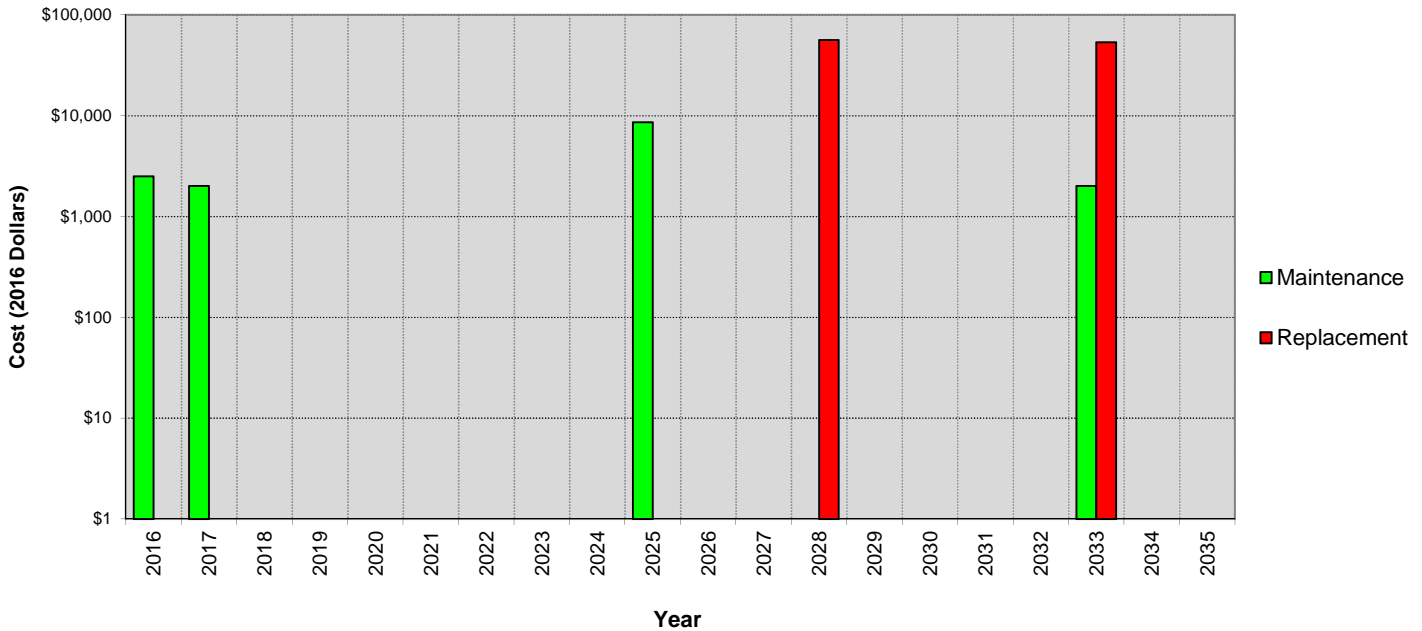
PROJECTED EXPENSES (Present Value)

The graph shows the costs associated with the maintenance and/or replacement of the component over time. The dollar axis is in logarithmic scale for ease of presentation.

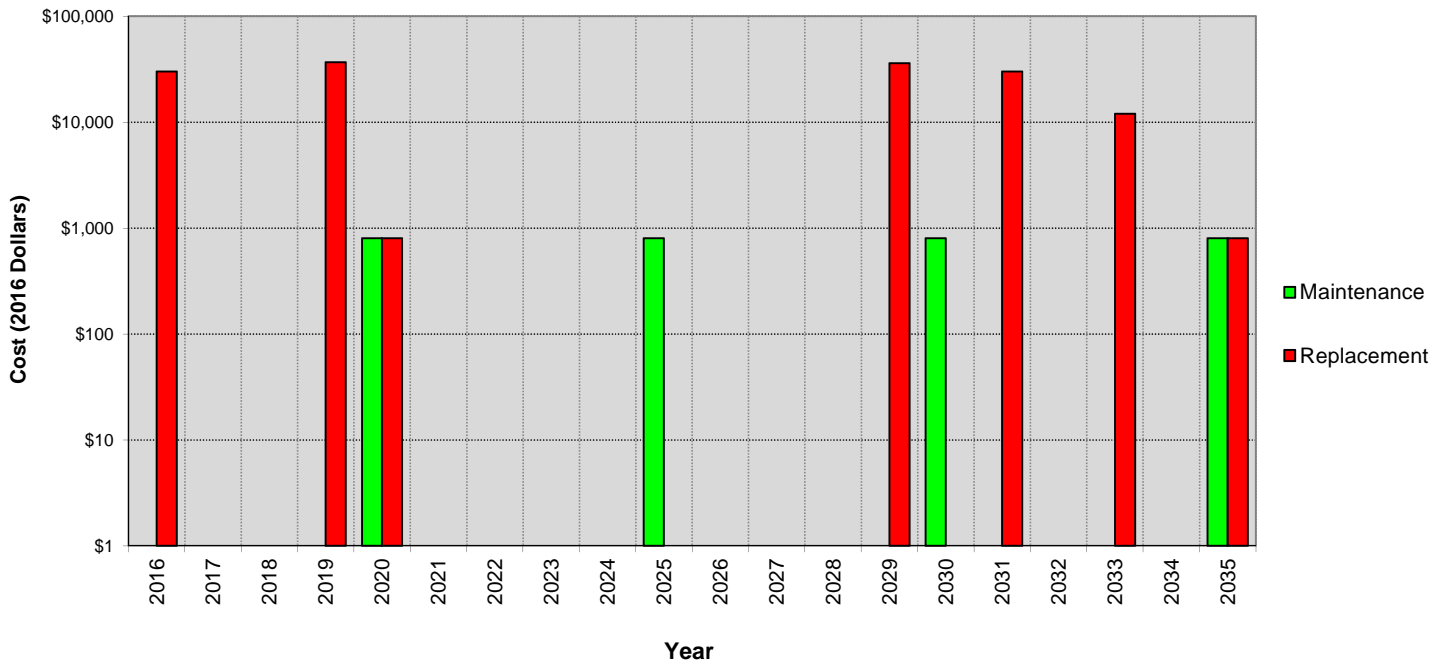
PROJECTED EXPENSES (Present Value)

The dollar axis is in logarithmic scale for ease of presentation.

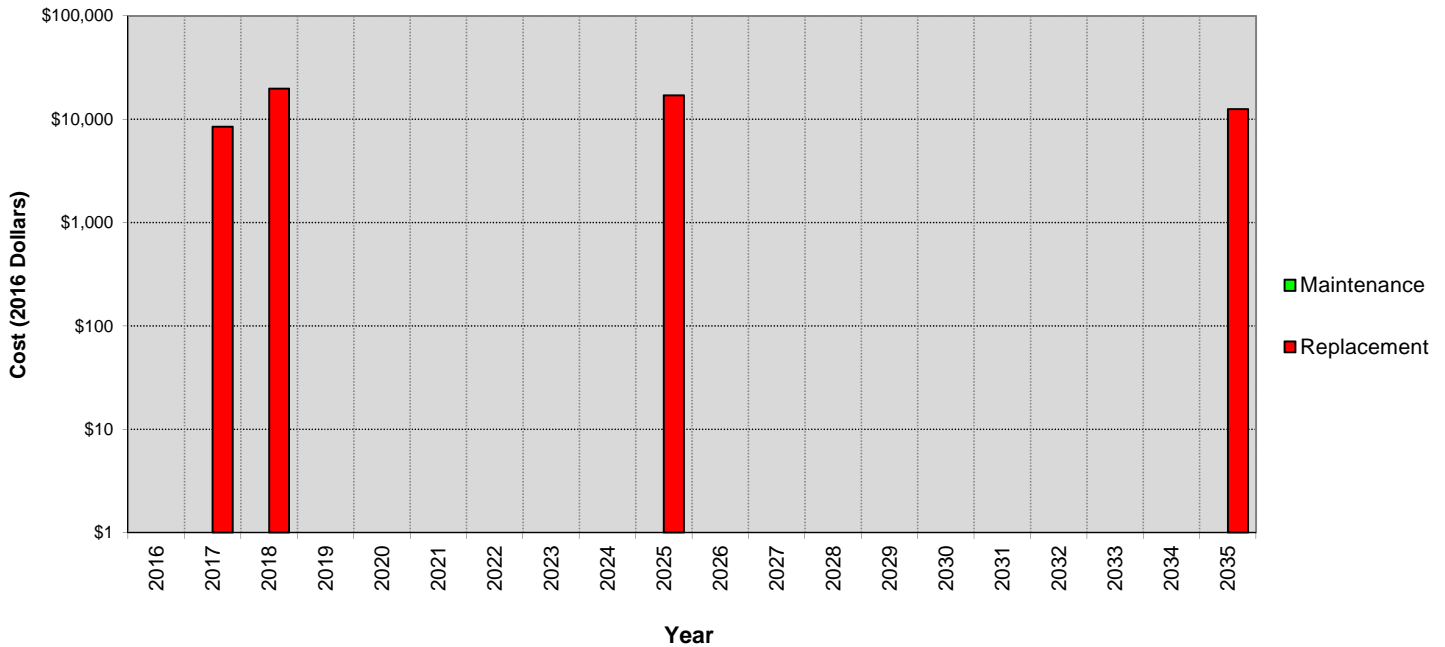
PROJECTED EXPENSES (Present Value)

The dollar axis is in logarithmic scale for ease of presentation.

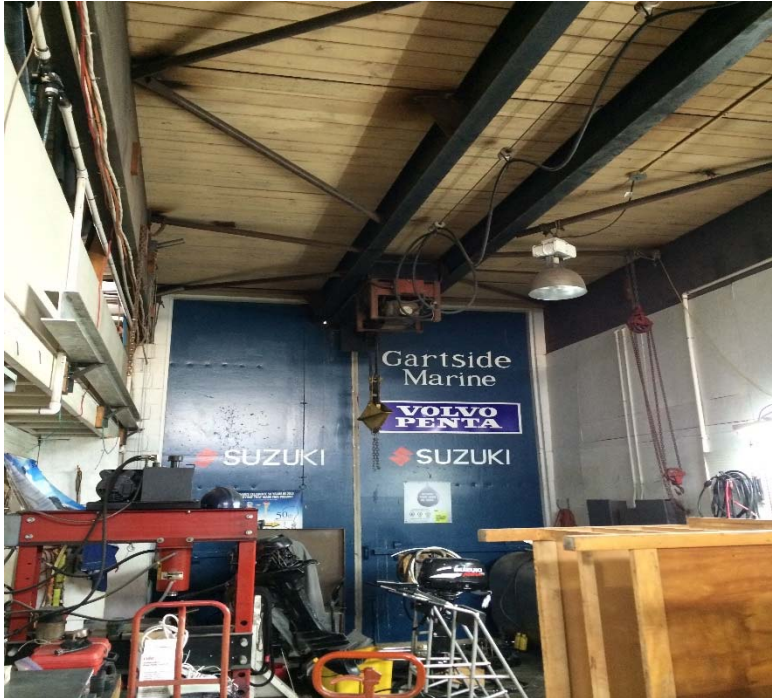
Figure 14 No. 26 – Marina Dockworks

<p>1327 Beach Drive</p> <p>Peak Occupancy: 10 Persons</p> <p>Staffing (avg.): 5 Persons</p> <p>Built: 1964</p> <p>Addition(s): None</p> <p>Current Area: 1,824 sf</p> <p>HVAC: Oil-fired furnace</p> <p>Fire Suppression: Extinguishers</p> <p>Access: Parking stalls at-grade, wheelchair access</p>

The Marina Dockworks is a detached building that lies to the west of the Marina Office. It was constructed with the other Marina buildings in 1964 and is accessed on the east façade via the wood decking walkway (parking lot side). At one time the building hauled boats up its north (water) facing gang way for servicing; present day, the gang way is no longer operating. The Oak Bay Dockworks building, managed by OBMG repairs marine engines and parts. The building plan is composed of a main shop floor with a wooden staircase on the west side leading up to loft storage and a workshop.

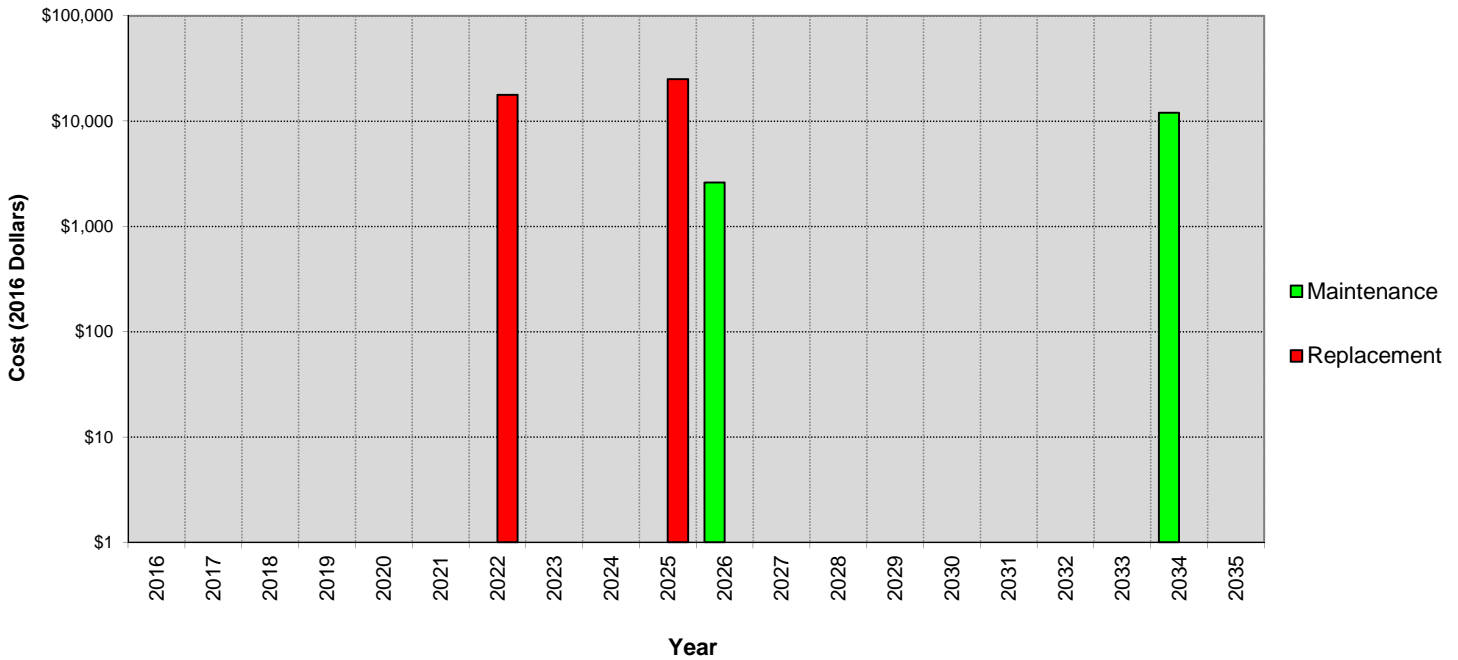
PROJECTED EXPENSES (Present Value)

The graph shows the costs associated with the maintenance and/or replacement of the component over time. The dollar axis is in logarithmic scale for ease of presentation.

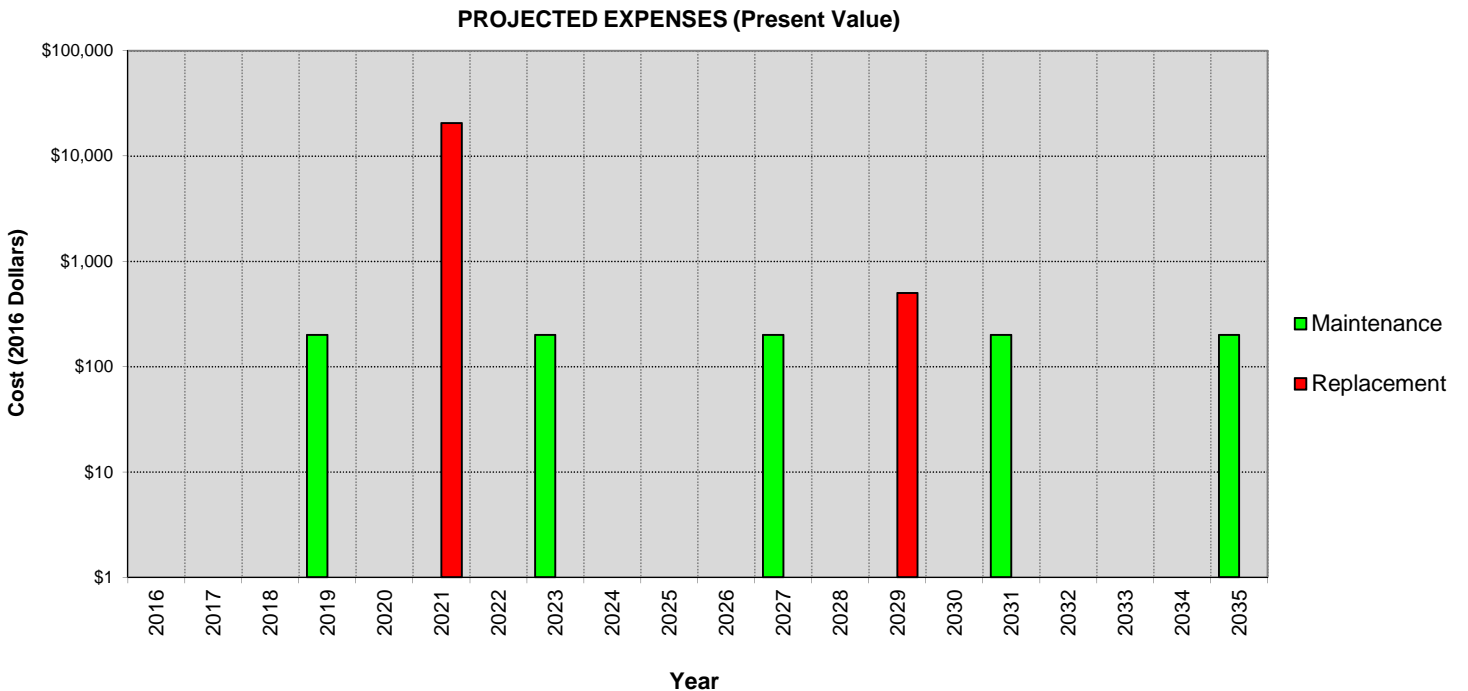
The dollar axis is in logarithmic scale for ease of presentation.

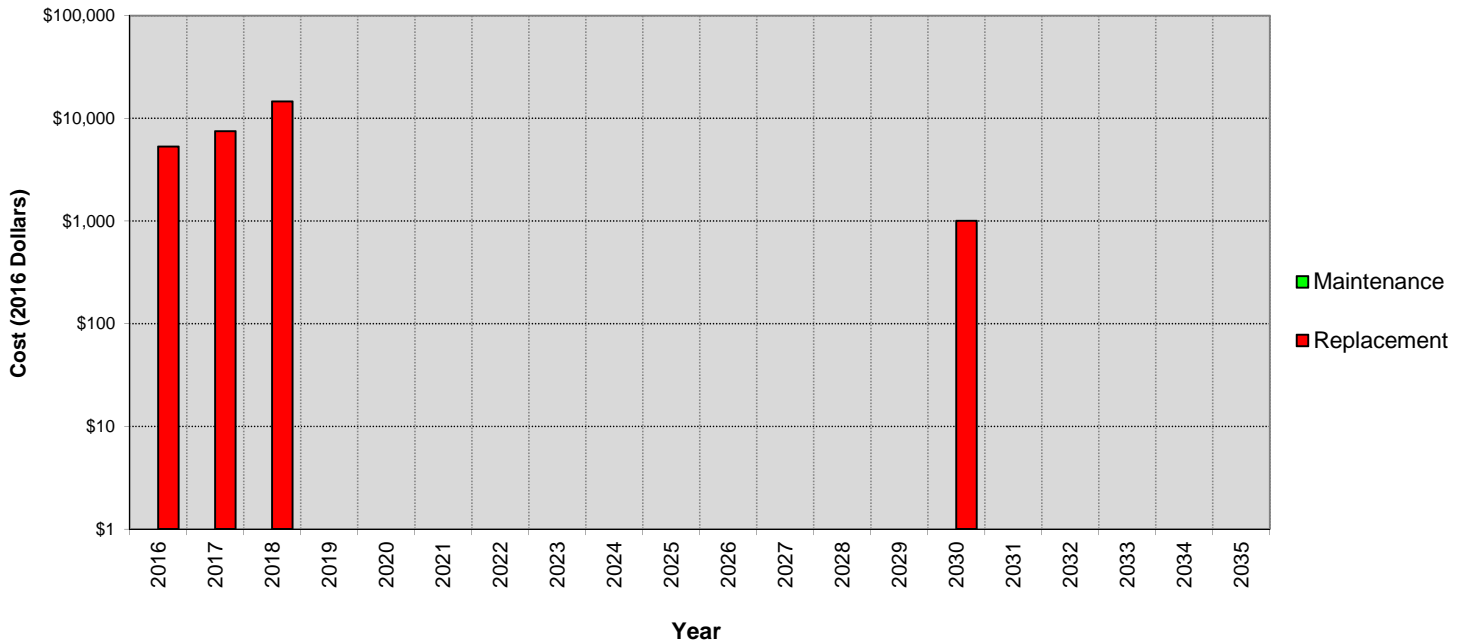
PROJECTED EXPENSES (Present Value)

The dollar axis is in logarithmic scale for ease of presentation.
