TOD HOUSE, 2564 HERON STREET OAK BAY - CONDITION SURVEY AND SPECIFICATION DRAWINGS

PREPARED FOR THE DISTRICT OF OAK BAY

Conservation and Repair
Specification, Tod House,
2564 Heron Street, Oak
Bay

Aug. 2020

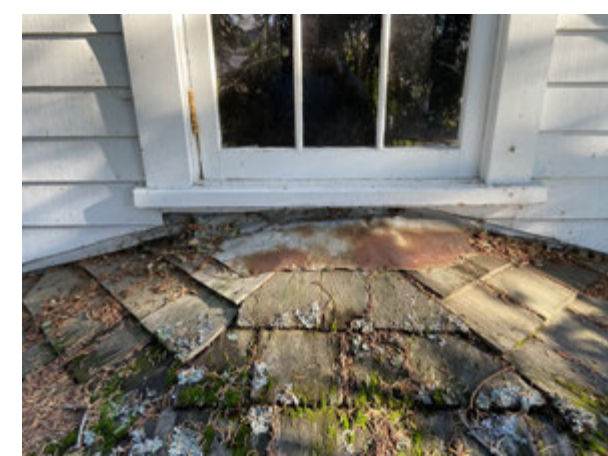
W12 sill with roof flashing.

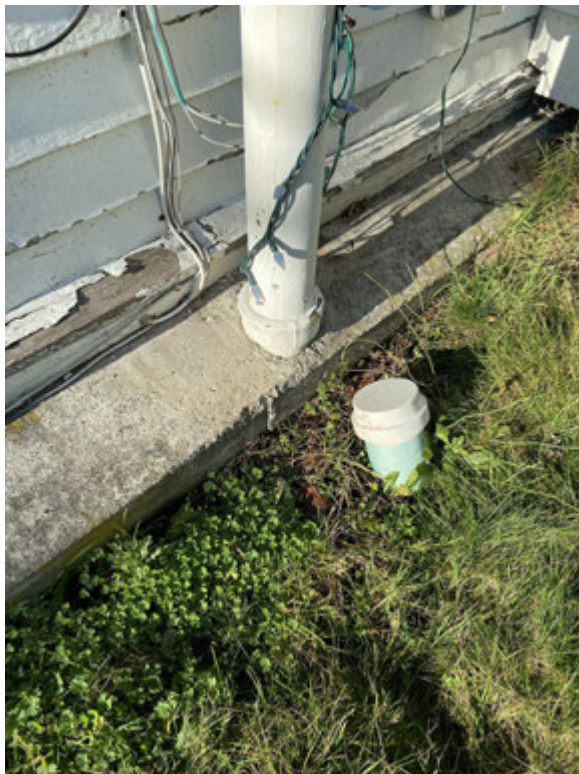
East Elevation. Soil pipe vent detail.

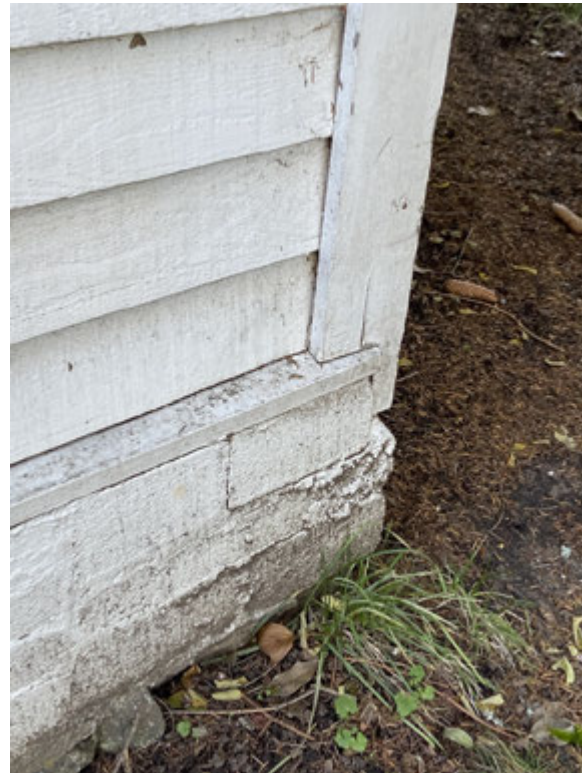
Northwest corner. Brick and block foundation detail.

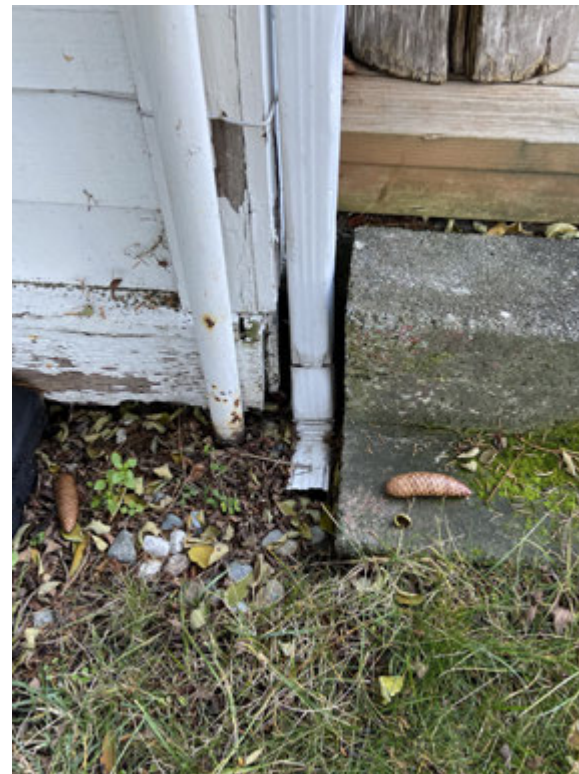
Downspout detail Southwest corner.

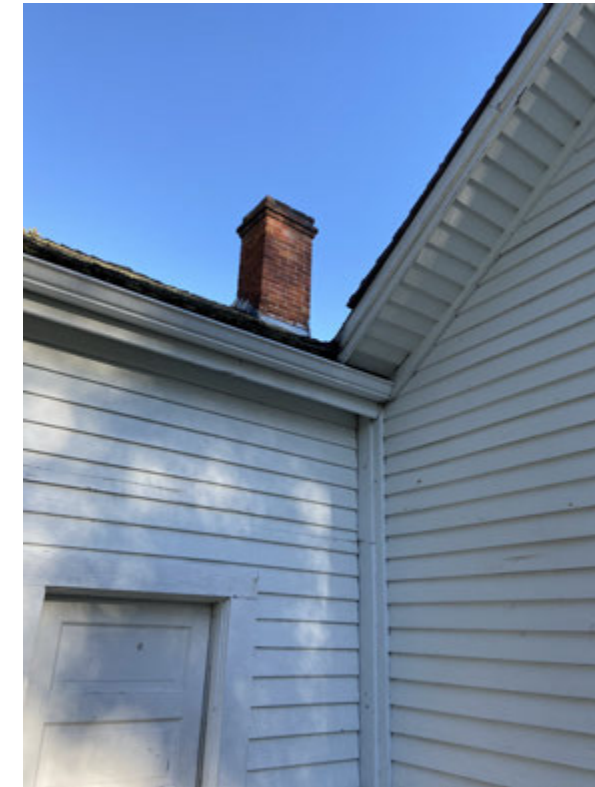
Valley gutter detail West Elevation.

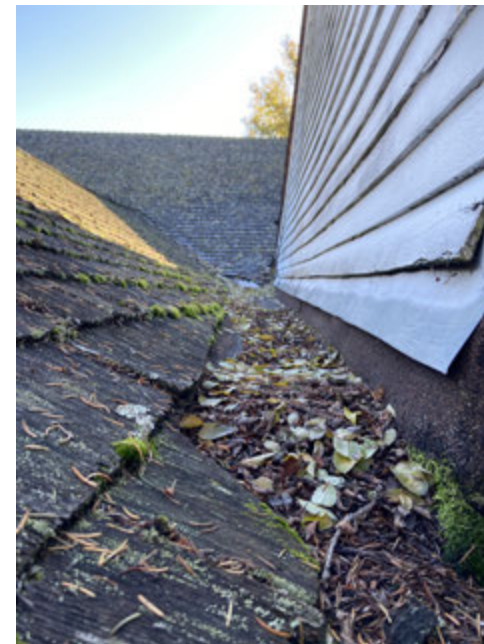
Valley gutter flashing detail.
