Facility Condition Assessment

2022 - Simple Inflation Update to Report

Oak Bay Marina
1327 Beach Drive, Victoria, British Columbia
March 08, 2022

Project Number **221-02267-00**

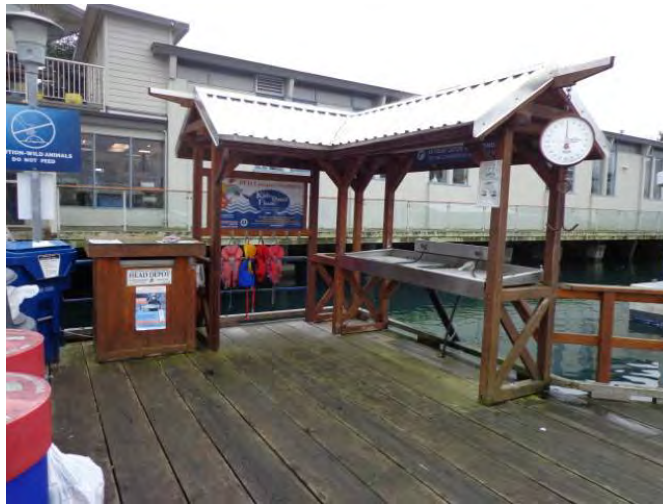
Photo #49: Marina Dock Fish Cleaning Station

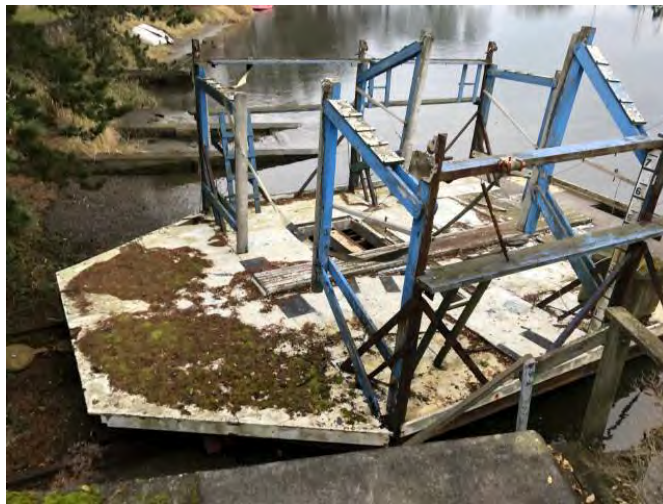
Photo #53: Marina Way.

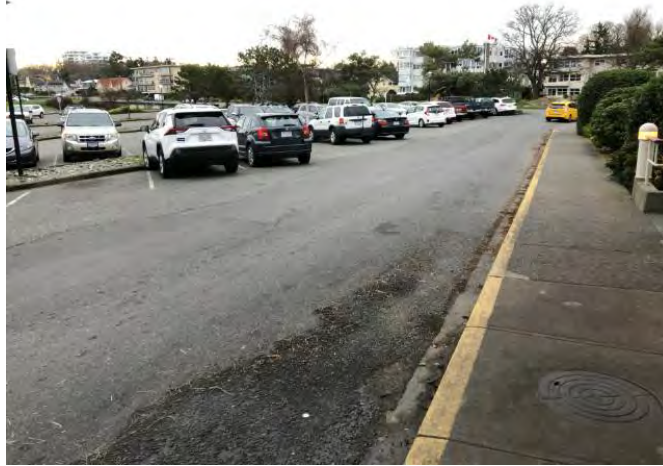
Photo #59: Parking Lot and Sidewalks - Typical.

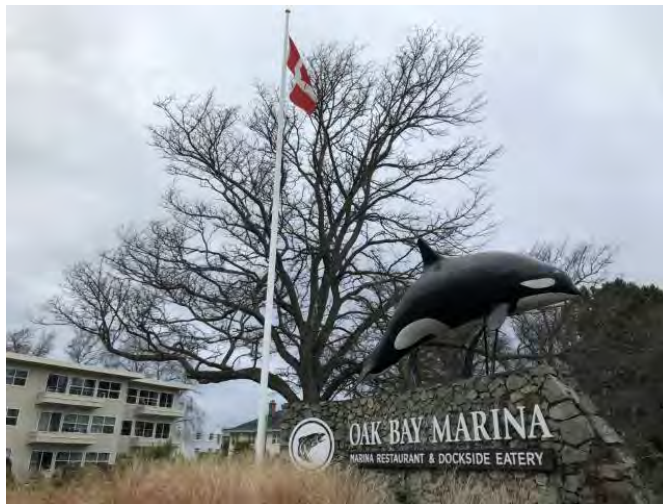
Photo #65: Entrance Sign and Flag Pole.

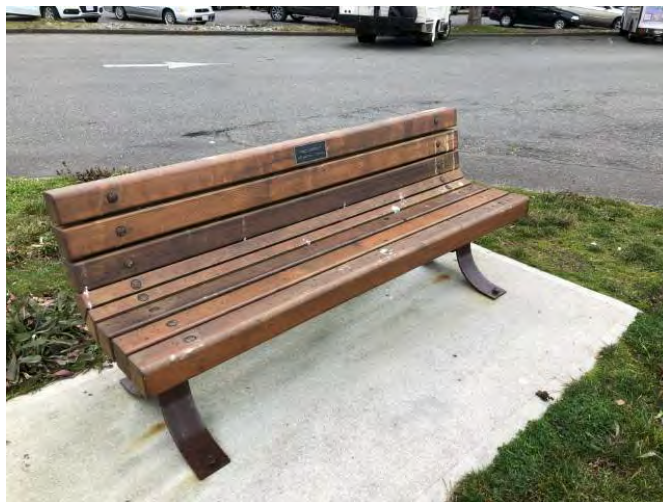
Photo #66: Site Bench - Typical.

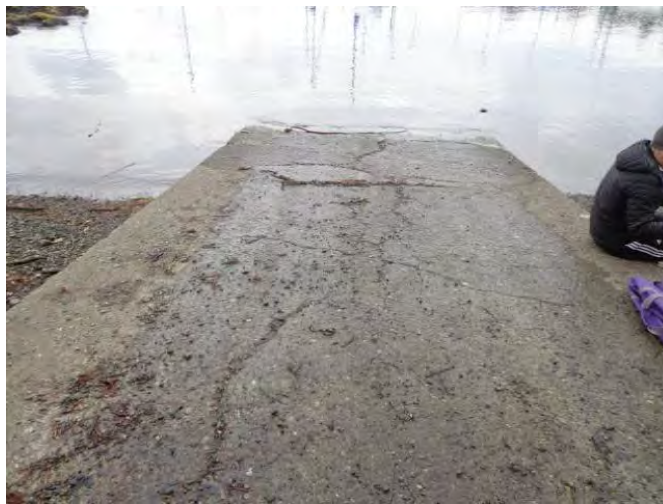
Photo #68: Boat Access Ramp

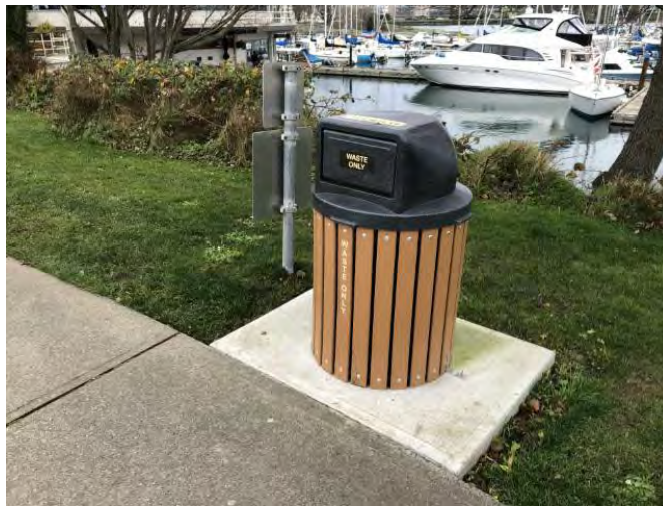
Photo #77: Trash Bin - Typical.
